GROUP 54D

CONTROLLER AREA NETWORK (CAN)

GENERAL INFORMATION

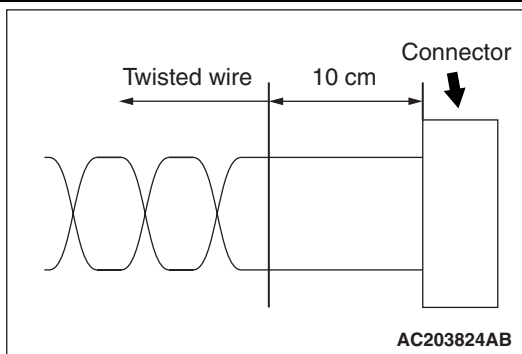
⚠ CAUTION The strand end of the twist wire should be within 10 cm from the connector.

<p>If you repair the wire due to a defective connector or its terminal or harness wire, you should cut the wire so that the strand end of the twist wire should be within 10 cm from the connector as shown. If it exceeds 10 cm, twist the wiring harness just like the original twisted wire. If the strand end exceeds 10 cm (4.0 inches), a communication error may be caused.</p>
⚠ CAUTION Strictly observe the specified wiring harness repair procedure.	When you repair a CAN bus line, observe the precautions on how to repair the CAN bus line strictly. Refer to P.54D-6 . If a new wire is added or a splice point is modified for the CAN_L or CAN_H line, an error in the CAN communication may be caused.

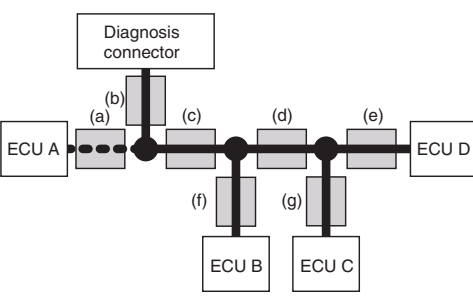
<p align="right">AC204742 AZ</p>
ECU.	CAN bus line (g) and power supply system to ECU.	<p>ECU C communicates with the M.U.T.-III via CAN bus lines (b), (c), (d) and (g). The M.U.T.-III judges that CAN bus lines (b), (c) and (d) are normal, because it can communicate with ECUs B and D. Possible trouble may be present in CAN bus line (g) or the power supply system to ECU C.</p>

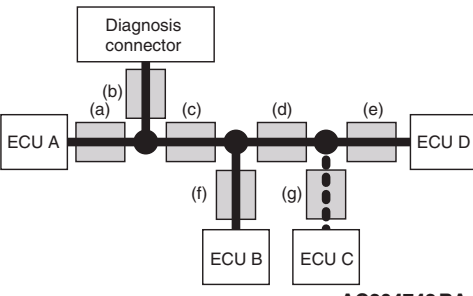
<p align="right">AC204742 BA</p>

ECU which cannot communicate with the M.U.T.-III	Possible trouble spot	Logic for narrowing down trouble spot
ECU C and ECU.	Trouble in CAN bus line (d)	<p>ECUs C and D communicate with the M.U.T.-III via CAN bus lines (b), (c), (d), (e) and (g). The M.U.T.-III judges that CAN bus lines (b) and (c) are normal, because it can communicate with ECU B. Possible trouble may be present in CAN bus line (d), (e) or (g) or the power supply system to ECU D. CAN bus line (d) is shared by ECUs C and D when they communicate with the M.U.T.-III, so CAN bus line (d) is suspected as ultimate cause. CAN bus line (g) or (e) and power supply systems to ECU C or D are also suspected as second cause.</p>
ECU B and ECU.	CAN bus line (e) or (f) or power supply system to ECU B or.	<p>ECUs C and D communicate with the M.U.T.-III via CAN bus lines (b), (c), (d), (e) and (g). The M.U.T.-III judges that CAN bus lines (b), (c) and (d) are normal, because it can communicate with ECU C. Possible trouble may be present in CAN bus line (f) or (e) or the power supply system to ECU B or D.</p>

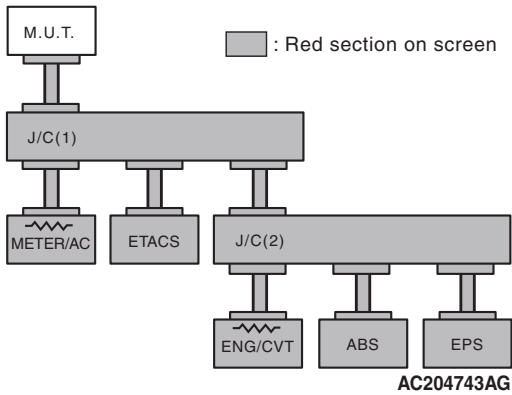
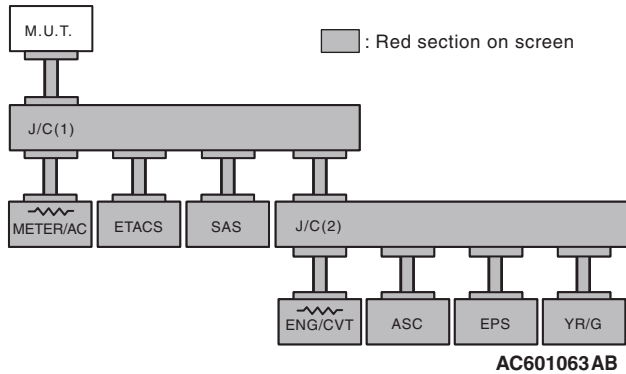
<p>AC204743AG</p>	Short circuit to battery in red displayed area is estimated.	Diagnostic Item 1 Diagnose the CAN bus lines for short to power supply.	P.54D-24
<p><Vehicles with ASC></p>

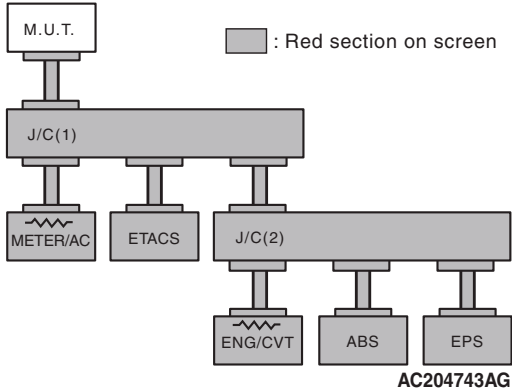
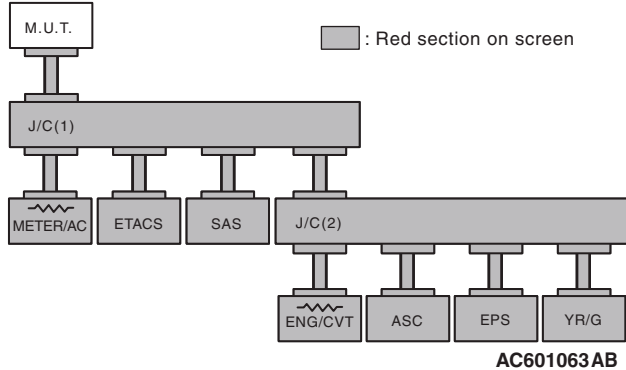
<p data-bbox="776 233 998 331">Grounding in red displayed area is estimated.</p>	<p data-bbox="1060 233 1328 365">Diagnostic Item 2 Diagnose the CAN bus lines for short to earth.</p>	<p data-bbox="1352 233 1482 260">P.54D-36</p>

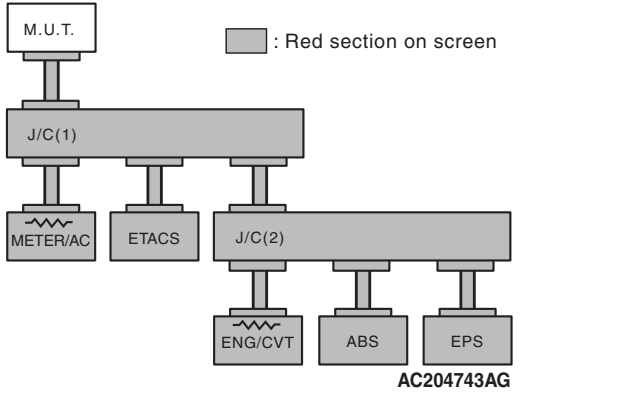
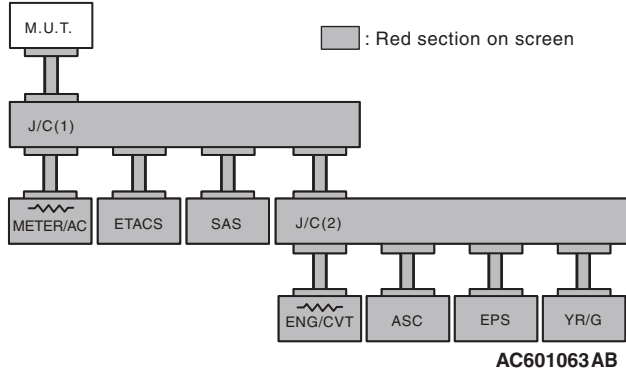
<p>Short circuit between CAN_H and CAN_L in red displayed area is estimated.</p>	<p>Diagnostic Item 3 Diagnose the lines between CAN_L and CAN_H for short circuit.</p>	<p>P.54D-48</p>

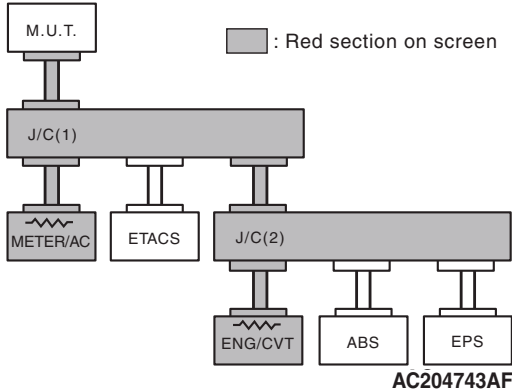
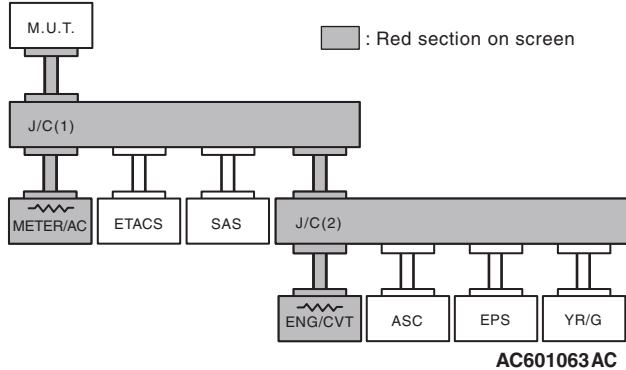
</div>	Terminating resistance trouble is estimated.	Diagnostic Item 4 Diagnose the terminator resistors at both ends.	P.54D-56

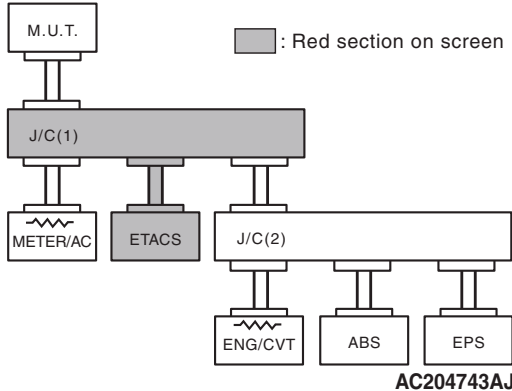
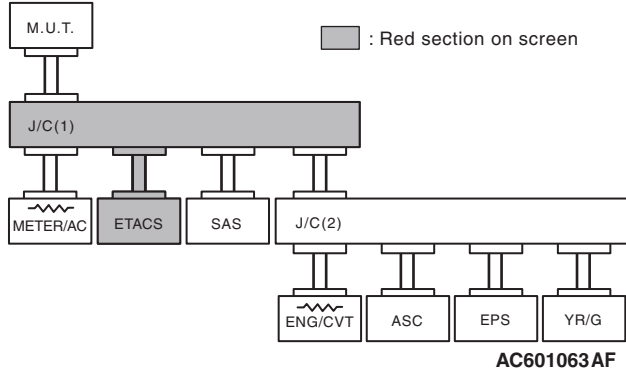
<p data-bbox="618 1167 737 1188">AC601063AF</p>	<p data-bbox="777 233 1045 327">Disconnection in red displayed area is estimated.</p>	<p data-bbox="1062 233 1331 401">Diagnostic Item 6 Diagnose when the M.U.T.-III cannot receive the data sent by ETACS-ECU.</p>	<p data-bbox="1356 233 1479 264">P.54D-61</p>

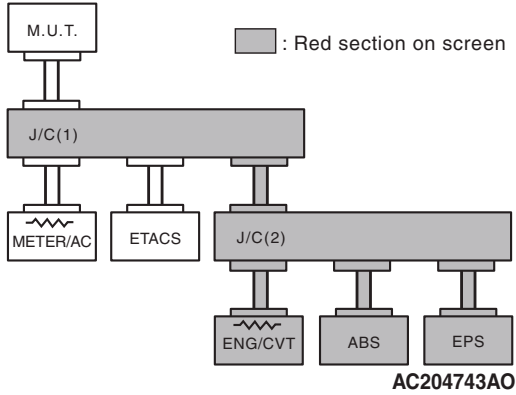
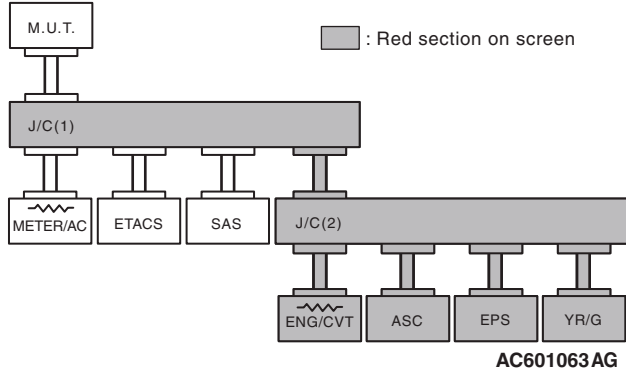
<p style="text-align: center;">AC601063AG</p>	<p>Disconnection in red displayed area is estimated.</p>	<p>Diagnostic Item 7 Diagnose the lines between the joint connectors (CAN1 and CAN2).</p>	<p>P.54D-64</p>

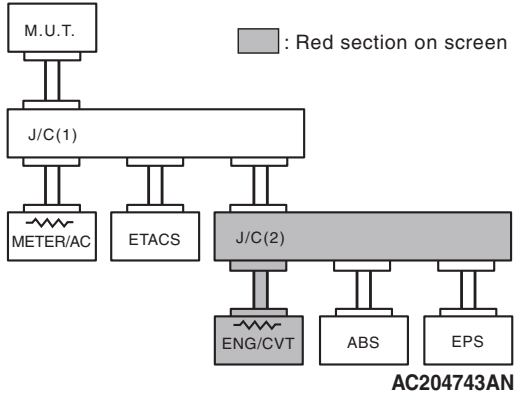
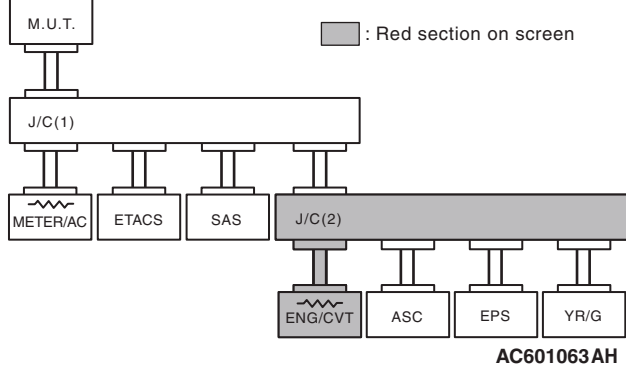
<p data-bbox="776 235 1049 331">Disconnection in red displayed area is estimated.</p>	<p data-bbox="1062 235 1333 506">Diagnostic Item 8 Diagnose when the M.U.T.-III cannot receive the data sent by engine-ECU <M/T> or engine-CVT-ECU <CVT>.</p>	<p data-bbox="1352 235 1482 262">P.54D-67</p>

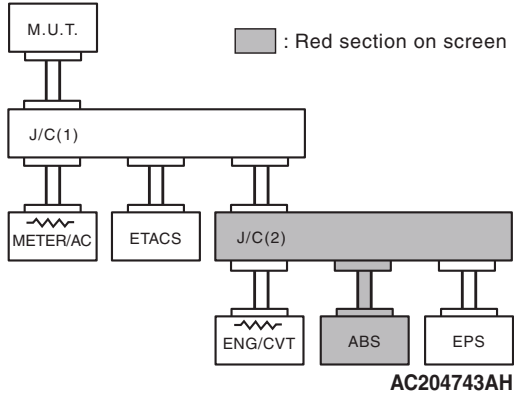
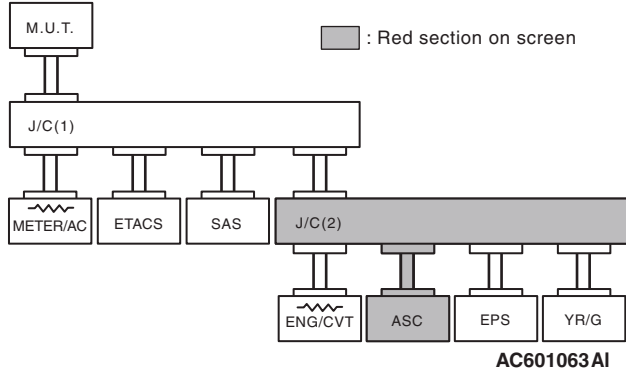
<p style="text-align: center;">AC601063AI</p>	<p>Disconnection in red displayed area is estimated.</p>	<p>Diagnostic Item 9 Diagnose when the M.U.T.-III cannot receive the data sent by ABS-ECU <vehicles without ASC> or ASC-ECU <vehicles with ASC>.</p>	<p>P.54D-71</p>

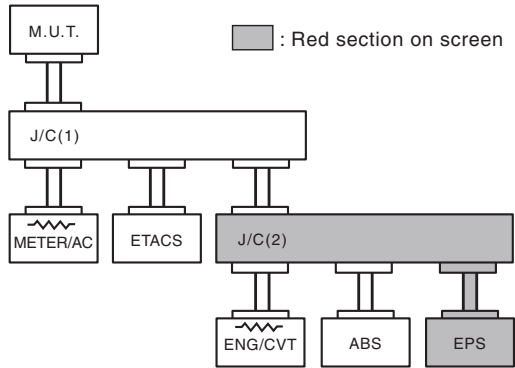
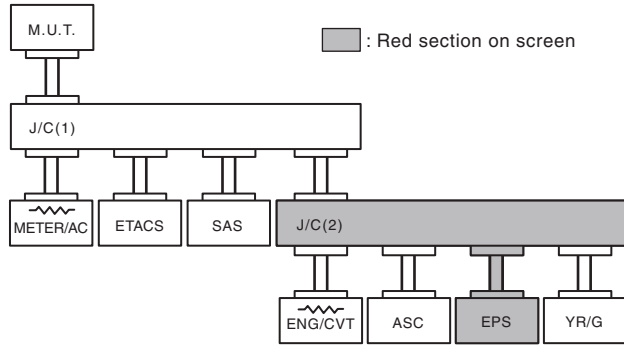
<p>AC204743AI</p>	Disconnection in red displayed area is estimated.	Diagnostic Item 10 Diagnose when the M.U.T.-III cannot receive the data sent by EPS-ECU.	P.54D-75
<p><Vehicles with ASC></p>

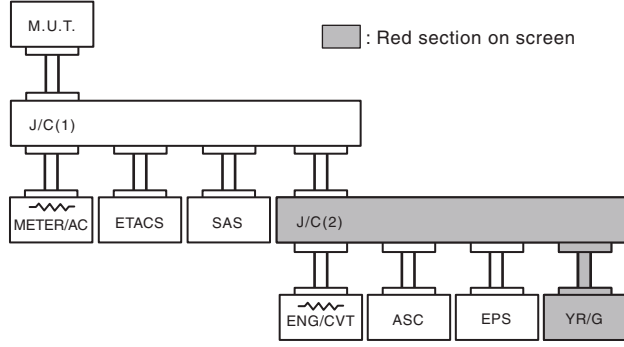
<p>AC601063AK</p>	Disconnection in red displayed area is estimated.	Diagnostic Item 11 Diagnose when the M.U.T.-III cannot receive the data sent by G and yaw rate sensor.	P.54D-78
