GROUP 54B

LOCAL
INTERCONNECT
NETWORK (LIN)

GENERAL INFORMATION

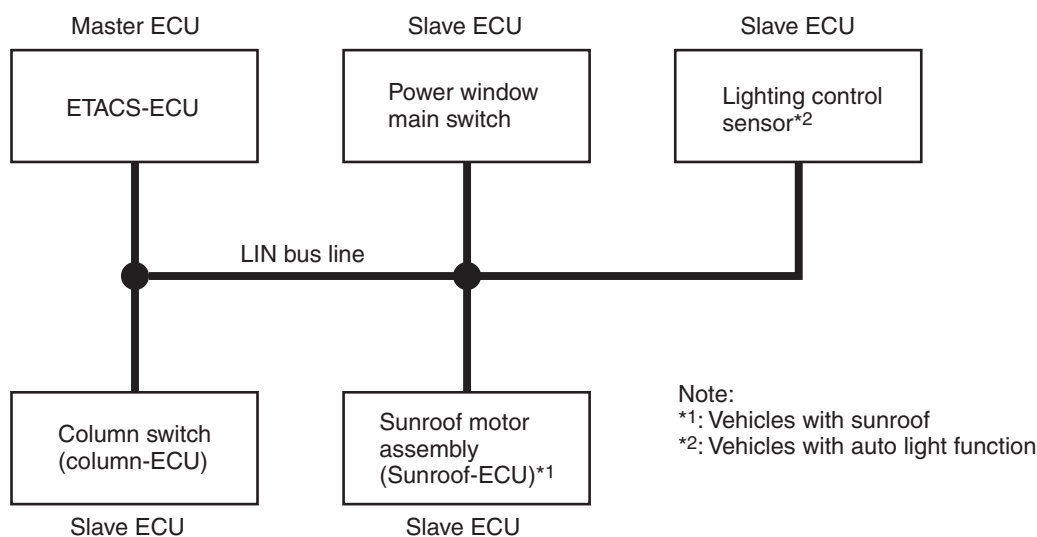
AC708922AE

Master and slave ECUs are connected to the LIN bus lines. The master ECU is the ETACS*¹-ECU, and the slave ECUs are the column switch (column-ECU), the power window main switch, the sunroof-ECU*² and the lighting control sensor*³. The master ECU requests these slave ECUs to communicate each other via communication lines.

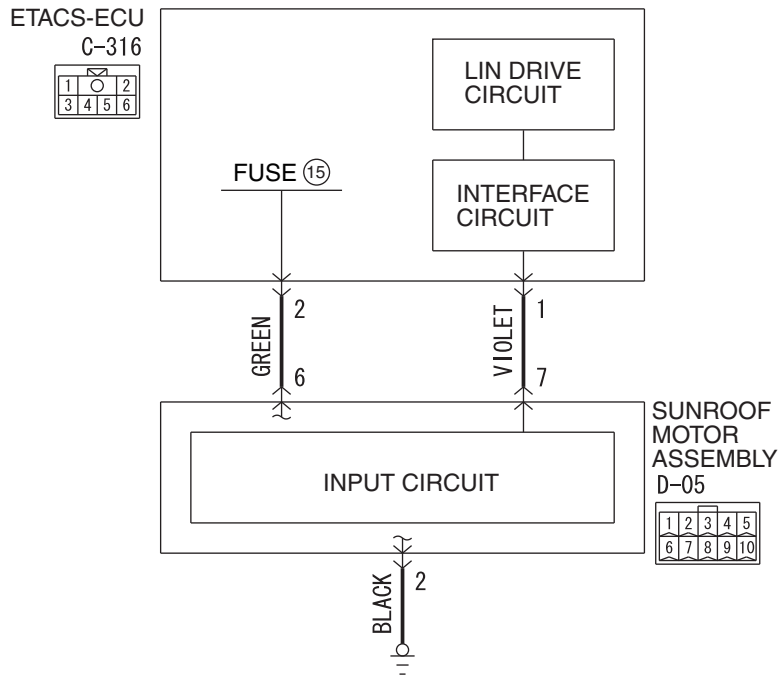
WAS54M022A

Sunroof Motor Assembly LIN Communication Circuit

The ETACS-ECU receives signal from the sunroof motor assembly (sunroof-ECU). If signal cannot be received at all, DTC U0169 will be set.

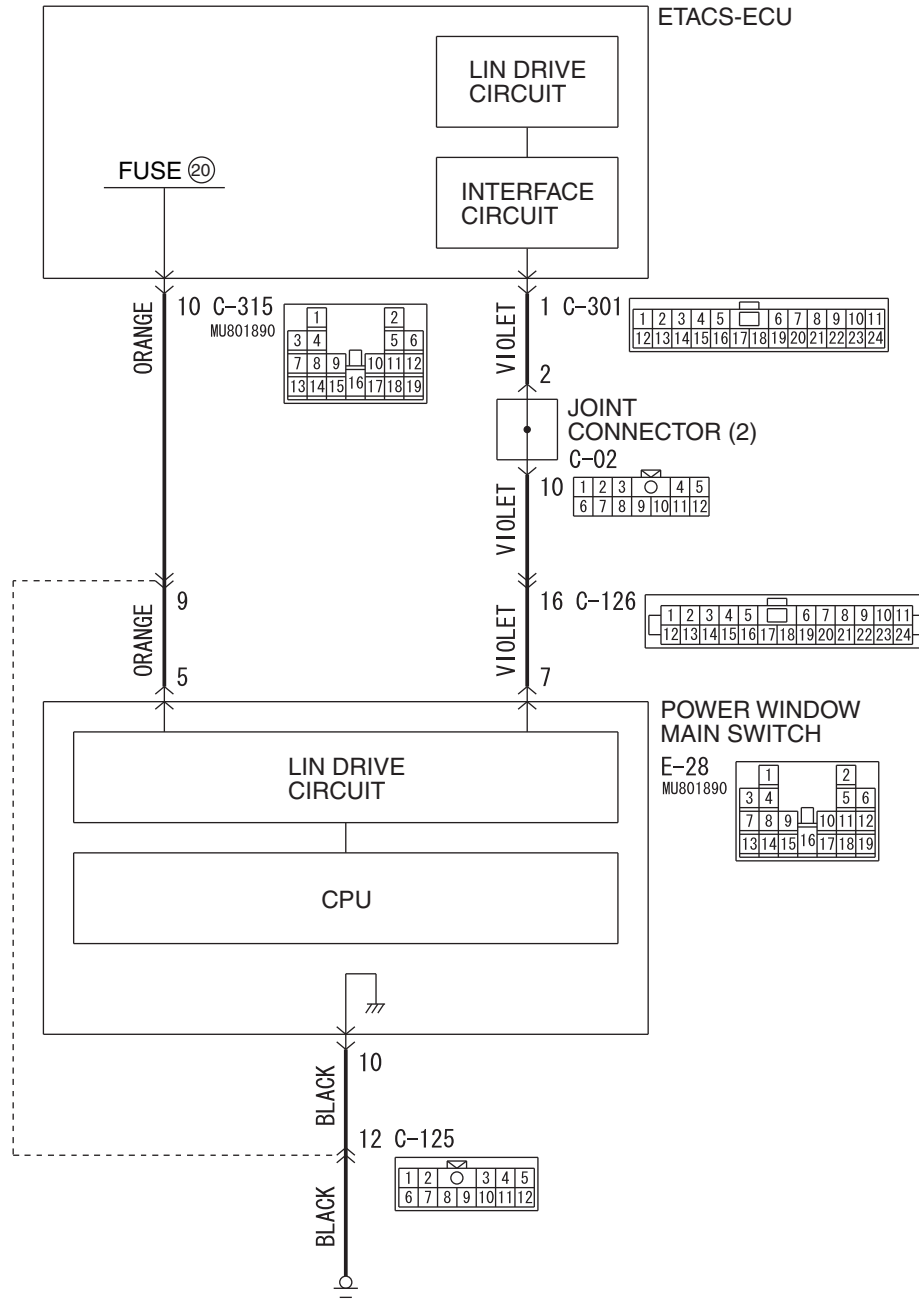
WAH54M044A

Power Window Main Switch LIN Communication Circuit

The ETACS-ECU receives signal from the power window main switch. If signal cannot be received at all, DTC U0215 will be set.

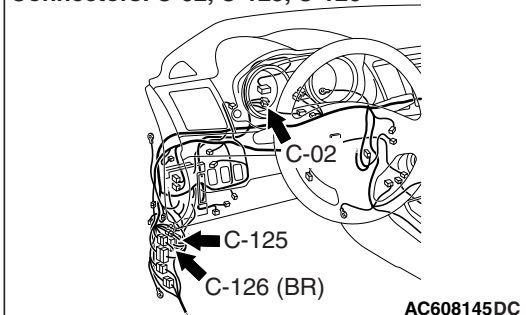
Connectors: C-02, C-125, C-126

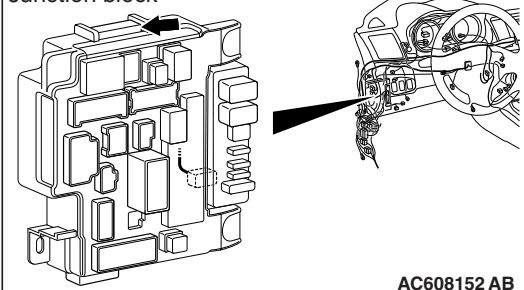
Connector: C-301
Junction block

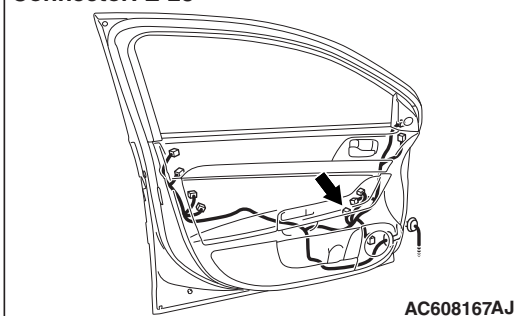
Connector: E-28

STEP 1. Check ETACS-ECU connectors C-301, C-315 and power window main switch connector E-28 for loose, corroded or damaged terminals, or terminals pushed back in the connector.

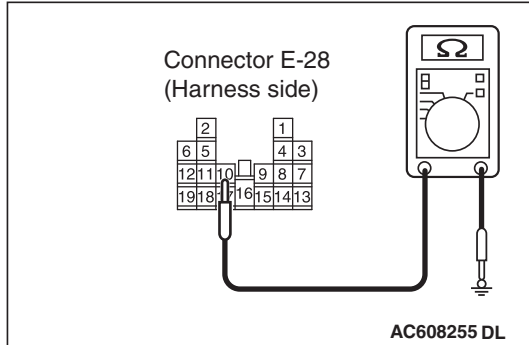
STEP 2. Check the ground circuit to the power window main switch. Measure the resistance at power window main switch connector E-28.

- (1) Disconnect power window main switch connector E-28 and measure the resistance available at the wiring harness side of the connector.
- (2) Measure the resistance value between power window main switch connector E-28 terminal 10 and ground.
 - The resistance should be 2 ohms or less.

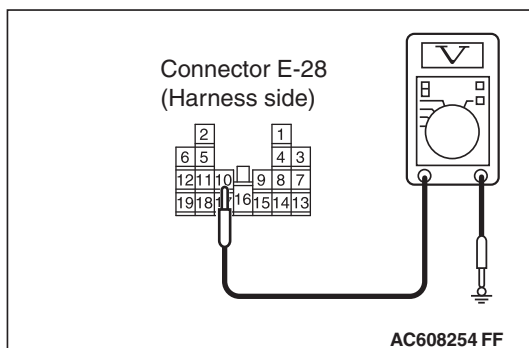
STEP 4. Check the battery power supply circuit to the power window main switch. Measure the voltage at power window main switch connector E-28.

- (1) Disconnect power window main switch connector E-28 and measure the voltage available at the wiring harness side of the connector.
- (2) Measure the voltage between power window main switch connector E-28 terminal 5 and ground.
 - The voltage should measure approximately 12 volts (battery positive voltage).

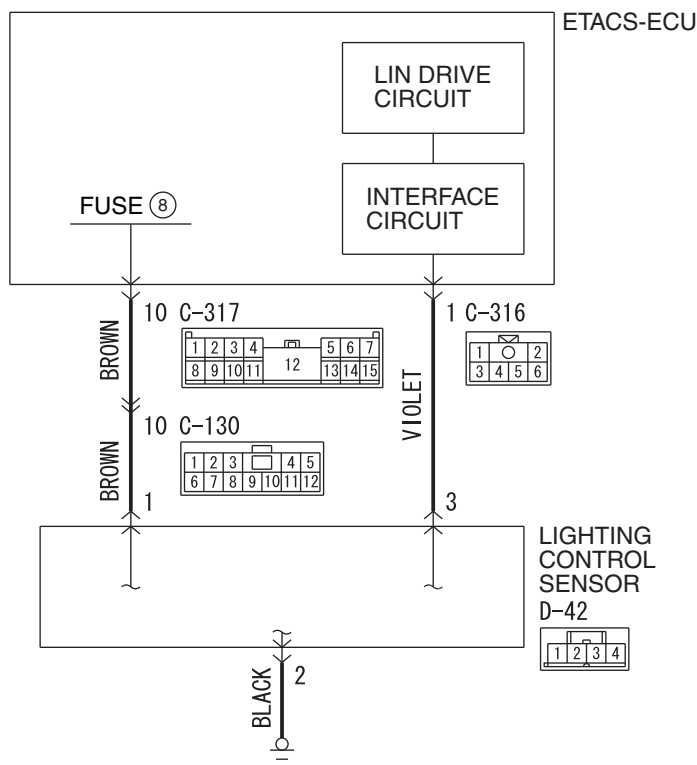
WAS54M024A

Lighting Control Sensor LIN Communication Circuit

The ETACS-ECU receives signal from the lighting control sensor. If signal cannot be received at all, DTC U0231 will be set.

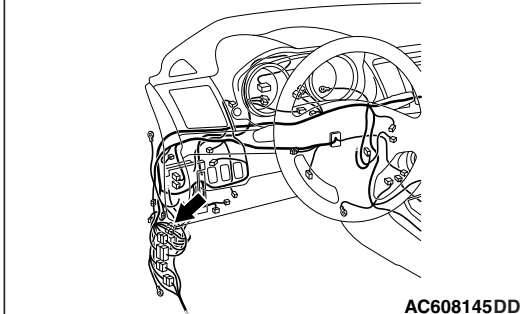
Connector: C-130

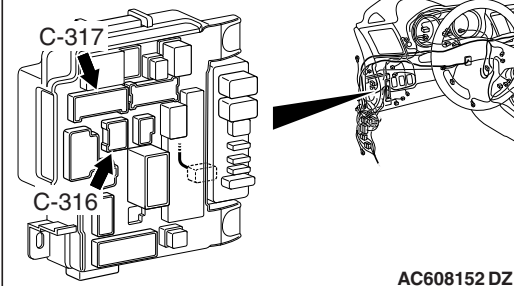
Connectors: C-316, C-317
ETACS-ECU

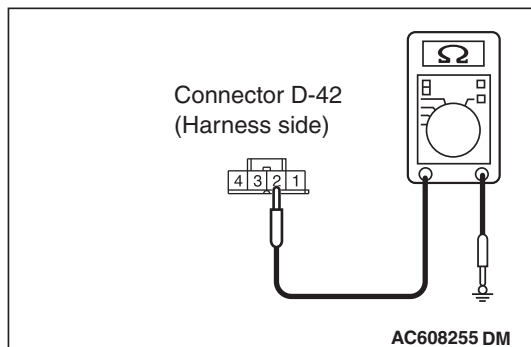
STEP 2. Check the ground circuit to the lighting control sensor. Measure the resistance at lighting control sensor connector D-42.

- (1) Disconnect power window main switch connector D-42 and measure the resistance available at the wiring harness side of the connector.
- (2) Measure the resistance value between power window main switch connector D-42 terminal 2 and ground.
 - The resistance should be 2 ohms or less.

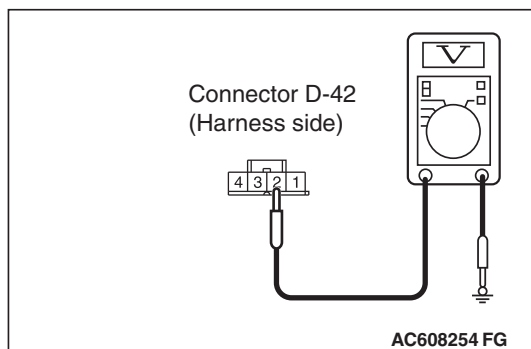
STEP 4. Check the battery power supply circuit to the lighting control sensor. Measure the voltage at lighting control sensor connector D-42.

- (1) Disconnect lighting control sensor connector D-42 measure the voltage available at the wiring harness side of the connector.
- (2) Measure the voltage between lighting control sensor connector D-42 terminal 2 and ground.
 - The voltage should measure approximately 12 volts (battery positive voltage).

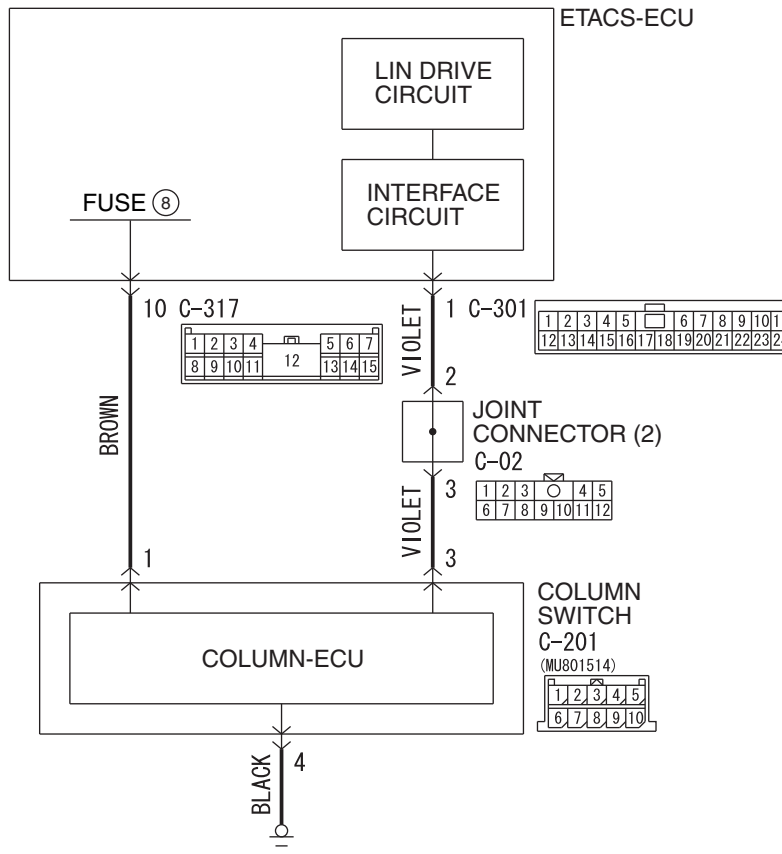
WAH54M045A

Column Switch LIN Communication Circuit

The ETACS-ECU receives signal from the column switch. If signal cannot be received at all, DTC U1109 will be set.

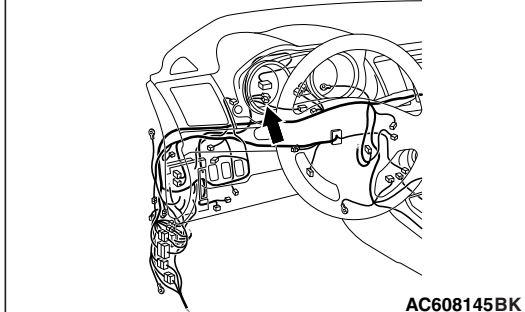
Connector: C-02

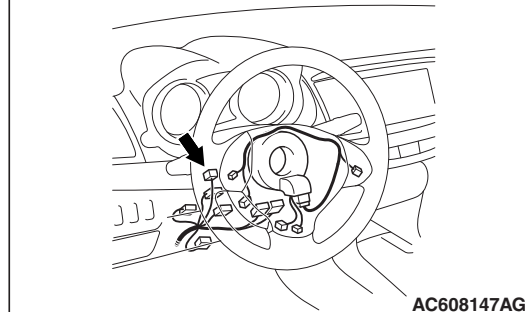
Connector: C-201

STEP 1. Check ETACS-ECU connectors C-301, C-317 and column switch connector C-201 for loose, corroded or damaged terminals, or terminals pushed back in the connector.

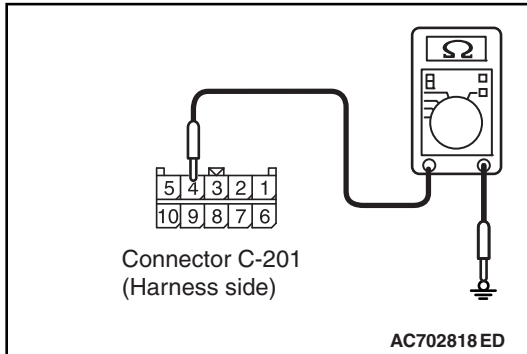
STEP 2. Check the ground circuit to the column switch. Measure the resistance at column switch connector C-201.

- (1) Disconnect column switch connector C-201 and measure the resistance available at the wiring harness side of the connector.
- (2) Measure the resistance value between column switch connector C-201 terminal 4 and ground.
 - The resistance should be 2 ohms or less.

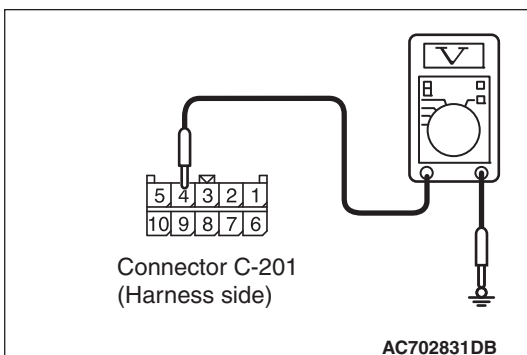
STEP 4. Check the battery power supply circuit to the column switch. Measure the voltage at column switch connector C-201.

- (1) Disconnect column switch connector C-201 measure the voltage available at the wiring harness side of the connector.
- (2) Measure the voltage between column switch connector C-201 terminal 1 and ground.
 - The voltage should measure approximately 12 volts (battery positive voltage).

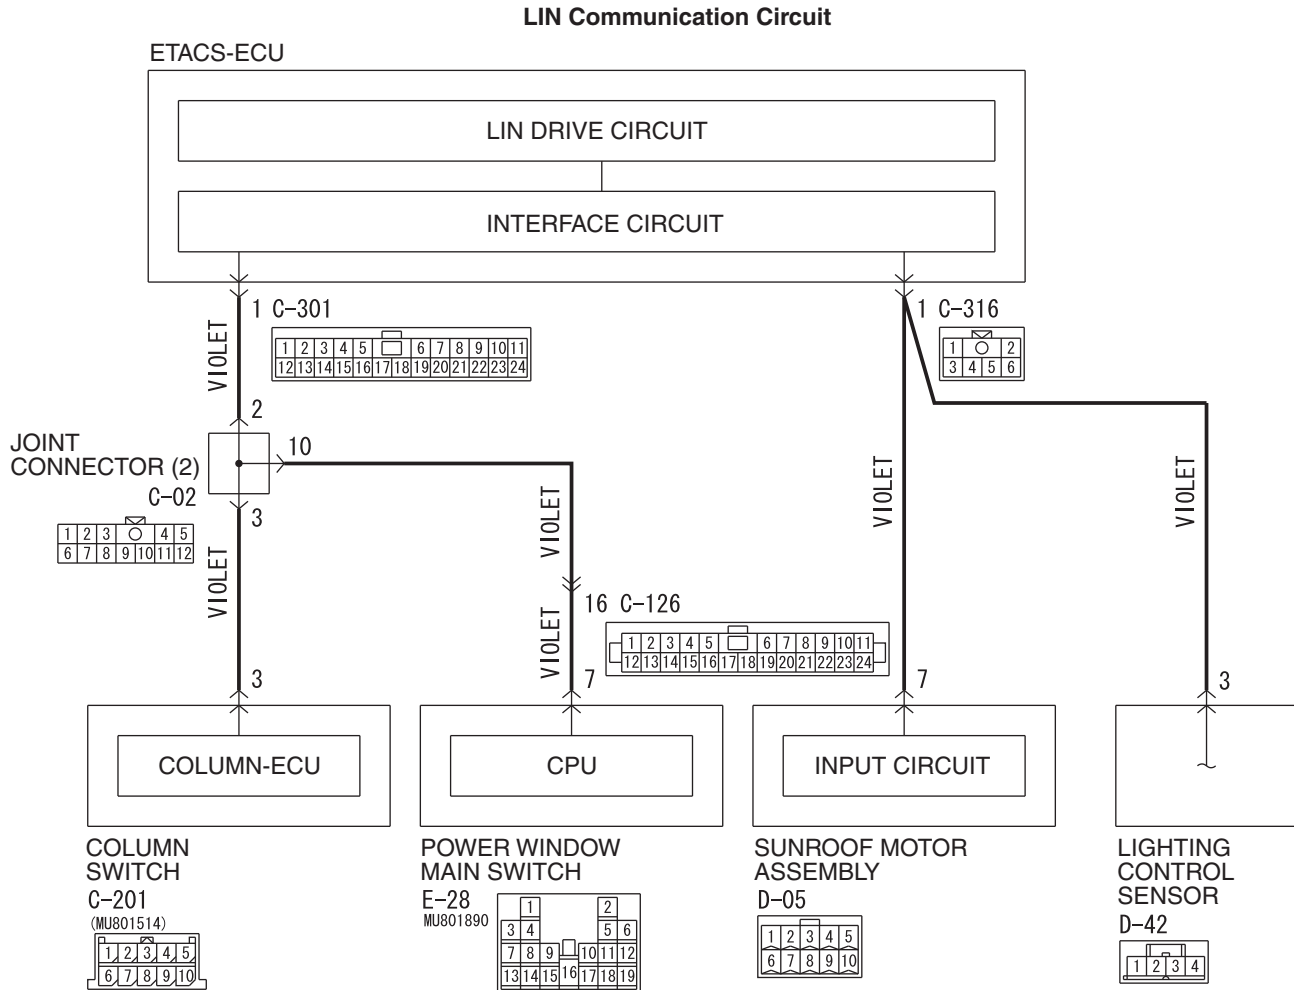
W9H54M054A

DTC U1515: No-Bus activity error (LIN)

The ETACS-ECU will set DTC U1515 when no communication has been carried out for more than a certain period after the slave task received last valid data.

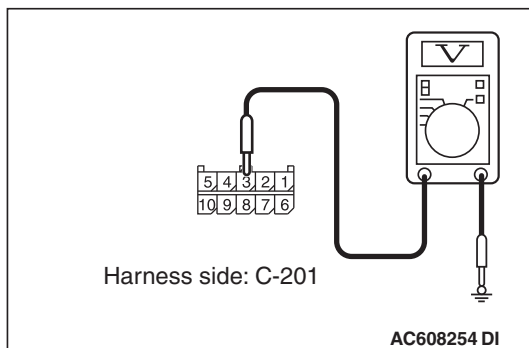
- (1) Disconnect all the ECU connectors which are connected to the LIN bus lines.
- (2) Turn the ignition switch from "LOCK" (OFF) to "ON" position.
- (3) Measure the voltage between column switch connector C-201 (terminal 3) and ground.
 - The voltmeter needle does not swing.

NOTE: If the LIN bus lines are short to power supply, the voltmeter indicates a constant value.

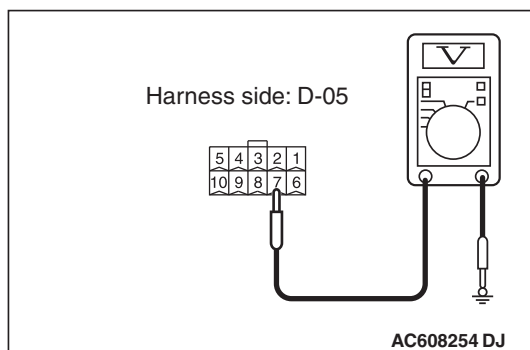
- (4) Measure the voltage between sunroof motor assembly connector D-05 (terminal 7) and ground. <Vehicles with sunroof>

- The voltmeter needle does not swing.

NOTE: If the LIN bus lines are short to power supply, the voltmeter indicates a constant value.

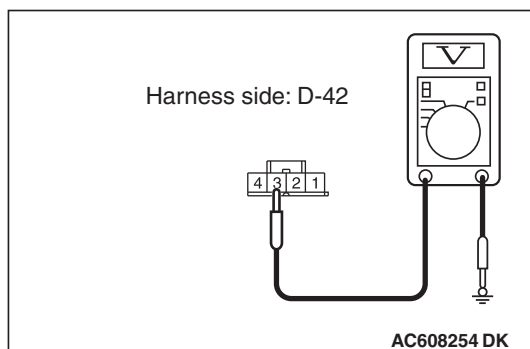
- (5) Measure the voltage between lighting control sensor connector D-42 (terminal 3) and ground. <Vehicles with auto light function>

- The voltmeter needle does not swing.

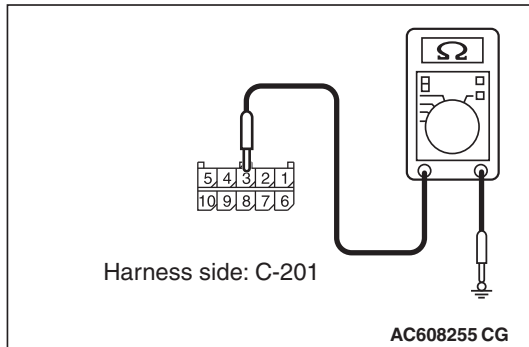
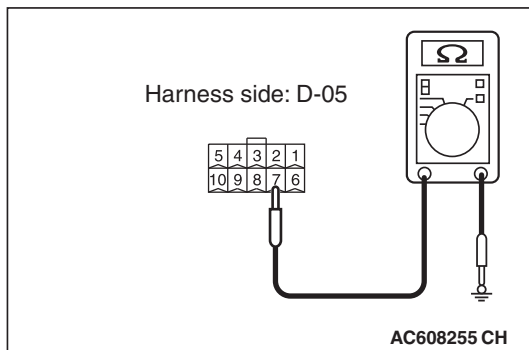
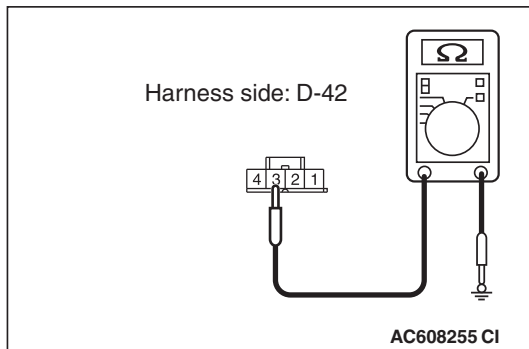
Check the LIN bus lines for short to ground.

- (1) Disconnect all the ECU connectors which are connected to the LIN bus lines.
- (2) Measure the resistance value between column switch connector C-201 (terminal 3) and ground.
 - No continuity (1 k Ω or more)

- (3) Measure the resistance value between sunroof motor assembly connector D-05 (terminal 7) and ground. <Vehicles with sunroof>

- No continuity (1 k Ω or more)

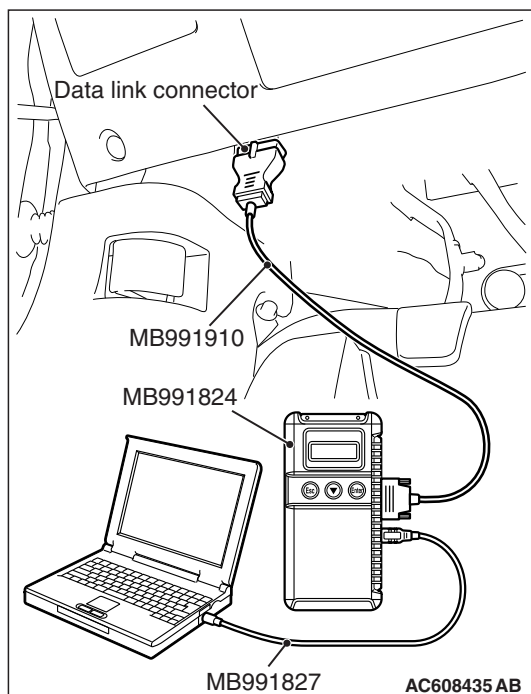
**STEP 5. Check the column switch.**

Disconnect column switch connector C-201, and recheck whether DTC U1515 is set.
