OUTLINE OF CHANGES

The following service procedures have been added to correspond to the use of the immobilizer system.

IGNITION SWITCH AND IMMOBILIZER SYSTEM

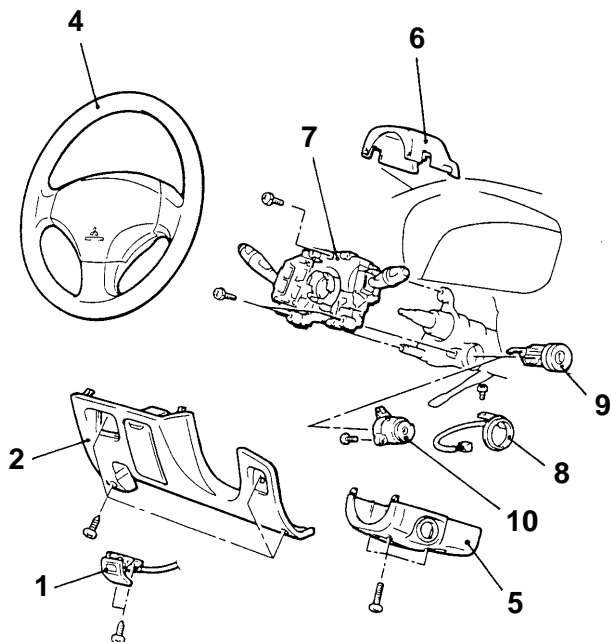
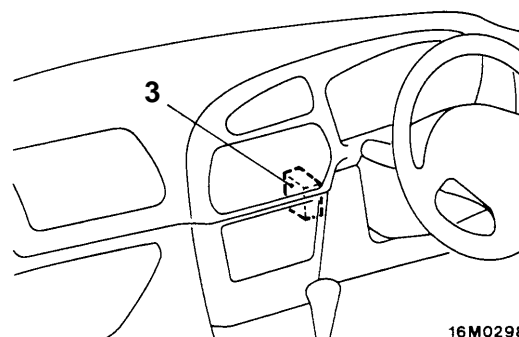
16M0298
00005134
Immobilizer-ECU removal steps

1. Hood lock release handle
2. Driver's side lower cover
 - Radio and tape player
 - Heater control assembly
3. Immobilizer-ECU

Ignition switch and ignition key ring antenna removal steps

1. Hood lock release handle
2. Driver's side lower cover
4. Steering wheel
5. Column cover, lower
6. Column cover, upper
7. Clock spring and column switch
<vehicles with SRS> or column switch <vehicle without SRS>
8. Ignition key ring antenna
9. Steering lock cylinder
10. Ignition switch

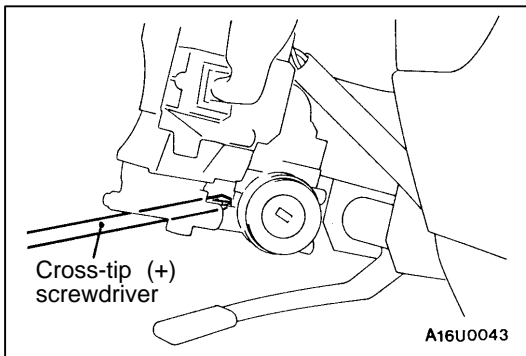
◀A▶ STEERING LOCK CYLINDER REMOVAL

1. Insert the key in the steering lock cylinder and turn it to the "ACC" position.
2. Using a cross-tip (+) screwdriver (small) or a similar tool, push the lock pin of the steering lock cylinder inward and then pull the steering lock cylinder toward you.

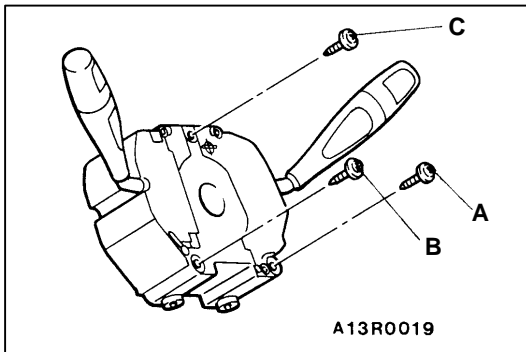
▶A◀ CLOCK SPRING AND COLUMN SWITCH/COLUMN SWITCH INSTALLATION

Tighten the screws in an alphabetical order.

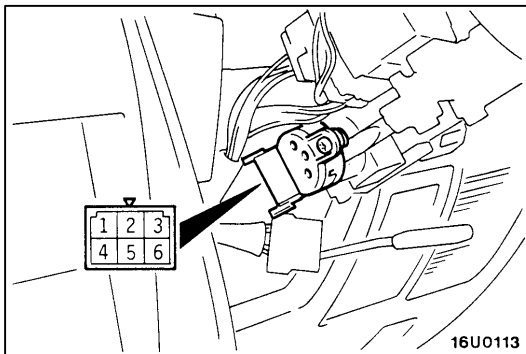
IGNITION SWITCH CONTINUITY CHECK

1. Remove the column cover lower and upper.
2. Disconnect the wiring connector from the ignition switch.
3. Operate the switch, and check the continuity between the terminals.

Ignition key position	Terminal No.				
	1	2	3	5	6
LOCK					
ACC		○	—	○	
ON	○	○	○	○	
START		○	○	—	○

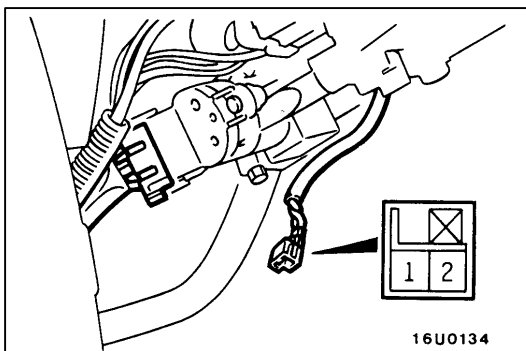
IGNITION KEY RING ANTENNA CONTINUITY CHECK

Use a circuit tester to check the continuity between the terminals.

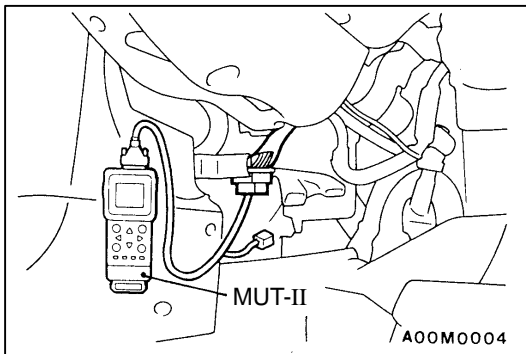
1. Connect the MUT-II to the diagnosis connector.
