GENERAL

OUTLINE OF CHANGES

Due to the addition of MITSUBISHI Active Stability & Traction Control System (M-ASTC) and MITSUBISHI Active Traction Control System (M-ATC), the following service procedures have been established. Operation must be carried out in the same manner as before except for the items described below.

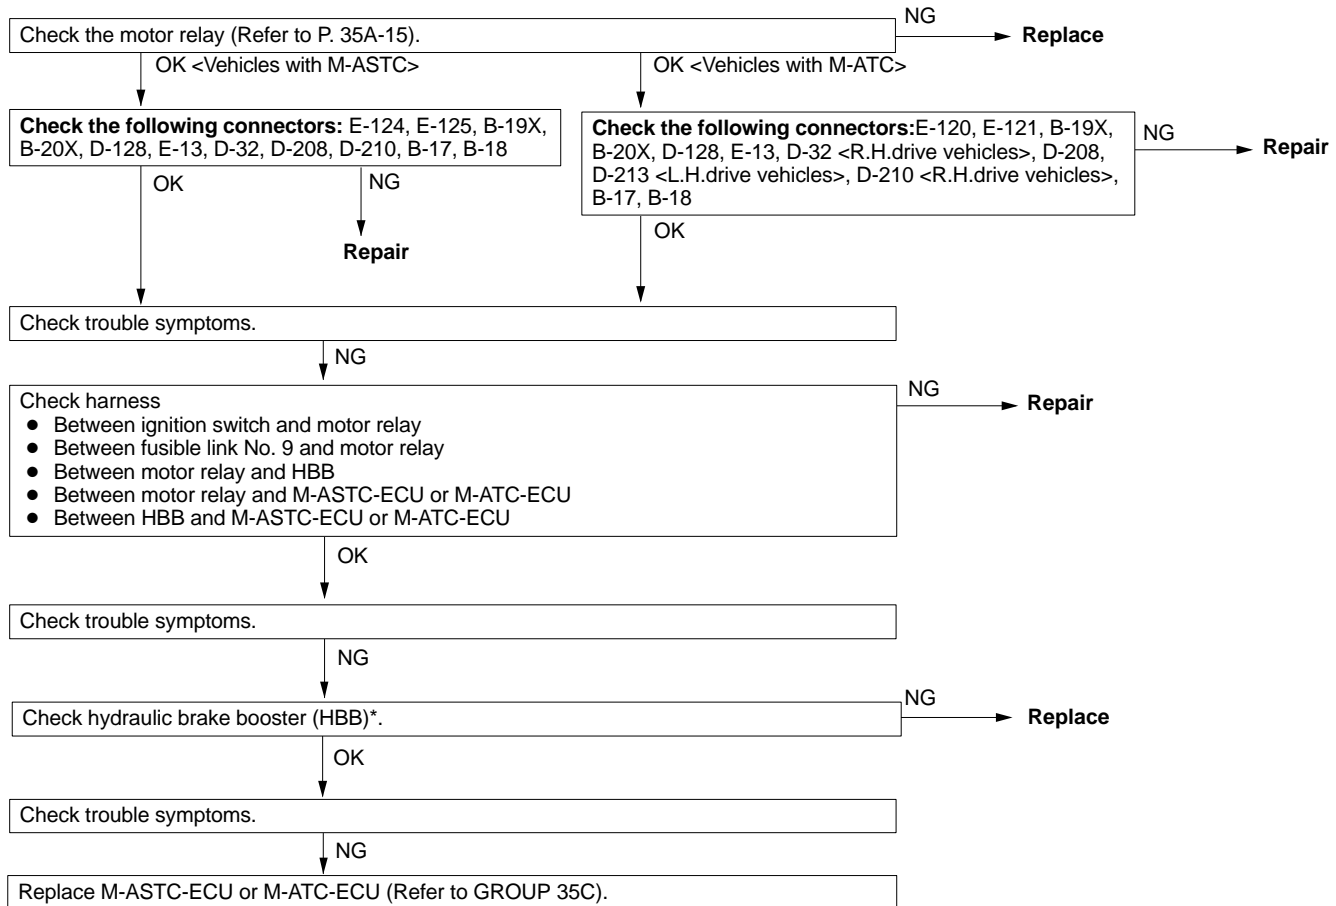
Code No. 54: Motor relay system (open circuit, short circuit or motor relay coil defect)	Possible cause
This code is set when the motor relay circuit is open/short-circuited, or internal circuit of M-ASTC-ECU or M-ATC-ECU is defective, or master cylinder & hydraulic unit assembly of hydraulic brake booster (HBB) is defective.	<ul style="list-style-type: none"> ● Malfunction of harness or connector ● Malfunction of motor relay ● Malfunction of the M-ASTC-ECU or the M-ATC-ECU ● Malfunction of HBB (Master cylinder & hydraulic unit assembly)

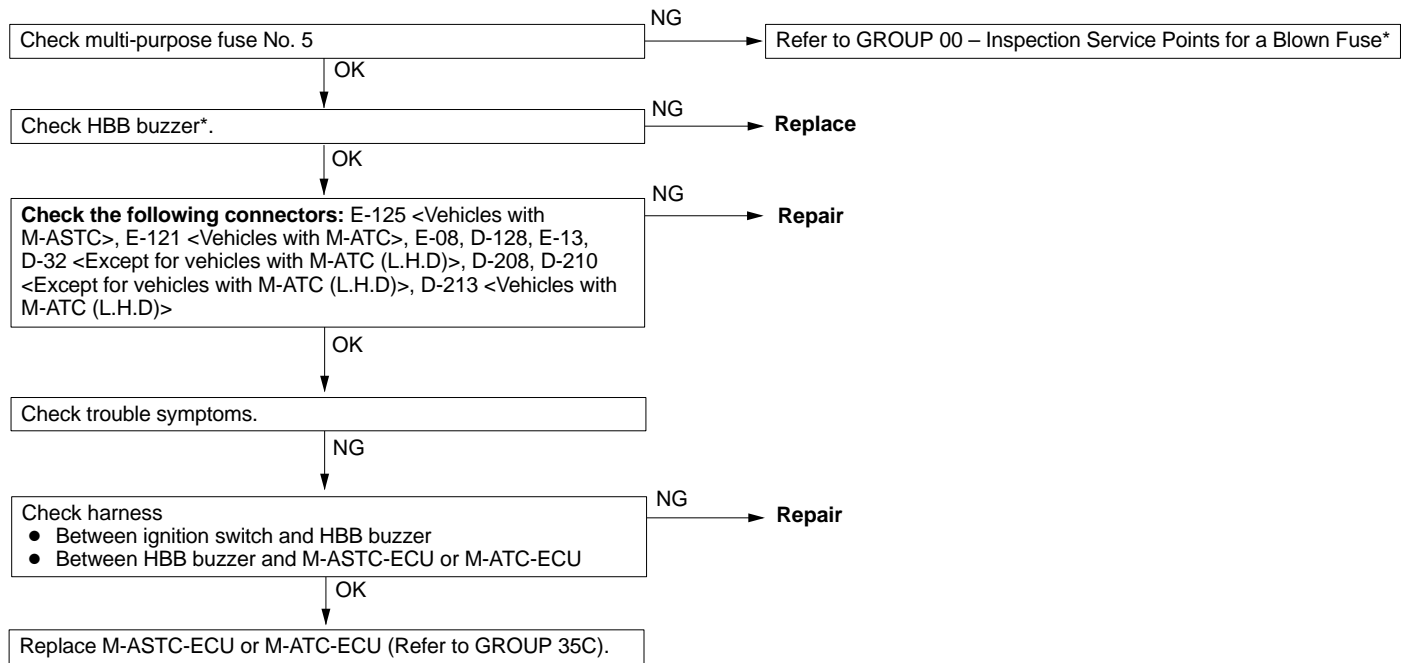
When hydraulic brake booster (HBB) does not operate normally, no sound comes from HBB buzzer.(The brake warning lamp illuminates).	Possible cause
Open circuit in the buzzer power supply circuit, buzzer defect, buzzer drive transistor fault in M-ASTC-ECU or M-ATC-ECU, open circuit between the ignition switch and HBB buzzer, and M-ASTC-ECU or M-ATC-ECU may be the cause.	<ul style="list-style-type: none"> ● Blown fuse ● Malfunction of HBB buzzer ● Malfunction of harness or connector ● Malfunction of the M-ASTC-ECU or M-ATC-ECU (buzzer drive transistor)

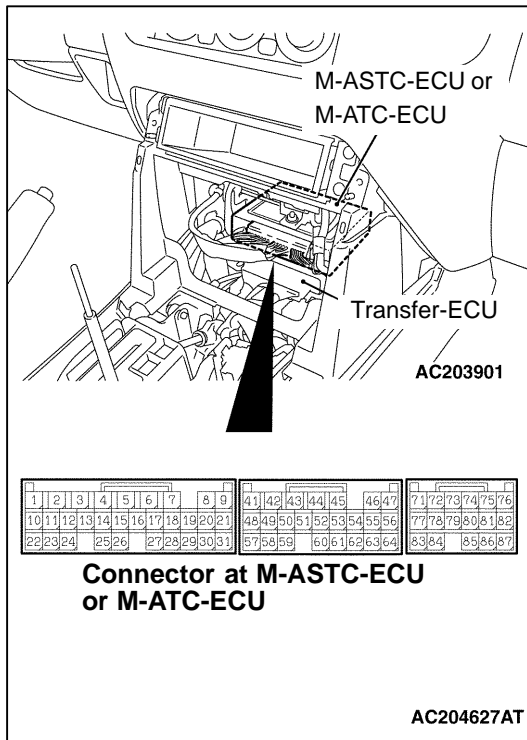
CHECK AT M-ASTC-ECU TERMINAL OR M-ATC-ECU TERMINAL

ECU's with the same profile are located at the upper and lower of the floor console. Upper ECU is M-ASTC-ECU or M-ATC-ECU, while the lower ECU is transfer-ECU.

1. Voltage is measured between individual terminals and earth terminals.
2. Individual terminals are arranged as shown in the figure.

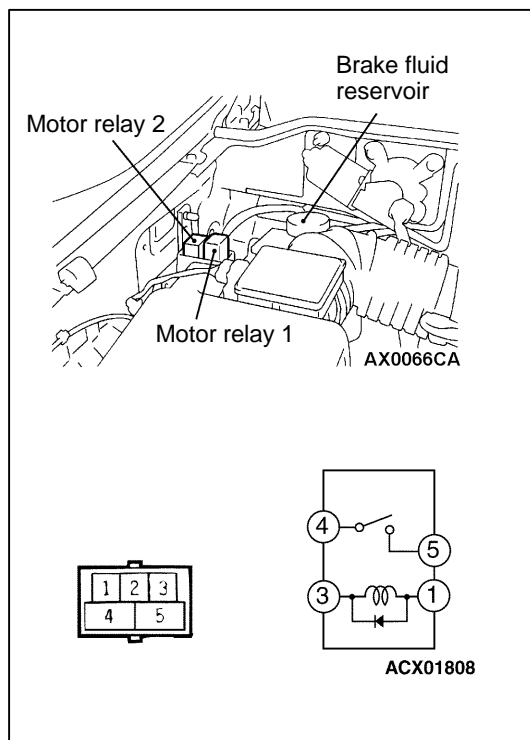
Motor relay 1, 2

MOTOR RELAY CONTINUITY CHECK

Battery Voltage	Terminal No.			
	1	3	4	5
De-energized	○	○		
Energized	⊖	⊕	○	○

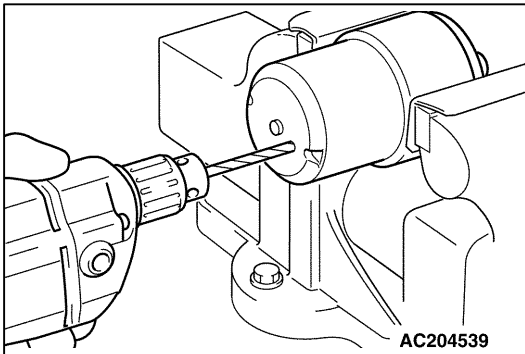
2. Use a punch to provide a drilling point within the shaded area shown in the figure.
3. Place the bit (diameter: 4 mm) on a drill.

4. Use the drill to make a hole on the accumulator, and then extract the sealed gas.

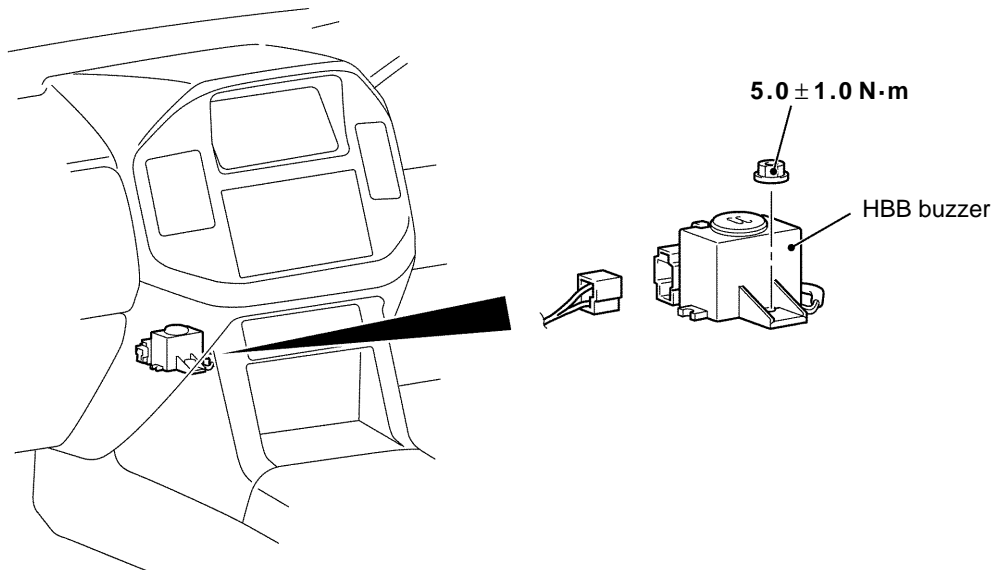
HBB BUZZER <VEHICLES WITH M-ASTC AND M-ATC>

REMOVAL AND INSTALLATION
