GROUP 34

REAR SUSPENSION

GENERAL INFORMATION

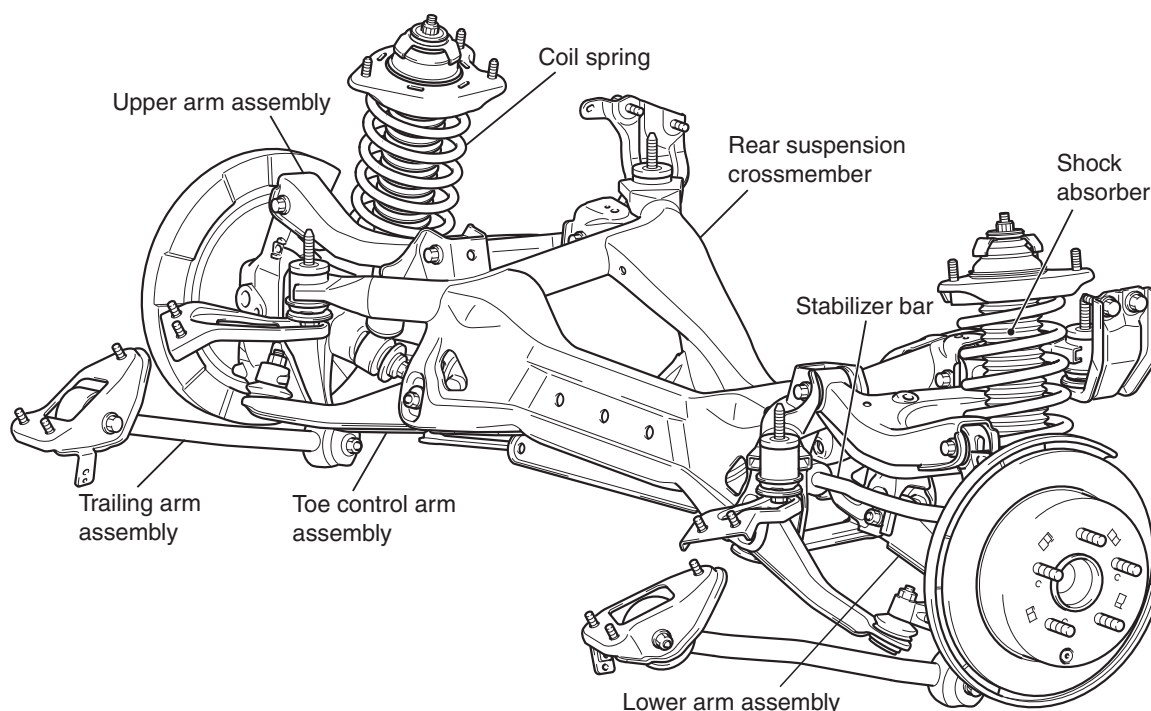
CONSTRUCTION DIAGRAM

A low-mount multilink suspension system is used to reduce road noise, making the vehicle quieter by all suspension arms except a trailing arm connected to the crossmembers with an elastic structure.

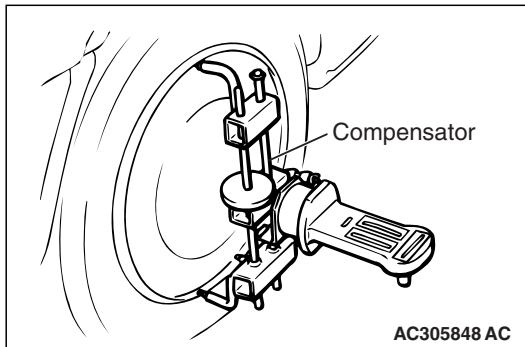
CAMBER

Standard value:

$-0^{\circ} 50' \pm 0^{\circ} 30'$ (Left/right deviation within 30')

NOTE: For vehicles with aluminum wheels, attach the camber/caster/kingpin gauge by using a compensator.

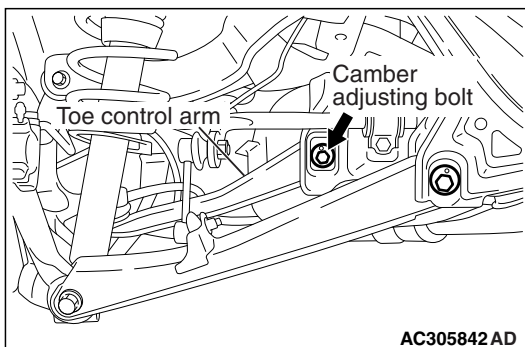
- When adjusting the camber, tighten the lower arm assembly and the trailing arm assembly, not the toe control arm.
- After adjusting the camber, be sure to adjust the toe.

1. Carry out camber adjustment by turning the camber adjusting bolt.

- LH: Clockwise viewed from the rear → (-) camber
- RH: Clockwise viewed from the rear → (+) camber
- If either the camber or toe is adjusted, both should fluctuate. For the relationship between the two, refer to CAMBER AND TOE REFERENCE TABLE (Refer to [P.34-7](#)).

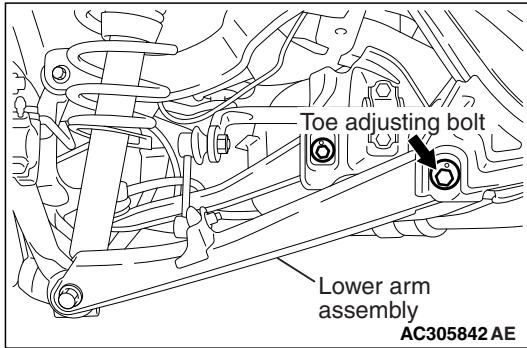
When adjusting the toe, tighten the toe control arm and the trailing arm assembly, not the lower arm assembly.

2. Carry out toe adjustment by turning the toe adjusting bolt.

- LH: Clockwise viewed from the rear →Toe-in
- RH: Clockwise viewed from the rear →Toe-out
- If either the camber or toe is adjusted, both should fluctuate. For the relationship between the two, refer to CAMBER AND TOE REFERENCE TABLE (Refer to P.34-7).

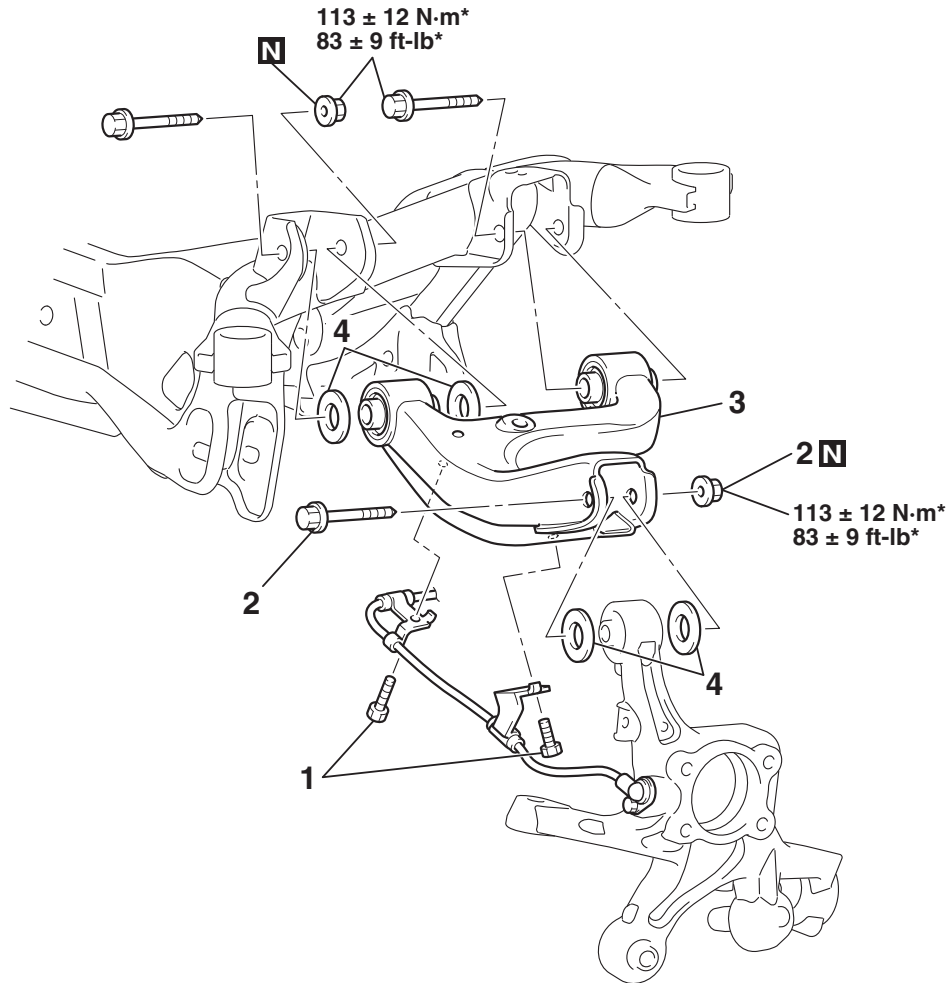
AC305776 AC

*: Indicates parts which should be temporarily tightened, and then fully tightened with the vehicle on the ground in an unladen condition.

1. ABS equipment bolt
2. Upper arm assembly and knuckle connection

3. Upper arm assembly
4. Upper arm stopper

- Check the bushings for wear and deterioration.
- Check the upper arm for bending or breakage.
- Check all bolts for condition and straightness.

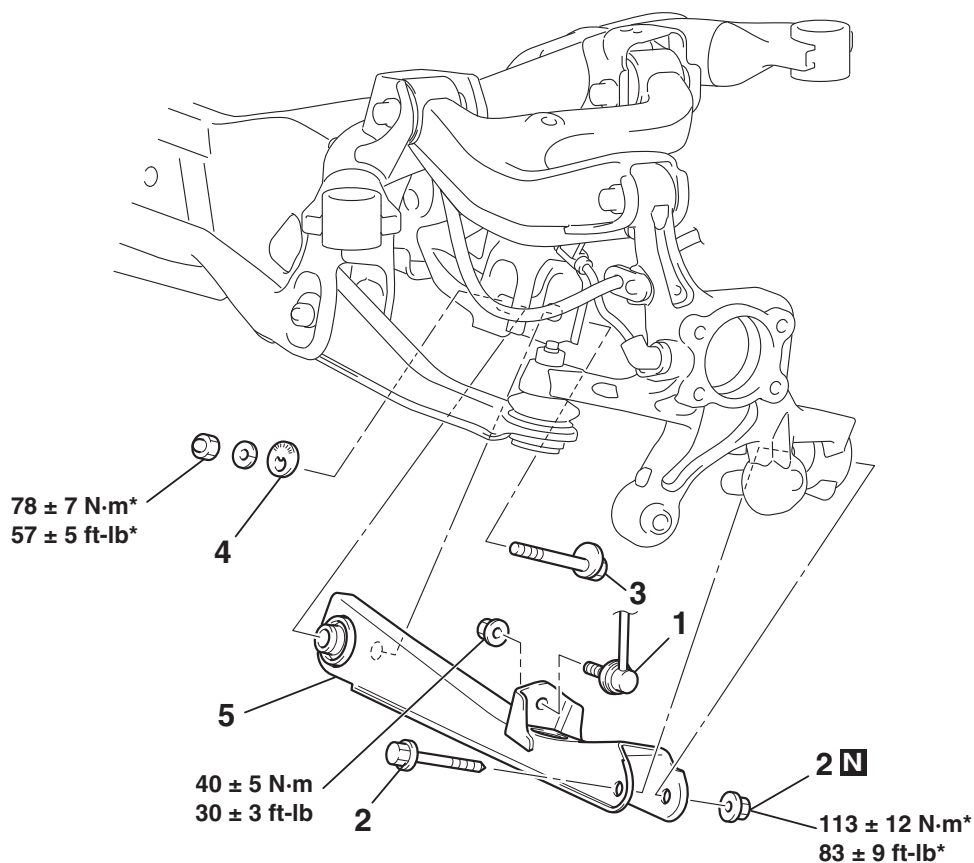
AC305777AB

* : Indicates parts which should be temporarily tightened, and then fully tightened with the vehicle on the ground in an unladen condition.

- Shock absorber assembly and knuckle connection (Refer to [P.34-16](#)).
1. Lower arm assembly and stabilizer bar link assembly connection

2. Lower arm assembly and knuckle connection
3. Lower arm bolt
4. Lower arm plate
5. Lower arm assembly

- Check the bushings for wear and deterioration.
- Check the lower arm for bending or breakage.
- Check all bolts for condition and straightness.

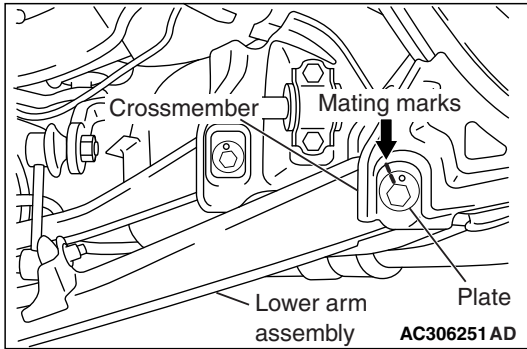
<<A>> LOWER ARM BOLT REMOVAL

Place mating marks on the crossmember and the plate before removing the lower arm bolt.

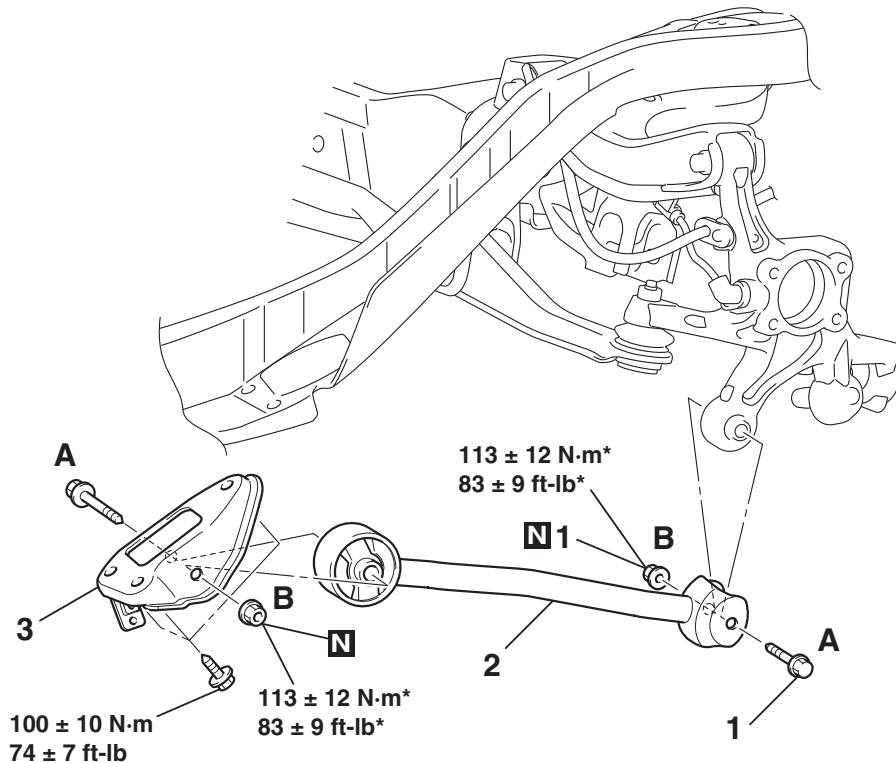
AC305778 AB

* : Indicates parts which should be temporarily tightened, and then fully tightened with the vehicle on the ground in an unladen condition.

1. Trailing arm assembly and knuckle connection

2. Trailing arm assembly
3. Trailing arm bracket

NOTE: Bolt A and nut B are interchangeable.

- Check the bushings for wear and deterioration.
- Check the trailing arm for bending or breakage.
- Check all bolts for condition and straightness.

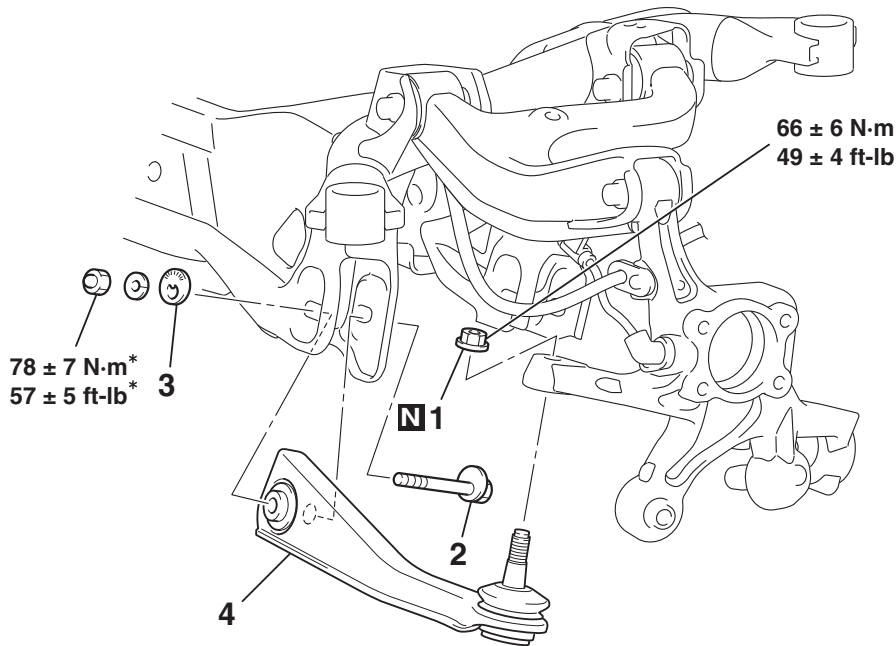
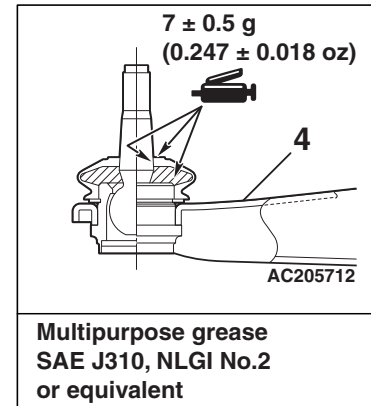
AC305779AC

* : Indicates parts which should be temporarily tightened, and then fully tightened with the vehicle on the ground in an unladen condition.

1. Trailing arm assembly and knuckle connection (Refer to P.34-12).
1. Toe control arm assembly and knuckle connection nut
2. Assist link bolt

3. Assist link plate
4. Toe control arm assembly

- Check the bushings for wear and deterioration.
- Check the toe control arm for bending or breakage.
- Check all bolts for condition and straightness.

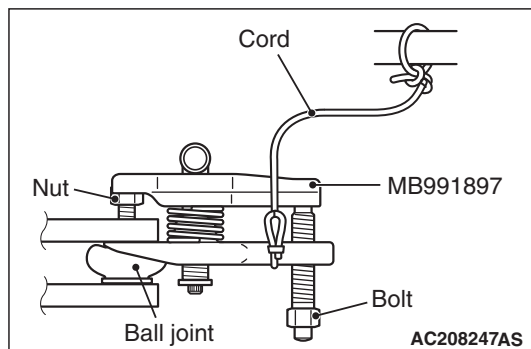
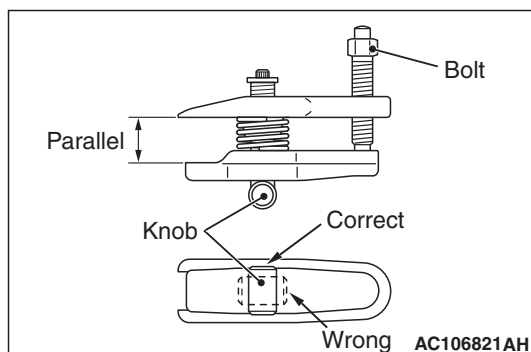
- Do not remove the nut from ball joint. Loosen it and use special tool MB991897 to avoid possible damage to ball joint threads.
- Hang special tool MB991897 with a cord to prevent it from falling.

1. Install special tool MB991897 as shown in the figure.

2. Turn the bolt and knob as necessary to make the jaws of the special tool MB991897 parallel, tighten the bolt by hand and confirm that the jaws are still parallel.

NOTE: When adjusting the jaws in parallel, make sure the knob is in the position shown in the figure.

3. Tighten the bolt with a wrench to disconnect the toe control arm assembly and the knuckle.

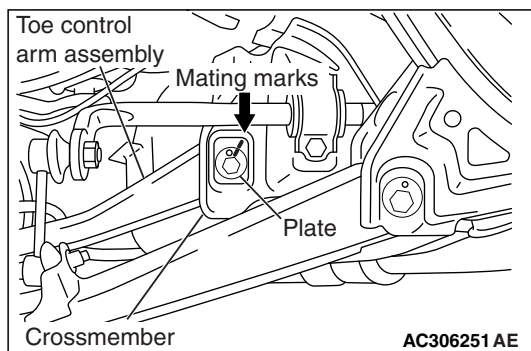
<> ASSIST LINK BOLT REMOVAL

Place mating marks on the crossmember and the plate before removing the assist link bolt.

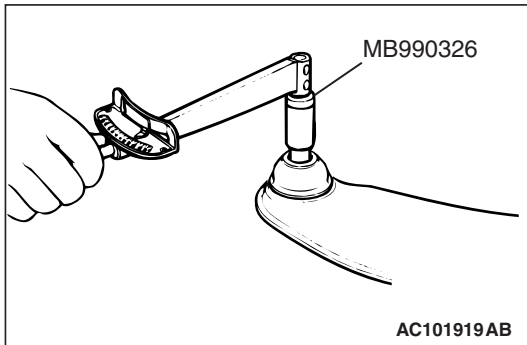
TOE CONTROL ARM BALL JOINT TURNING TORQUE CHECK

1. After shaking the ball joint stud several times, in order to make the ball joint turn smoothly, install the nut to the stud and use special tool MB990326 to measure the turning torque of the ball joint.

Standard value: 1.0 –2.6 N·m (8.9 –23 in-lb)

2. If the measured value exceeds the standard value, replace the toe control arm assembly.
3. If the measured value is lower than the standard value, check that the ball joint turns smoothly without excessive play. If so, it is possible to re-use that ball joint.

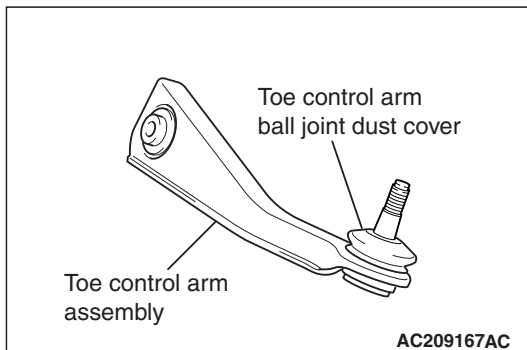
TOE CONTROL ARM BALL JOINT DUST COVER CHECK

1. Check the toe control arm ball joint dust cover for cracks or damage by pushing it with your finger.
2. If the dust cover is cracked or damaged, replace the toe control arm assembly.

NOTE: Cracks or damage of the dust cover may cause damage to the ball joint. When it is damaged during service work, replace the dust cover.

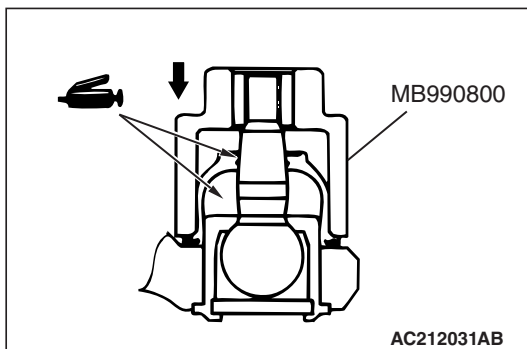
TOE CONTROL ARM BALL JOINT DUST COVER REPLACEMENT

Only when the dust cover is damaged accidentally during service work, replace the dust cover as follows:

1. Remove the dust cover.
2. Fill the new dust cover with multipurpose grease and lubricate the lip [Amount of grease in the dust cover: approximately 7 g (0.247 ounce)].
3. Using special tool MB990800, punch the dust cover until it contacts the snap ring.
4. Press the dust cover with your finger to check that there are no cracks or damage in the dust cover.

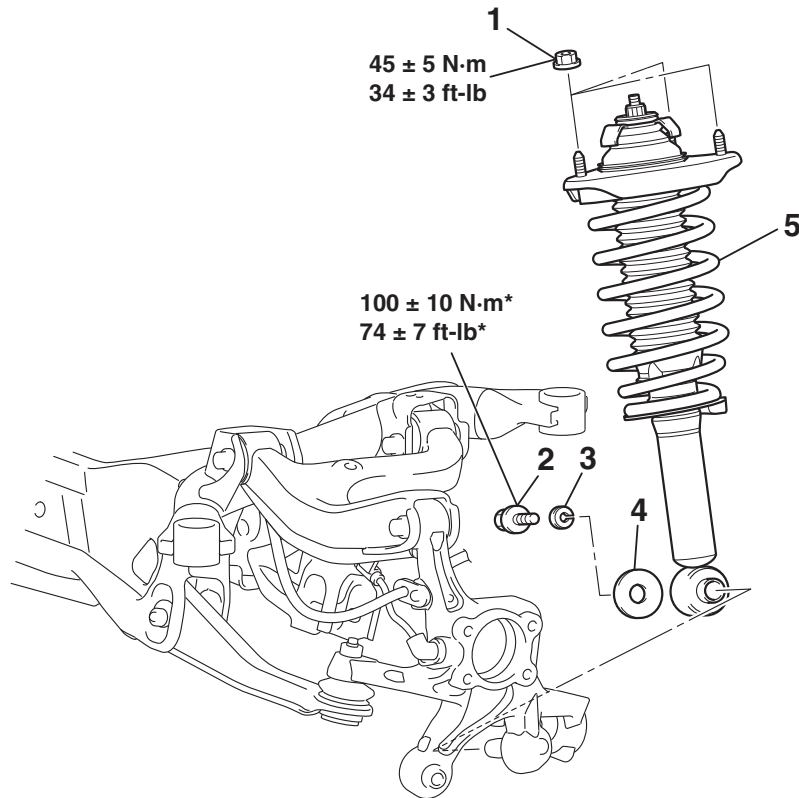
AC305780 AB

*: Indicates parts which should be temporarily tightened, and then fully tightened with the vehicle on the ground in the unladen condition.

1. Shock absorber assembly mounting nut
2. Shock absorber assembly and knuckle connection bolt

3. Spring washer
4. Washer
5. Shock absorber assembly

- Check the rubber parts for cracks and wear.
- Check the shock absorber for malfunctions, oil leakage, or abnormal noise.

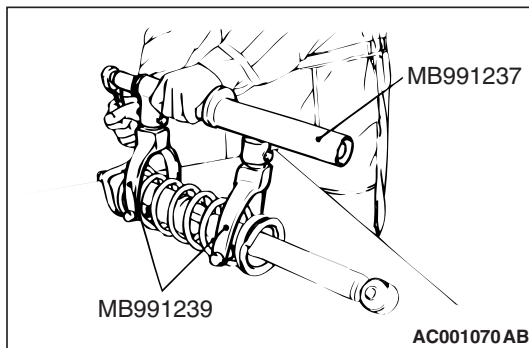
- To hold the coil spring securely, install special tools MB991237 and MB991239 evenly, and so that the space between both arms of the special tool will be maximum within the installation range.
- Do not use an impact wrench to tighten the bolt of special tool MB991237. The usage of impact wrench will break the special tool.

1. Use special tools MB991237 and MB991239 to compress the coil spring.

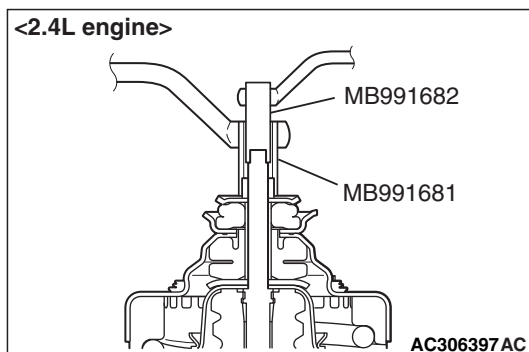
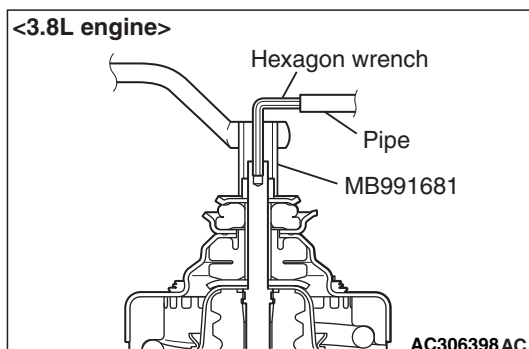
- **Vibration of the impact wrench will cause special tools MB991237 and MB991239 to slip and cause personal injury.**
- **Vibration of the impact wrench will cause the valve inside the shock absorber to drop out.**

2. For 2.4L engine models, use special tool MB991682 to secure the piston rod, and then remove the shock absorber nut (jam nut) using special tool MB991681.

For 3.8L engine models, use a hexagon wrench and a pipe to secure the piston rod, and then remove the shock absorber nut (jam nut) using special tool MB991681.

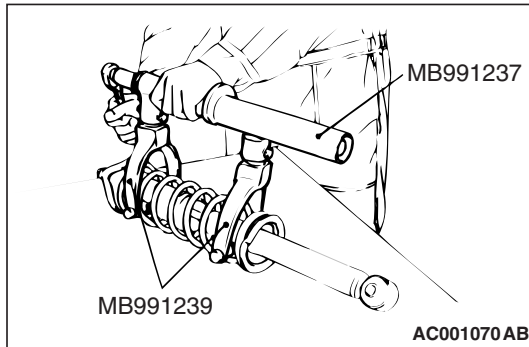
>>A<< COIL SPRING INSTALLATION

Do not use an impact wrench to tighten the bolt of special tool MB991237. It will break the special tool.

1. Use special tools MB991237 and MB991239 to compress the coil spring, and install it to the spring seat of the shock absorber.
2. Align the end of the coil spring with the stepped section of the spring seat of the shock absorber.

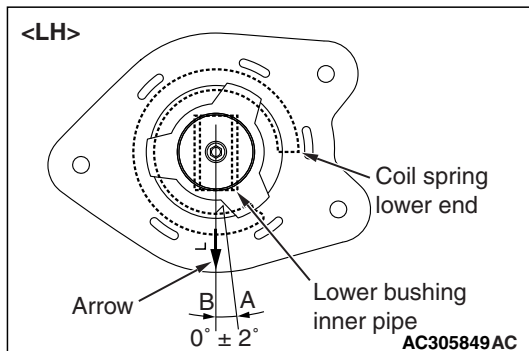
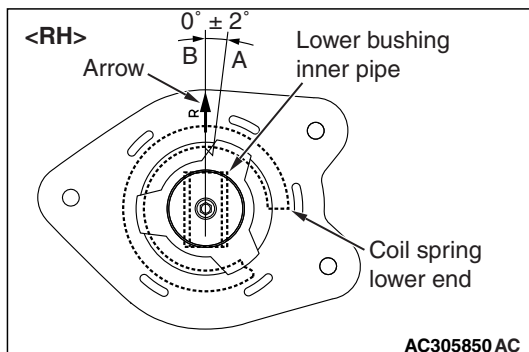
>>B<< SHOCK ABSORBER INSULATOR INSTALLATION

Install the shock absorber insulator as follows.

1. Position the coil spring lower end as shown.
2. Position a center line (A) of the shock absorber lower bushing inner pipe as shown from the arrow (B) on the shock absorber insulator.

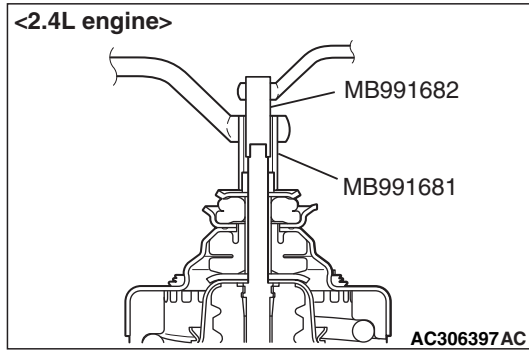
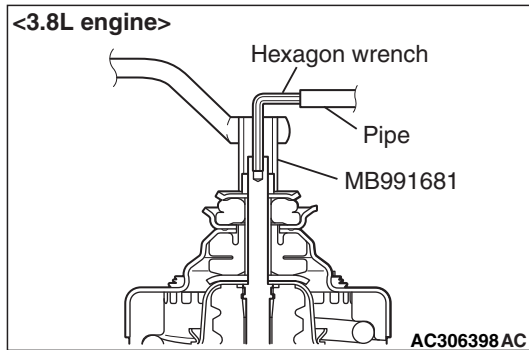
>>C<< SHOCK ABSORBER NUT (JAM NUT) INSTALLATION

1. Temporarily tighten the shock absorber nut (jam nut).

Do not use an impact wrench to tighten the bolt of special tool MB991237. It will break the special tool. Vibration of the impact wrench will cause the valve inside the shock absorber to drop out.

2. Remove special tools MB991237 and MB991239.
3. For 2.4L engine models, using special tools MB991681 and MB991682, tighten the shock absorber nut (jam nut) to $23 \pm 2 \text{ N} \cdot \text{m}$ ($17 \pm 1 \text{ ft-lb}$).

For 3.8L engine models, using special tool MB991681, a hexagon wrench and a pipe, tighten the shock absorber nut (jam nut) to $23 \pm 2 \text{ N} \cdot \text{m}$ ($17 \pm 1 \text{ ft-lb}$).

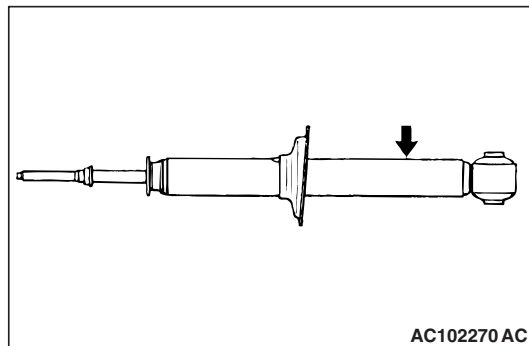
SHOCK ABSORBER DISPOSAL

Wear goggles when drilling to protect your eyes from flying metal debris.

The gas must be discharged from the shock absorber before discarding it. Place the shock absorber horizontally with its piston rod extended. Then drill a hole of approximately 3 mm (0.1 inch) in diameter at the location shown in the illustration and discharge the gas.

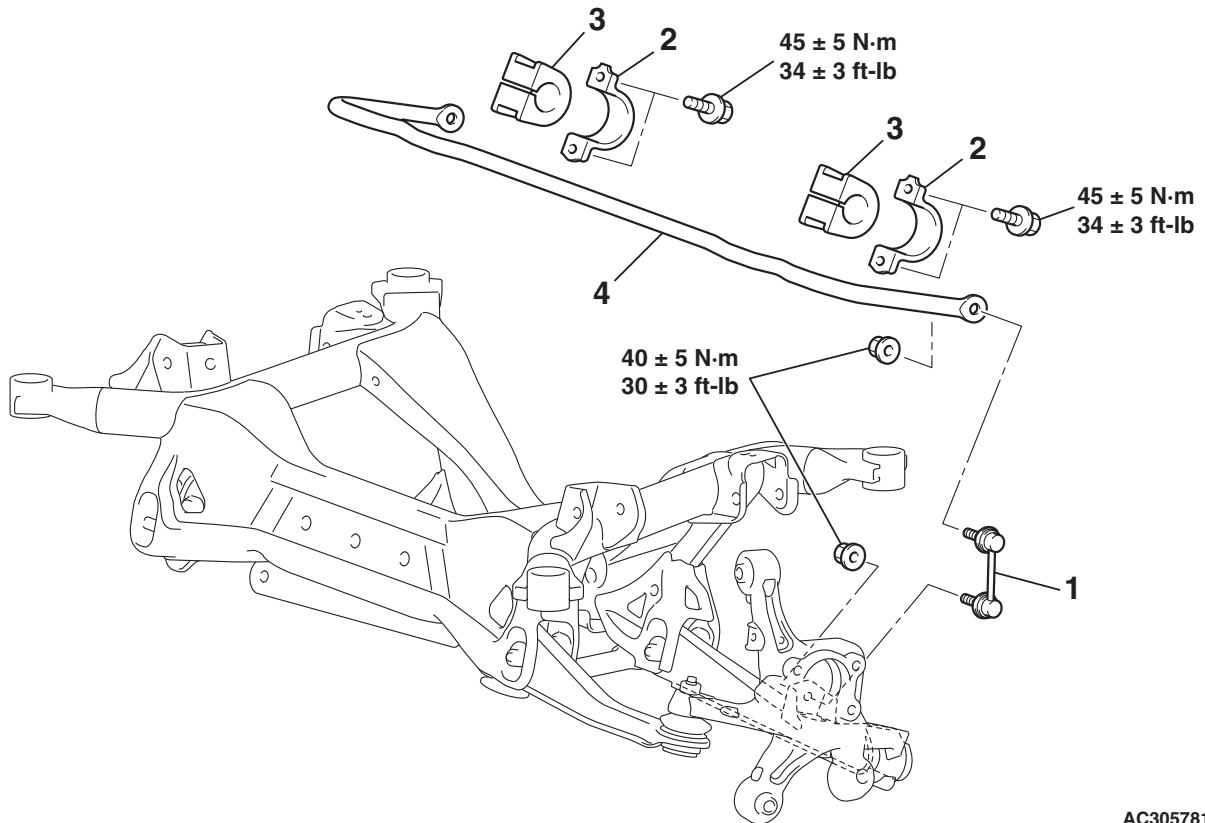
AC305781AB

- >>A<< 1. Stabilizer bar link assembly
>>A<< 2. Stabilizer bar bracket

- >>A<< 3. Stabilizer bushing
>>A<< 4. Stabilizer bar

- Check the stabilizer bushings for wear and deterioration.
- Check the stabilizer bar for deterioration or damage.
- Check all bolts for condition and straightness.

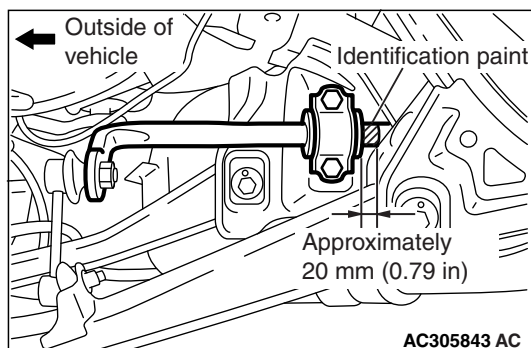
1. Position the stabilizer bar identification paint to the left side.
2. Adjust the identification paint position as shown in the figure, and tighten the stabilizer bolt.

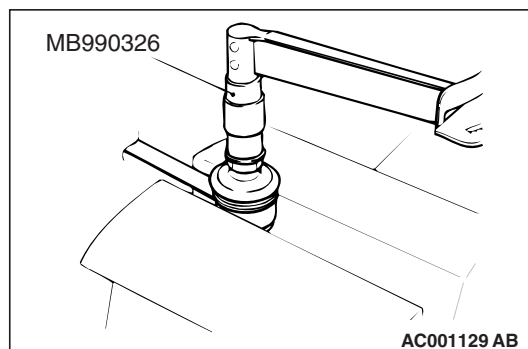
STABILIZER BAR LINK BALL JOINT BREAKAWAY TORQUE CHECK

1. After shaking the ball joint stud several times, install the nut to the stud and use special tool MB990326 to measure the breakaway torque of the ball joint.

Standard value: 3.4 –9.0 N· m (30 –80 in-lb)

2. When the measured value exceeds the standard value, replace the stabilizer bar link assembly.
3. When the measured value is lower than the standard value, check that the ball joint turns smoothly without excessive play. If so, it is possible to re-use that ball joint.

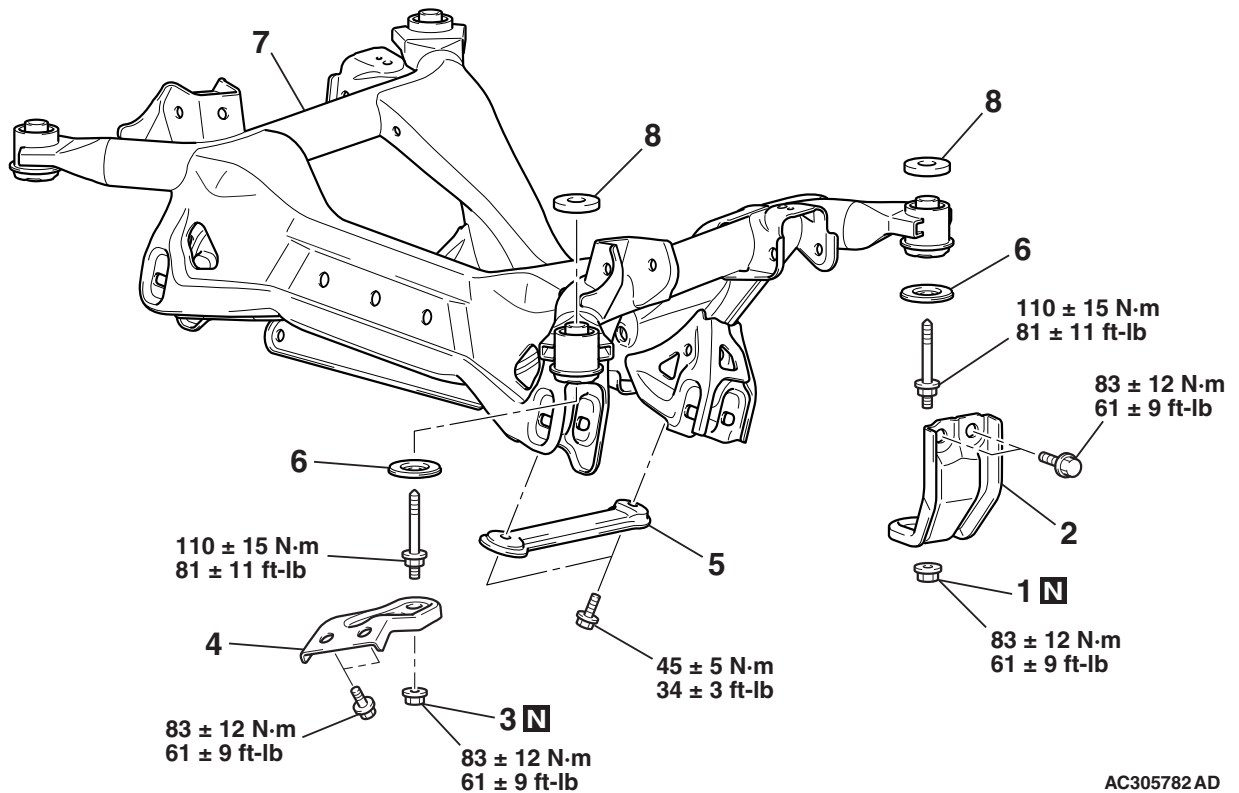
AC305782 AD

Be careful when handling the pole piece at the tip of the wheel speed sensor so as not to damage it by striking against other parts.

- Check the crossmember for cracks or deformation.
- Check all bolts for condition and straightness.

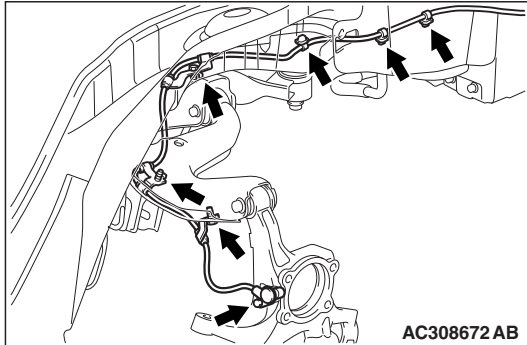
Be careful when handling the pole piece at the tip of the wheel speed sensor so as not to damage it by striking against other parts.

The rear wheel speed sensor can be damaged during service work. Unclamp the rear wheel speed sensor cable as shown, and use a cord to tie it out of the way.

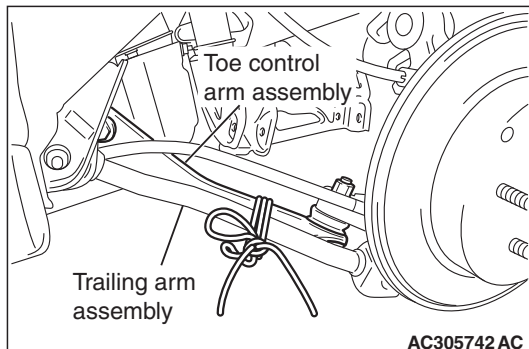
<> TOE CONTROL ARM ASSEMBLY REMOVAL

Disconnect the toe control arm only from its rear suspension crossmember side, and use a cord to tie it to the trailing arm assembly as shown.

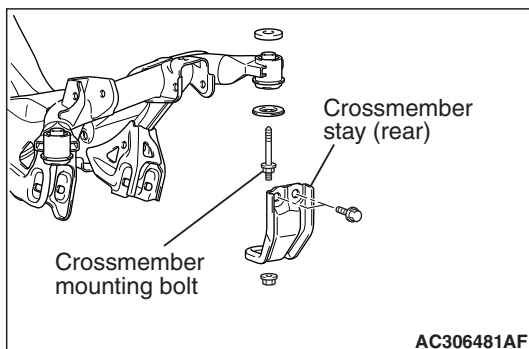
<<C>> CROSSMEMBER STAY (REAR) REMOVAL

The crossmember mounting bolts need not be unscrewed when the crossmember stay is replaced. However, the bolts may be loosened while the crossmember stay is removed. It is recommended that you should retighten the bolts to 110 ± 15 N·m (81 ± 11 ft-lb).

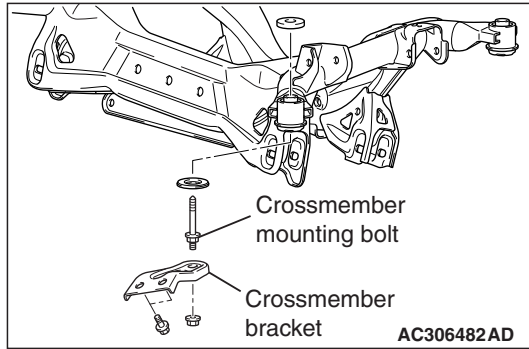
<<D>> CROSSMEMBER BRACKET REMOVAL

The crossmember mounting bolts need not be unscrewed when the crossmember bracket is replaced. However, the bolts may be loosened while the crossmember bracket is removed. It is recommended that you retighten the bolts to $110 \pm 15 \text{ N} \cdot \text{m}$ ($81 \pm 11 \text{ ft} \cdot \text{lb}$).

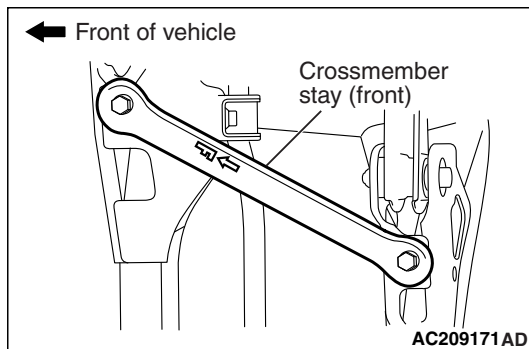
>>A<< CROSSMEMBER STAY (FRONT) INSTALLATION

Install the crossmember stay with its arrow facing the front of vehicle.

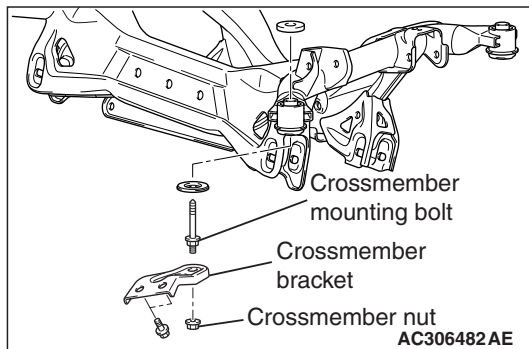
>>B<< CROSSMEMBER BRACKET/CROSSMEMBER NUT INSTALLATION

Ensure that the crossmember mounting bolts have been tightened to $110 \pm 15 \text{ N} \cdot \text{m}$ ($81 \pm 11 \text{ ft} \cdot \text{lb}$), and then install the crossmember bracket with the crossmember nut.

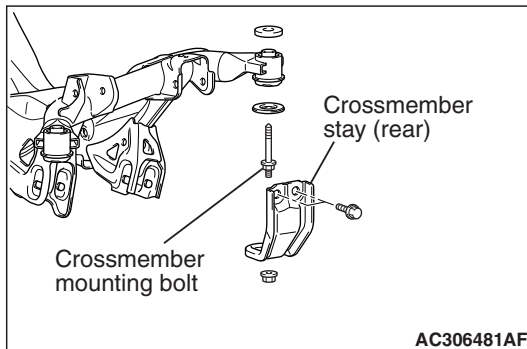
**>>C<< CROSSMEMBER STAY
(REAR)/CROSSMEMBER NUT INSTALLATION**

Ensure that the crossmember mounting bolts have been tightened to $110 \pm 15 \text{ N} \cdot \text{m}$ ($81 \pm 11 \text{ ft-lb}$), and then install the crossmember stay with the crossmember nut.
