## GROUP 52B

# SUPPLEMENTAL RESTRAINT SYSTEM (SRS)

## GENERAL INFORMATION

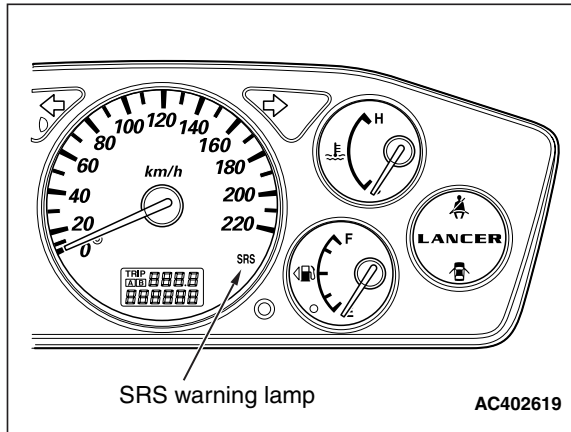
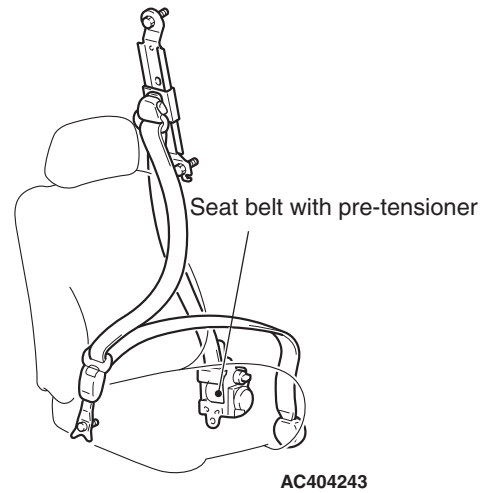
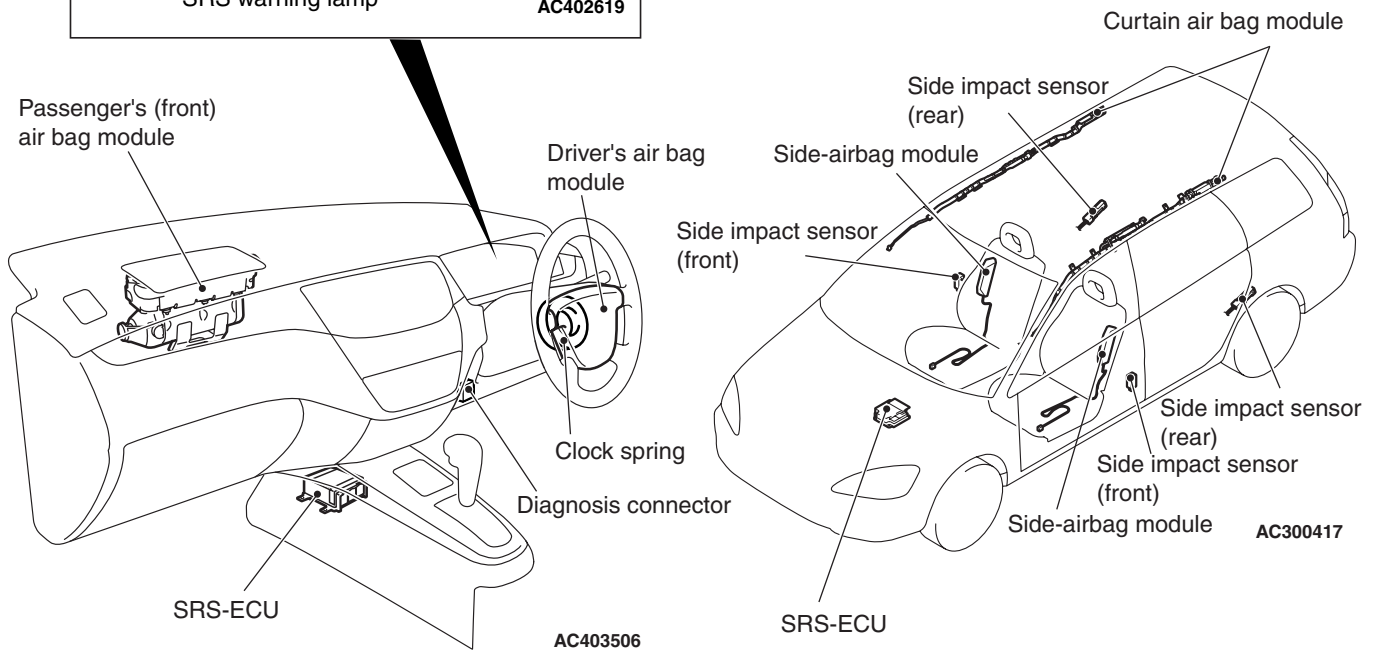
The clock spring is installed in the steering column.

The seat belt pre-tensioner is built into the driver's and front passenger's seat belt retractor.

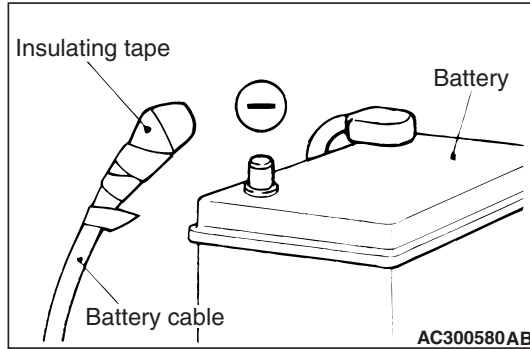
**After disconnecting the battery cable, wait 60 seconds or more before proceeding with the following work. In addition, insulate the negative battery terminal with a tape. The condenser inside the SRS-ECU is designed to retain enough voltage to deploy the air bag for a short time even after the battery has been disconnected, so serious injury may result from unintended air bag deployment if work is done on the SRS system immediately after the battery cables are disconnected.**

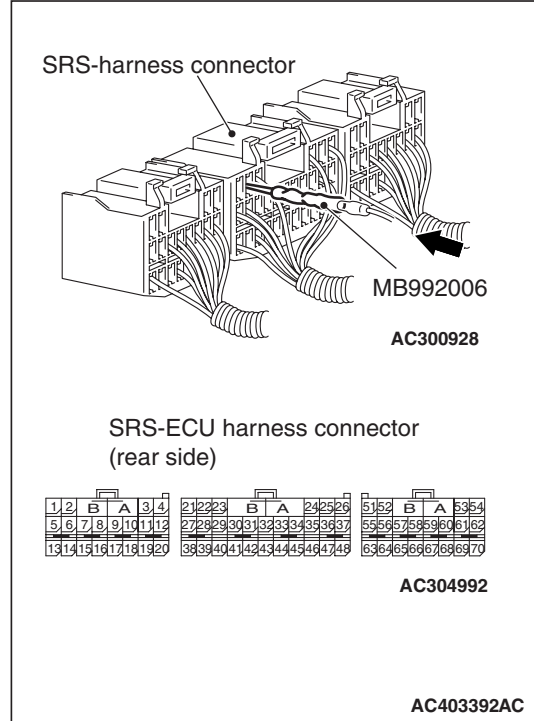
If checks are carried out by using the SRS-ECU harness connector, observe the following procedures: Insert the special tool extra fine probe (MB992006) into connector from harness side (rear side), and connect the tester to this probe. If any tool than special tool is used, damage to the harness and other components will result. Never insert the probe directly to the terminals from the front of the connector. The terminals are plated to increase their conductivity, so that if they are touched directly by the probe, the plating may break, which will cause drops in reliability.

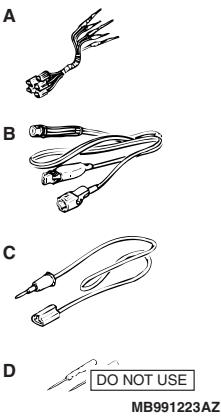
A B C D DO NOT USE MB991223AZ	MB991223 A: MB991219 B: MB991220 C: MB991221 D: MB991222	Harness set A: Test harness B: LED harness C: LED harness adapter D: Probe	Checking the continuity and measuring the voltage at the SRS-ECU harness connector

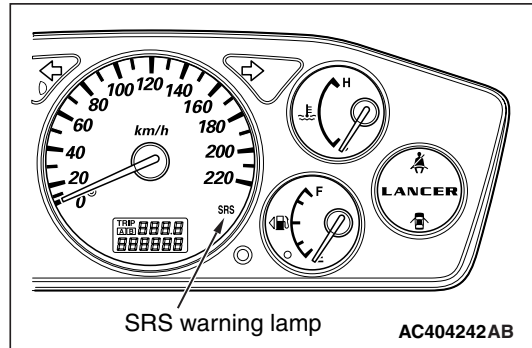
1. Check that the SRS warning lamp comes on when the ignition switch is turned ON.
2. Check that the SRS warning lamp illuminates for about 7 seconds and then goes out.
3. If this is not the cause, check the diagnosis codes.

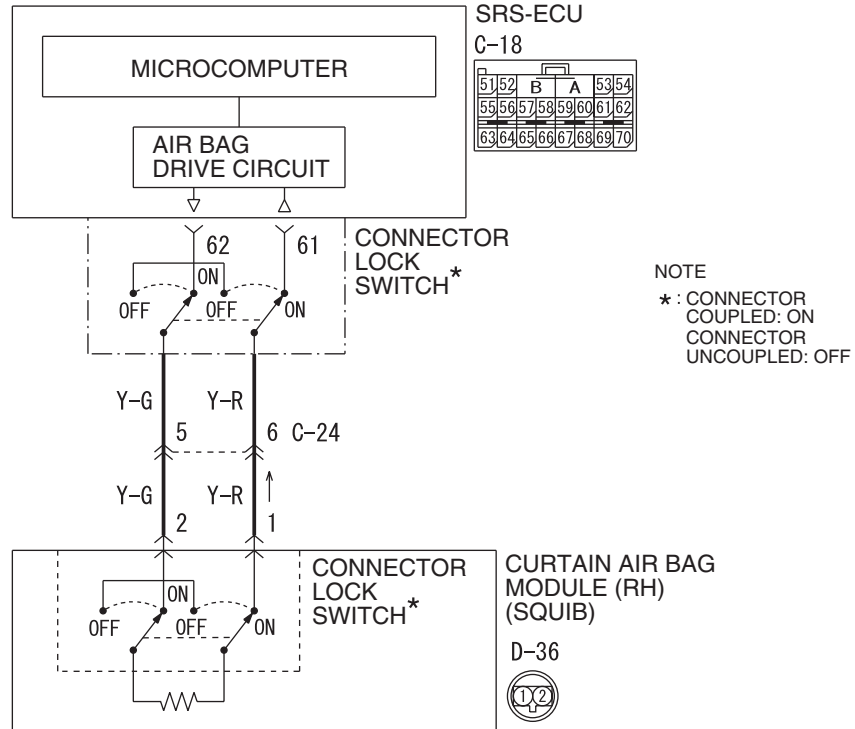
Curtain Air Bag Module (Squib) (RH) Circuit

- Improper engaged connector or defective short spring\*
- Short circuit between the curtain air bag module (squib) (RH) circuit terminals
- Damaged connector(s)
- Malfunction of the SRS-ECU

**NOTE:** \*: The squib circuit connectors integrate a "short" spring (which prevents the air bag from deploying unintentionally due to static electricity by shorting the positive wire to the earth wire in the squib circuit when the connectors are disconnected). Therefore, if connector C-18 or D-36 is damaged or improperly engaged, the short spring may not be released when the connector is connected.

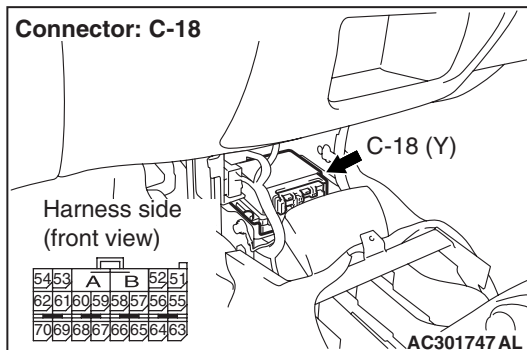
- (2) Disconnect connectors C-18 and then reconnect them.
- (3) Connect the negative battery terminal.
- (4) Erase the diagnosis code memory, and check the diagnosis code.

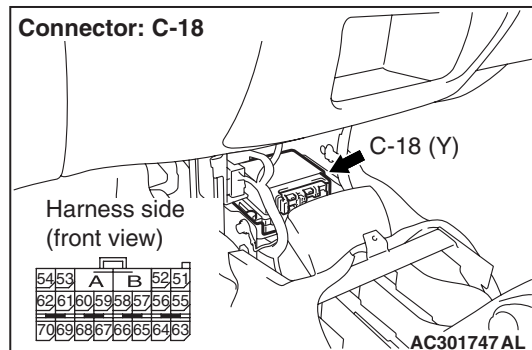
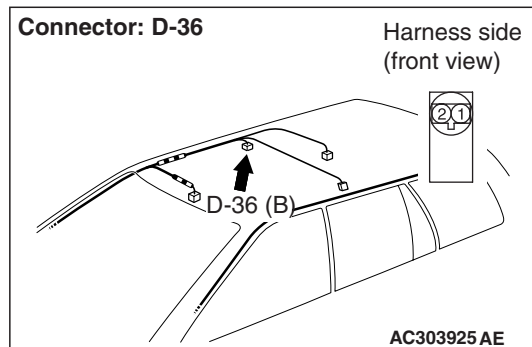
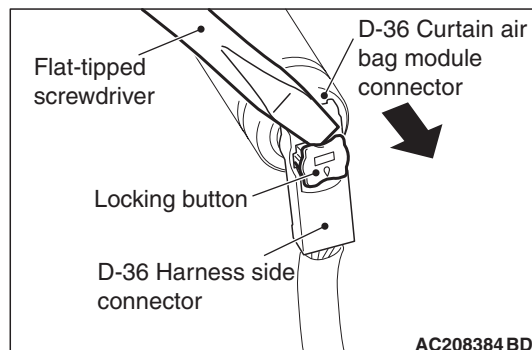
- (2) Disconnect connectors C-18 and D-36, and then reconnect them. For connector D-36, use a flat-tipped screwdriver to pull out the locking button at the harness side connector, and then disconnect the connector.
- (3) Connect the negative battery terminal.
- (4) Erase the diagnosis code memory, and check the diagnosis code.

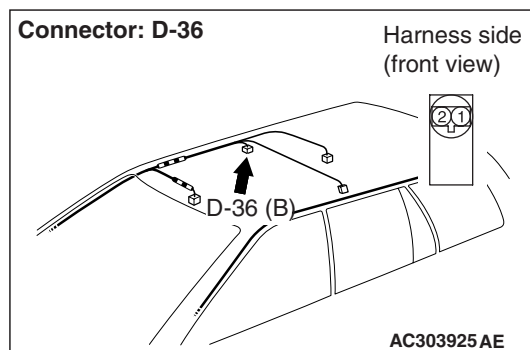
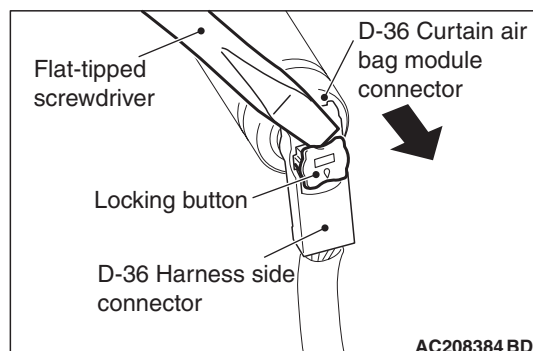
(2) Disconnect curtain air bag module connector D-36. Use a flat-tipped screwdriver to pull out the locking button at the harness side connector, and then disconnect the connector.

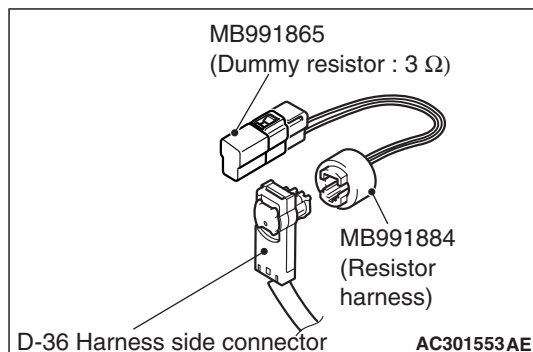
(3) Connect special tool dummy resistor (MB991865) to special tool resistor harness (MB991884).

- (4) Connect special tool (MB991884) to the D-36 harness side connector.
- (5) Connect the negative battery terminal.
- (6) Erase diagnosis code memory, and then check the diagnosis code.

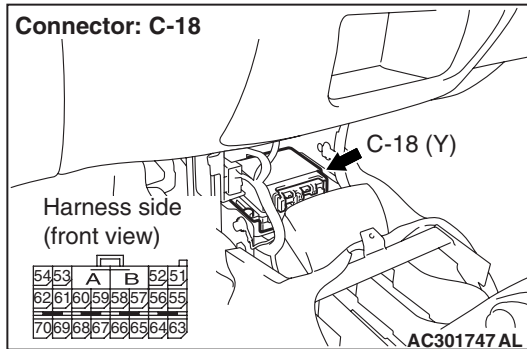
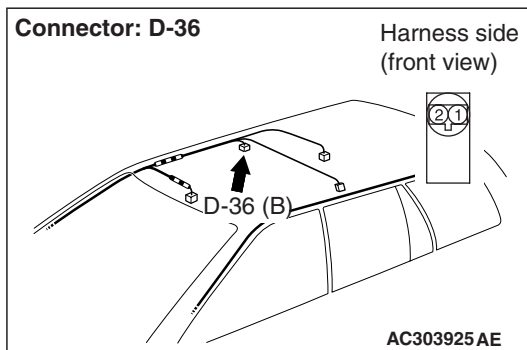
(1) Disconnect SRS-ECU connector C-18.

**To prevent the air bag from deploying unintentionally, disconnect the curtain air bag module connector D-36 to short the squib circuit.**

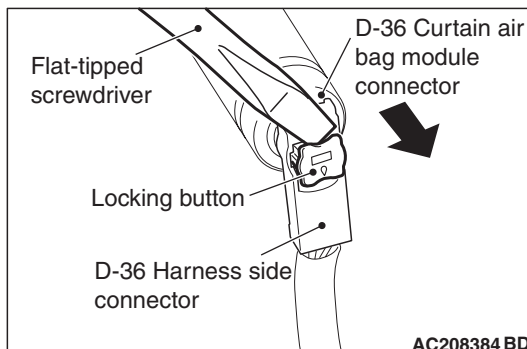
(2) Disconnect curtain air bag module connector D-36. Use a flat-tipped screwdriver to pull out the locking button at the harness side connector, and then disconnect the connector.

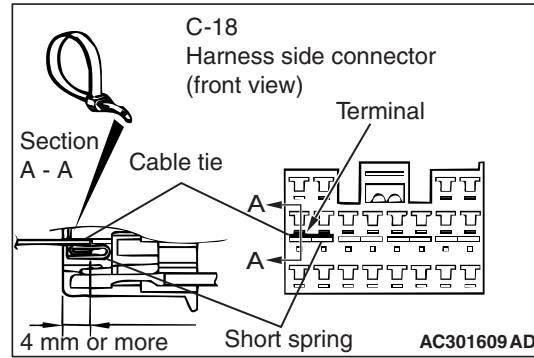
**Insert an insulator such as a cable tie to a depth of 4 mm or more, otherwise the short spring will not be released.**

(3) Insert a cable tie [3 mm wide, 0.5 mm thick] between terminals 61, 62 and the short spring to release the short spring.

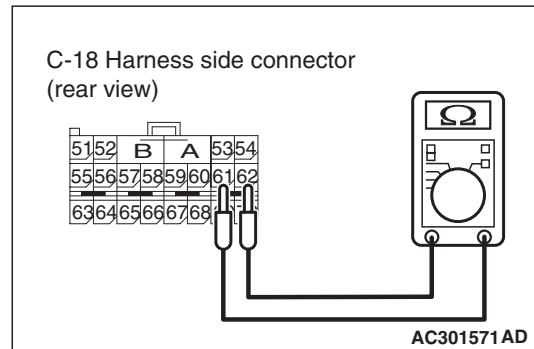
**Do not insert a test probe into the terminal from its front side directly as the connector contact pressure may be weakened.**

(4) Resistance measurement between C-18 harness side connector terminals 61 and 62.

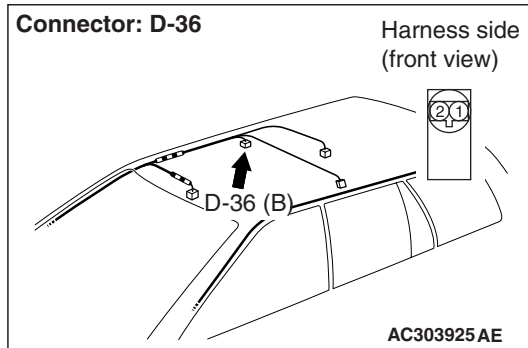
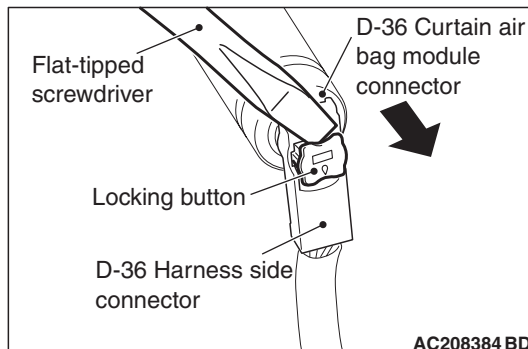
(2) Disconnect curtain air bag module connector D-36. Use a flat-tipped screwdriver to pull out the locking button at the harness side connector, and then disconnect the connector.

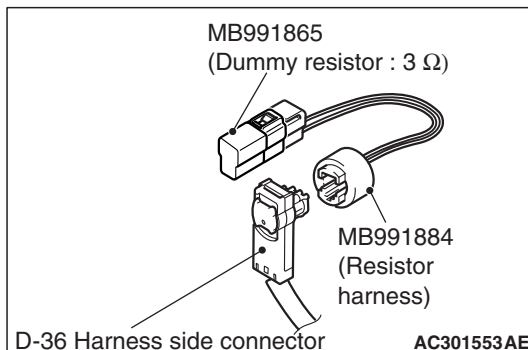
- (3) Connect special tool dummy resistor (MB991865) to special tool resistor harness (MB991884).  
 (4) Connect special tool (MB991884) to the D-36 harness side connector.

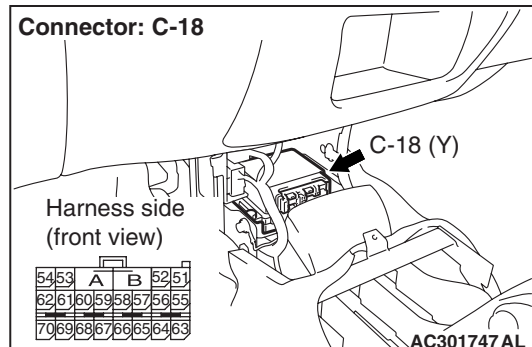
- (1) Disconnect SRS-ECU connector C-18 and curtain air bag module connector D-36, and measure at the wiring harness side. For connector D-36, use a flat-tipped screwdriver to pull out the locking button at the harness side connector, and then disconnect the connector.

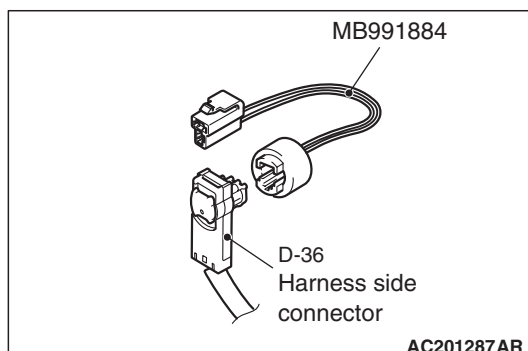
- (2) Connect D-36 harness side connector to special tool resistor harness (MB991884).

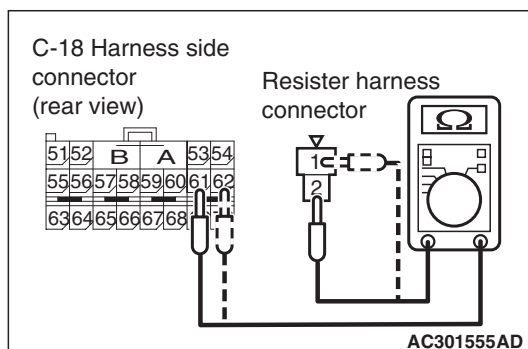
**Do not insert a test probe into the terminal from its front side directly as the connector contact pressure may be weakened.**

- (3) Resistance measurement between the following terminals.

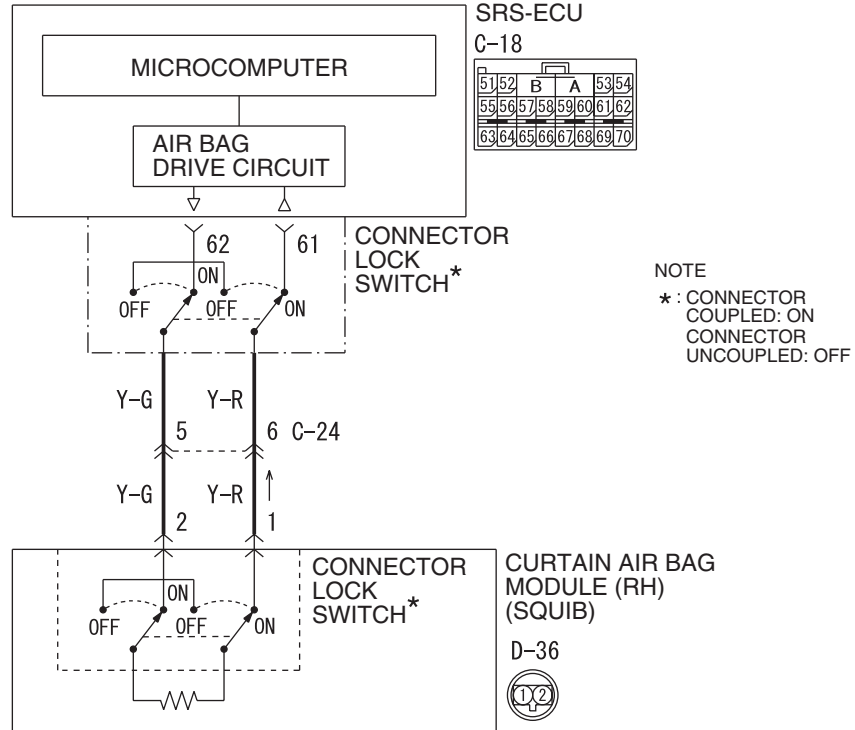
**Curtain Air Bag Module (Squib) (RH) Circuit**

- Damaged wiring harnesses or connectors
- Short to the power supply in the curtain air bag module (squib) (RH) harness
- Malfunction of the SRS-ECU

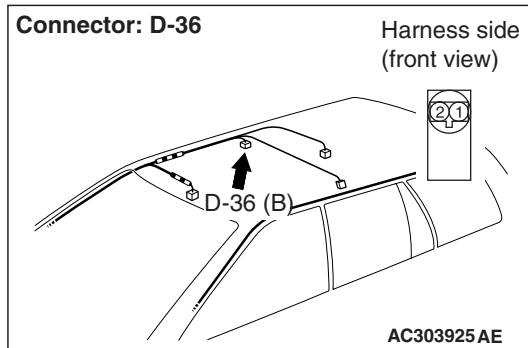
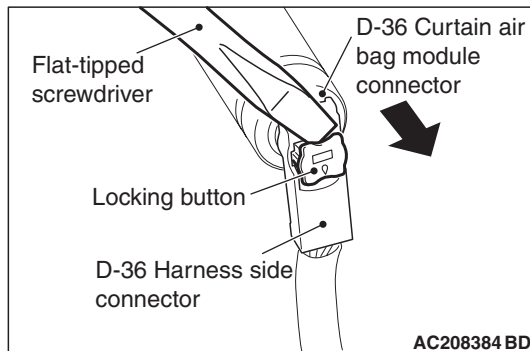
(2) Disconnect curtain air bag module connector D-36. Use a flat-tipped screwdriver to pull out the locking button at the harness side connector, and then disconnect the connector.

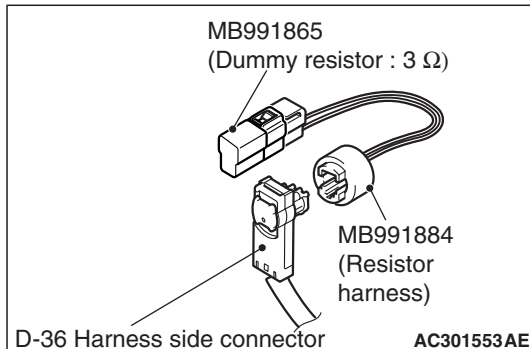
- (3) Connect special tool dummy resistor (MB991865) to special tool resistor harness (MB991884).  
 (4) Connect special tool (MB991884) to the D-36 harness side connector.  
 (5) Connect the negative battery terminal.

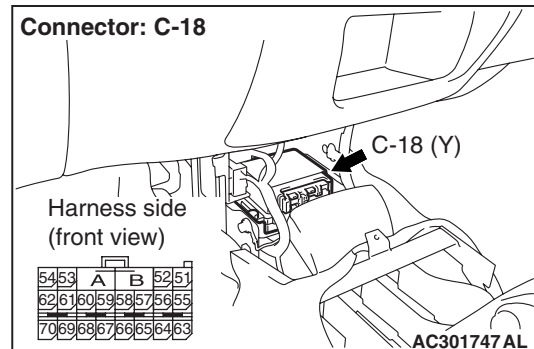
**Q: Is diagnosis code 3E set?****YES :** Go to Step 2.**NO :** Replace the curtain air bag module (Refer to [P.52B-164](#)).**STEP 2. Voltage measurement at the SRS-ECU connector C-18**

(1) Disconnect SRS-ECU connector C-18.

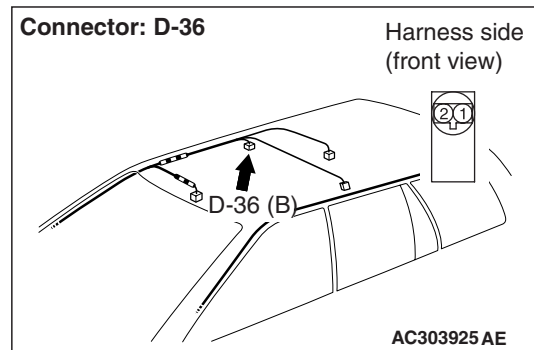
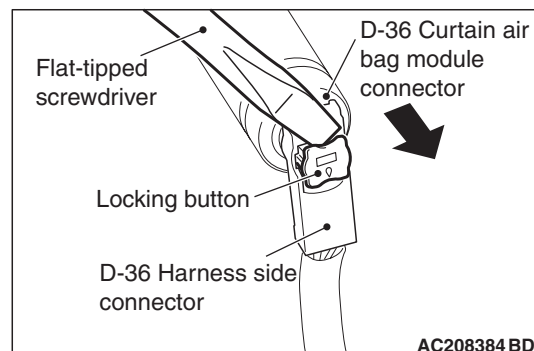
(2) Disconnect curtain air bag module connector D-36. Use a flat-tipped screwdriver to pull out the locking button at the harness side connector, and then disconnect the connector.

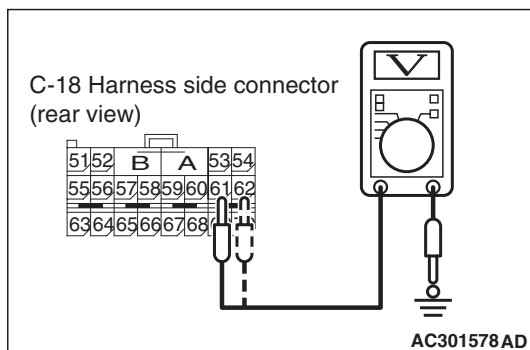
**Do not insert a test probe into the terminal from its front side directly as the connector contact pressure may be weakened.**

(4) Voltage measurement between C-18 harness side connector terminals 61, 62 and body earth.

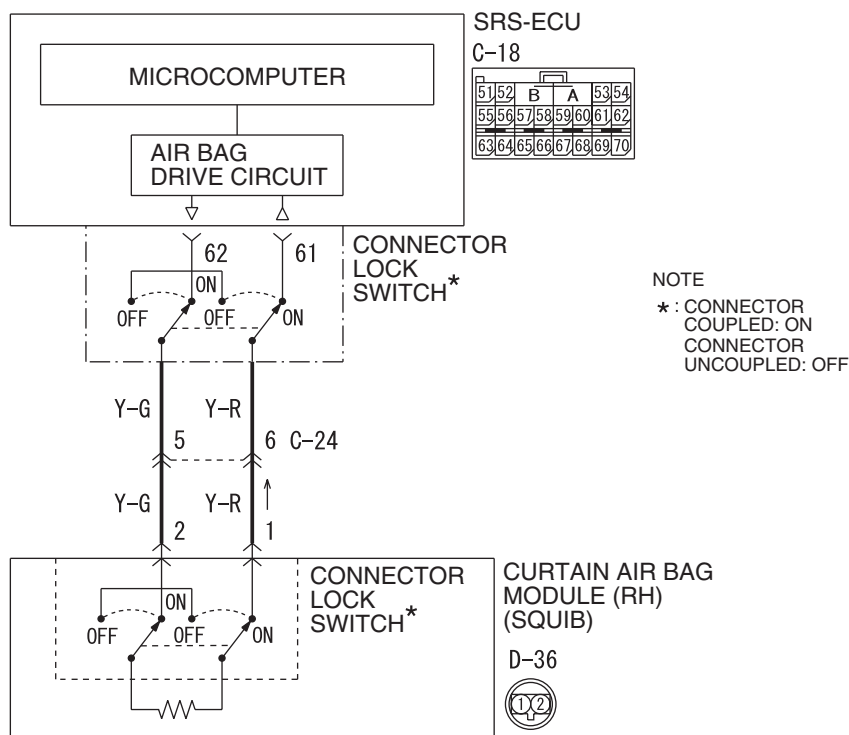
## Curtain Air Bag Module (Squib) (RH) Circuit

- Damaged wiring harnesses or connectors
- Short to the earth in the curtain air bag module (squib) (RH) harness
- Malfunction of the SRS-ECU

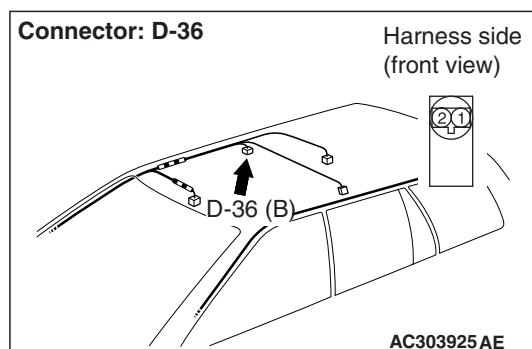
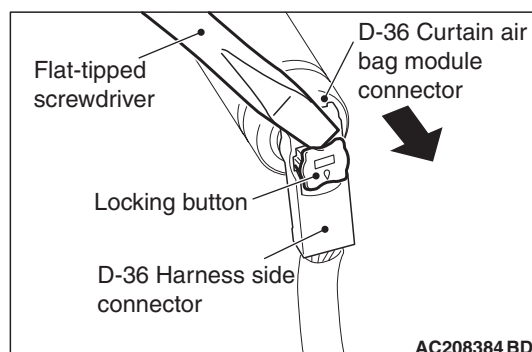
- (2) Disconnect curtain air bag module connector D-36. Use a flat-tipped screwdriver to pull out the locking button at the harness side connector, and then disconnect the connector.

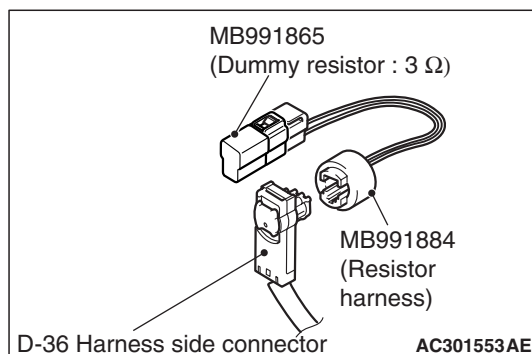
- (3) Connect special tool dummy resistor (MB991865) to special tool resistor harness (MB991884).  
(4) Connect special tool (MB991884) to the D-36 harness side connector.  
(5) Connect the negative battery terminal.

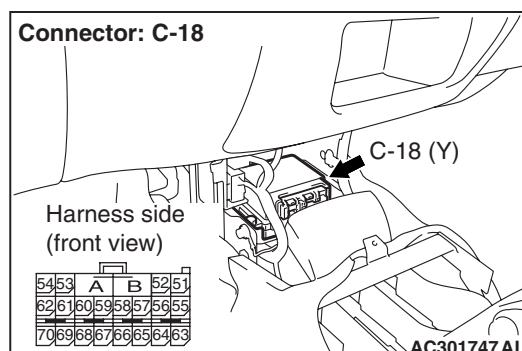
- (1) Disconnect SRS-ECU connector C-18.

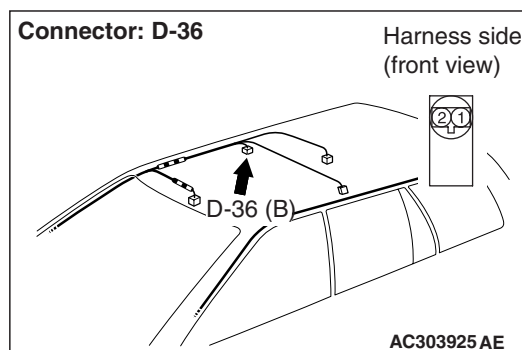
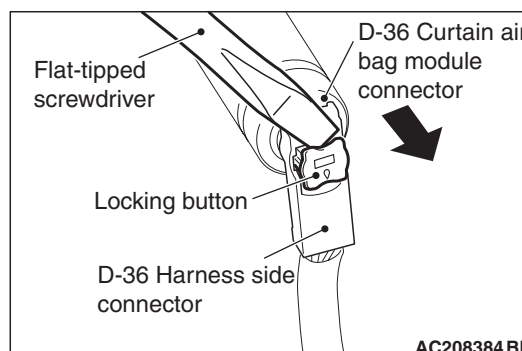
- (2) Disconnect curtain air bag module connector D-36. Use a flat-tipped screwdriver to pull out the locking button at the harness side connector, and then disconnect the connector.

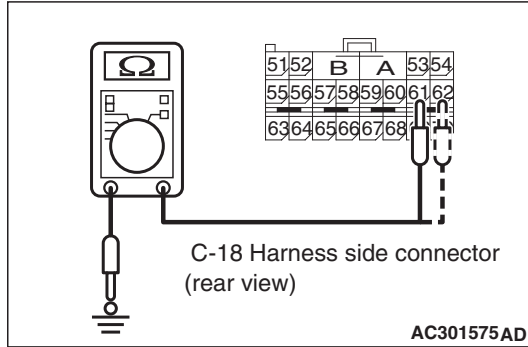
Do not insert a test probe into the terminal from its front side directly as the connector contact pressure may be weakened.

(3) Resistance measurement between C-18 harness side connector terminals 61, 62 and body earth.

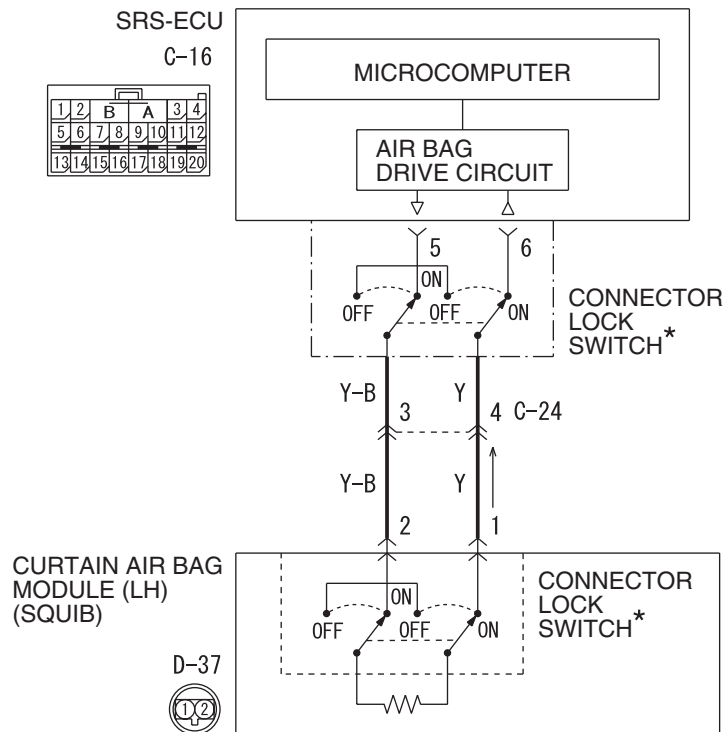
#### Curtain Air Bag Module (Squib) (LH) Circuit

### Code No.4A: Curtain air bag module (squib) (LH) system (short-circuited between terminals of the squib circuit)

\* : CONNECTOR  
COUPLED: ON  
CONNECTOR  
UNCOUPLD: OFF

- Improper engaged connector or defective short spring\*
- Short circuit between the curtain air bag module (squib) (LH) circuit terminals
- Damaged connector(s)
- Malfunction of the SRS-ECU

**NOTE:** \*: The squib circuit connectors integrate a "short" spring (which prevents the air bag from deploying unintentionally due to static electricity by shorting the positive wire to the earth wire in the squib circuit when the connectors are disconnected). Therefore, if connector C-16 or D-37 is damaged or improperly engaged, the short spring may not be released when the connector is connected.

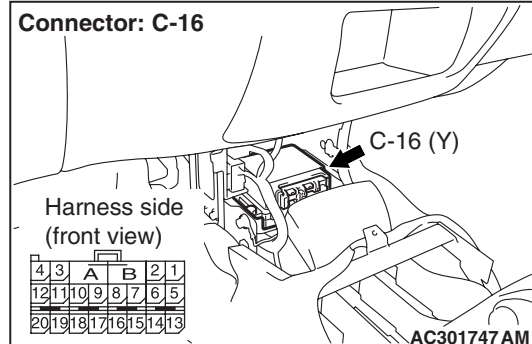
- (2) Disconnect connectors C-16 and then reconnect them.  
(3) Connect the negative battery terminal.  
(4) Erase the diagnosis code memory, and check the diagnosis code.

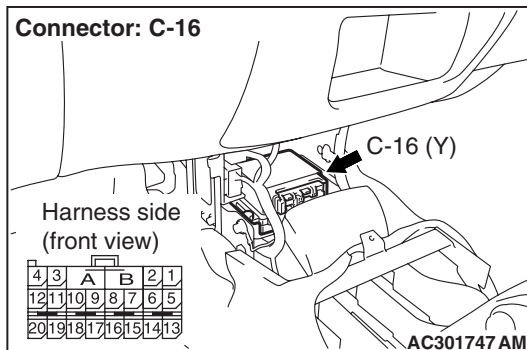
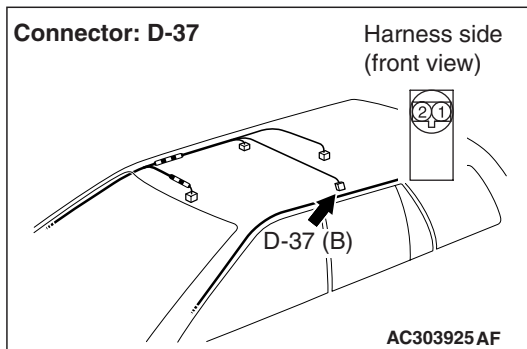
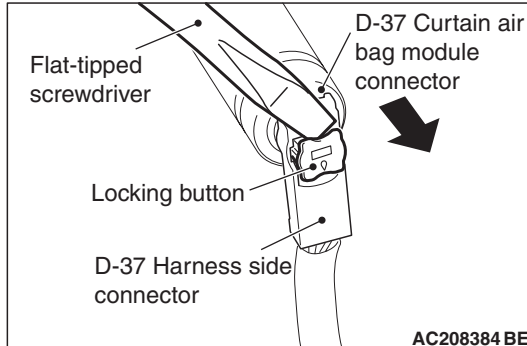
- (2) Disconnect connectors C-16 and D-37, and then reconnect them. For connector D-37, use a flat-tipped screwdriver to pull out the locking button at the harness side connector, and then disconnect the connector.
- (3) Connect the negative battery terminal.
- (4) Erase the diagnosis code memory, and check the diagnosis code.

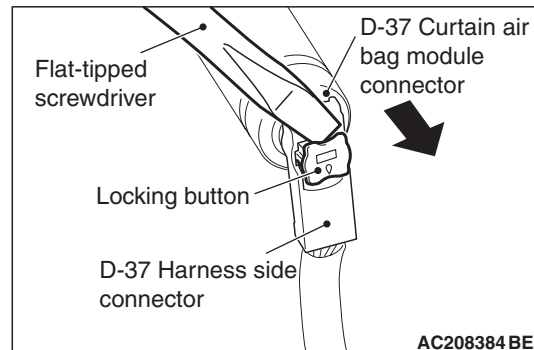
- (2) Disconnect curtain air bag module connector D-37. Use a flat-tipped screwdriver to pull out the locking button at the harness side connector, and then disconnect the connector.

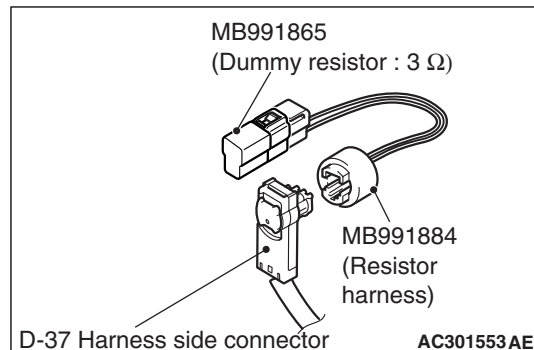
- (3) Connect special tool dummy resistor (MB991865) to special tool resistor harness (MB991884).
- (4) Connect special tool (MB991884) to the D-37 harness side connector.
- (5) Connect the negative battery terminal.
- (6) Erase diagnosis code memory, and then check the diagnosis code.

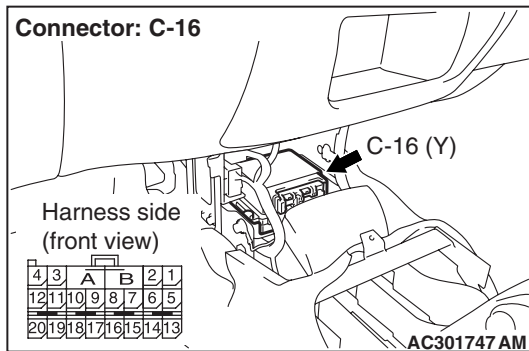
**STEP 5. Resistance measurement at the SRS-ECU connector C-16**

(1) Disconnect SRS-ECU connector C-16.

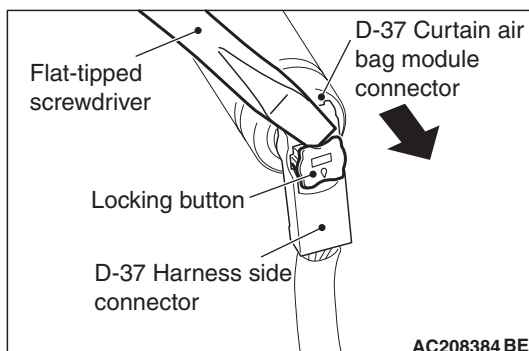
(2) Disconnect curtain air bag module connector D-37. Use a flat-tipped screwdriver to pull out the locking button at the harness side connector, and then disconnect the connector.

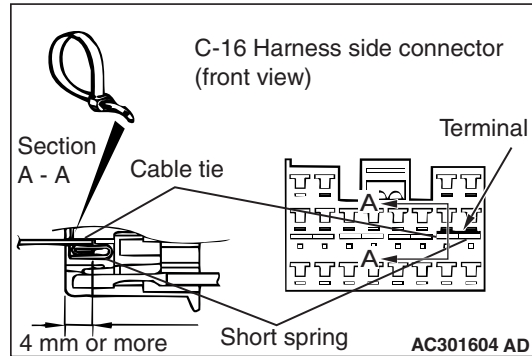
**Insert an insulator such as a cable tie to a depth of 4 mm or more, otherwise the short spring will not be released.**

(3) Insert a cable tie [3 mm wide, 0.5 mm thick] between terminals 5, 6 and the short spring to release the short spring.

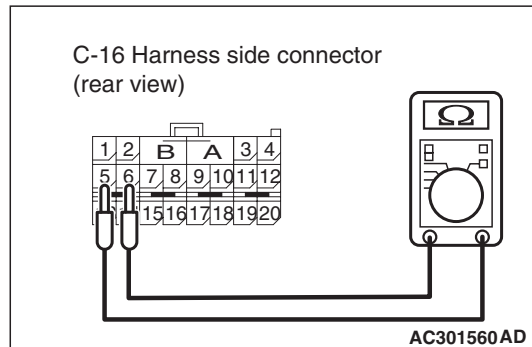
**Do not insert a test probe into the terminal from its front side directly as the connector contact pressure may be weakened.**

(4) Resistance measurement between C-16 harness side connector terminals 5 and 6.

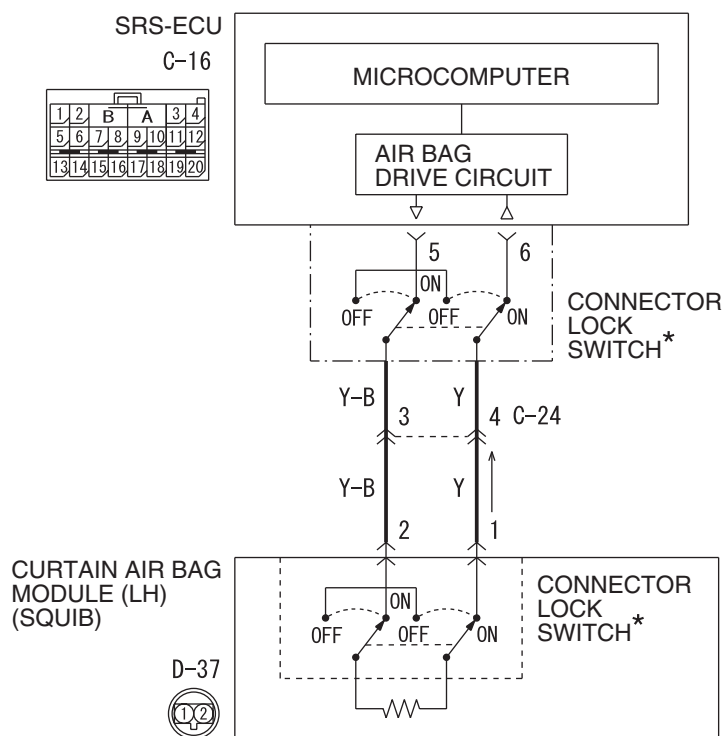
**Code No.4B: Curtain air bag module (squib) (LH) system (open-circuited in the squib circuit)****Curtain Air Bag Module (Squib) (LH) Circuit**

\* : CONNECTOR  
COUPLED: ON  
CONNECTOR  
UNCOUPLD: OFF

- Improper connector contact
- Open circuit in the curtain air bag module (squib) (LH) circuit
- Malfunction of the SRS-ECU

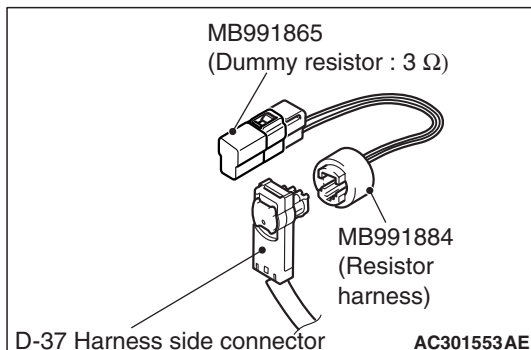
- (3) Connect special tool dummy resistor (MB991865) to special tool resistor harness (MB991884).  
 (4) Connect special tool (MB991884) to the D-37 harness side connector.

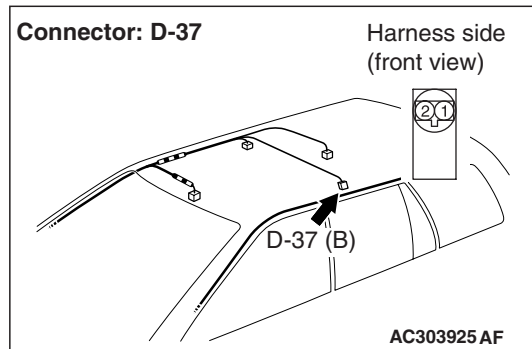
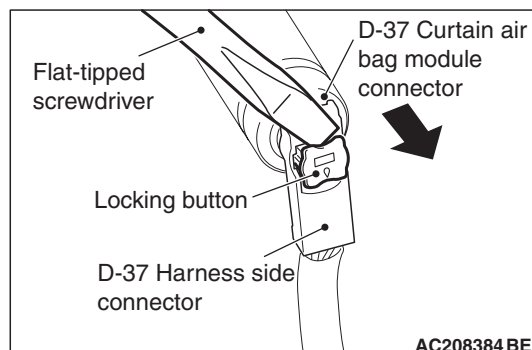
### STEP 2. Resistance measurement between SRS-ECU connector C-16 (terminal No.5 and 6) and the curtain air bag module D-37 (terminal No.1 and 2).

- (1) Disconnect SRS-ECU connector C-16 and curtain air bag module connector D-37, and measure at the wiring harness side. For connector D-37, use a flat-tipped screwdriver to pull out the locking button at the harness side connector, and then disconnect the connector.

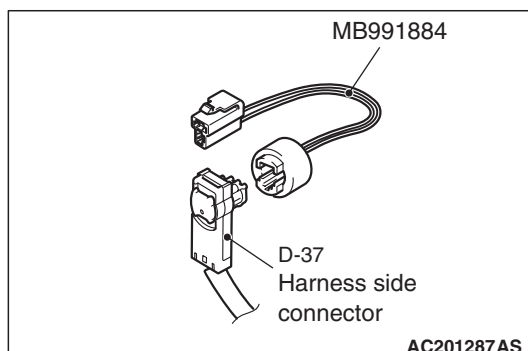
- (2) Connect D-37 harness side connector to special tool resistor harness (MB991884).

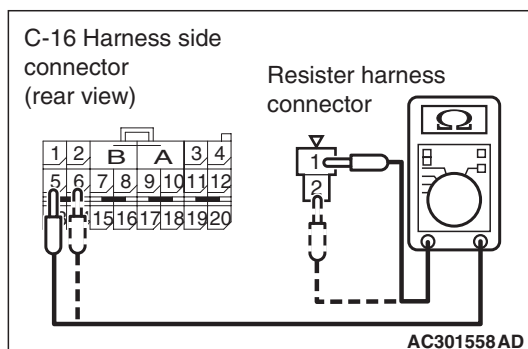
**Do not insert a test probe into the terminal from its front side directly as the connector contact pressure may be weakened.**

- (3) Resistance measurement between the following terminals.

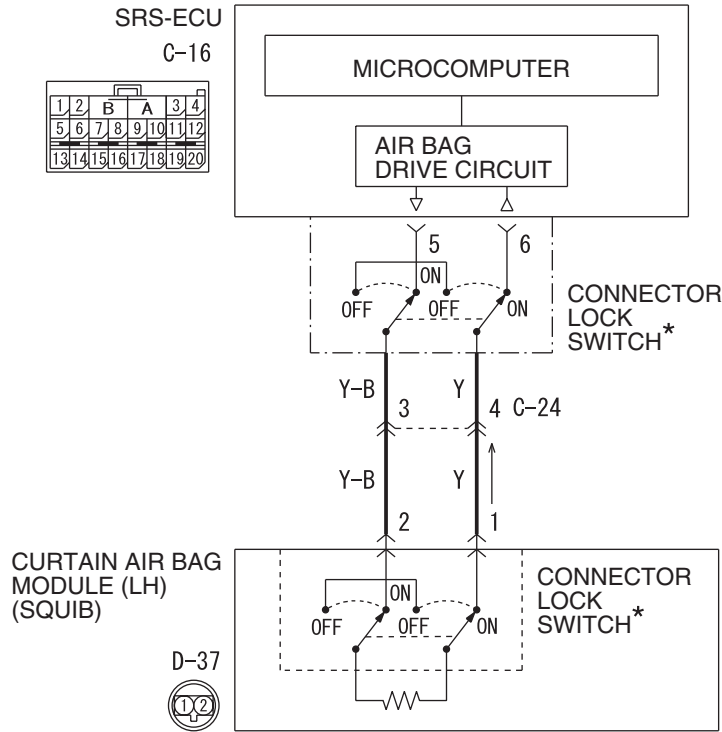
**Curtain Air Bag Module (Squib) (LH) Circuit**

**Code No.4E: Curtain air bag module (squib) (LH) system (short-circuited to the power supply)**

\* : CONNECTOR  
COUPLED: ON  
CONNECTOR  
UNCOUPLD: OFF

- Damaged wiring harnesses or connectors
- Short to the power supply in the curtain air bag module (squib) (LH) harness
- Malfunction of the SRS-ECU

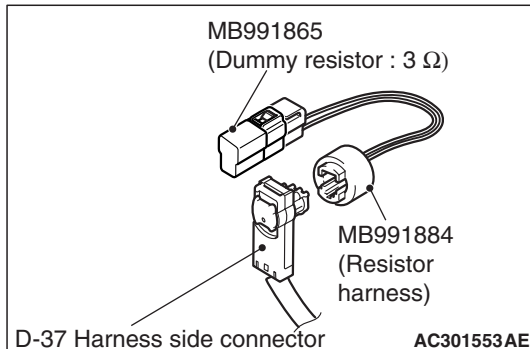
- (3) Connect special tool dummy resistor (MB991865) to special tool resistor harness (MB991884).  
(4) Connect special tool (MB991884) to the D-37 harness side connector.  
(5) Connect the negative battery terminal.

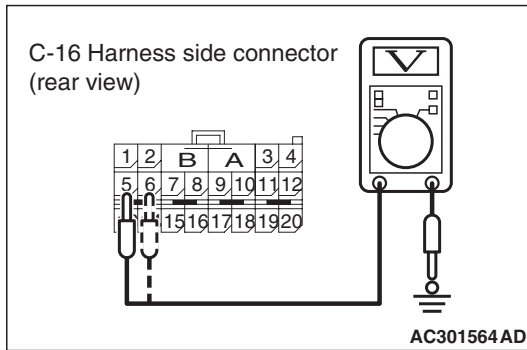
**Do not insert a test probe into the terminal from its front side directly as the connector contact pressure may be weakened.**

(4) Voltage measurement between C-16 harness side connector terminals 5, 6 and body earth.

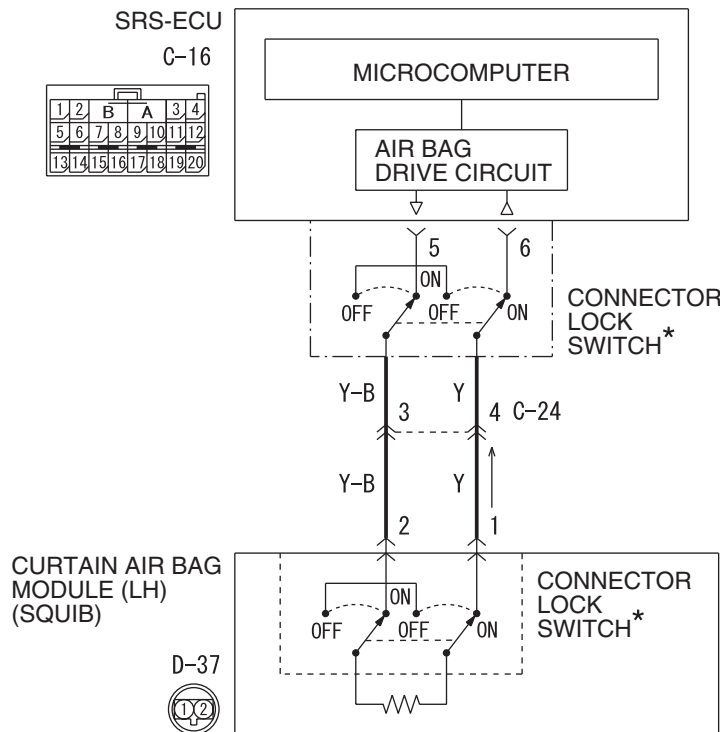
**Curtain Air Bag Module (Squib) (LH) Circuit**

**Code No.4F: Curtain air bag module (squib) (LH) system (short-circuited to the earth)**

\* : CONNECTOR  
COUPLED: ON  
CONNECTOR  
UNCOUPLD: OFF

- Damaged wiring harnesses or connectors
- Short to the earth in the curtain air bag module (squib) (LH) harness
- Malfunction of the SRS-ECU

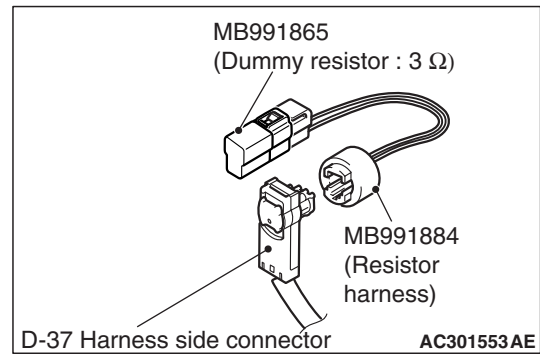
- (3) Connect special tool dummy resistor (MB991865) to special tool resistor harness (MB991884).
- (4) Connect special tool (MB991884) to the D-37 harness side connector.
- (5) Connect the negative battery terminal.
- (6) Erase diagnosis code memory, and check the diagnosis code.

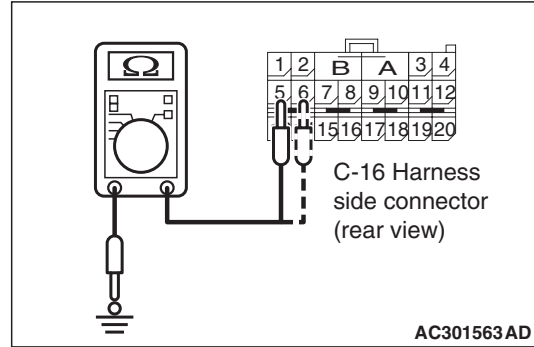
**Do not insert a test probe into the terminal from its front side directly as the connector contact pressure may be weakened.**

(3) Resistance measurement between C-16 harness side connector terminals 5, 6 and body earth.

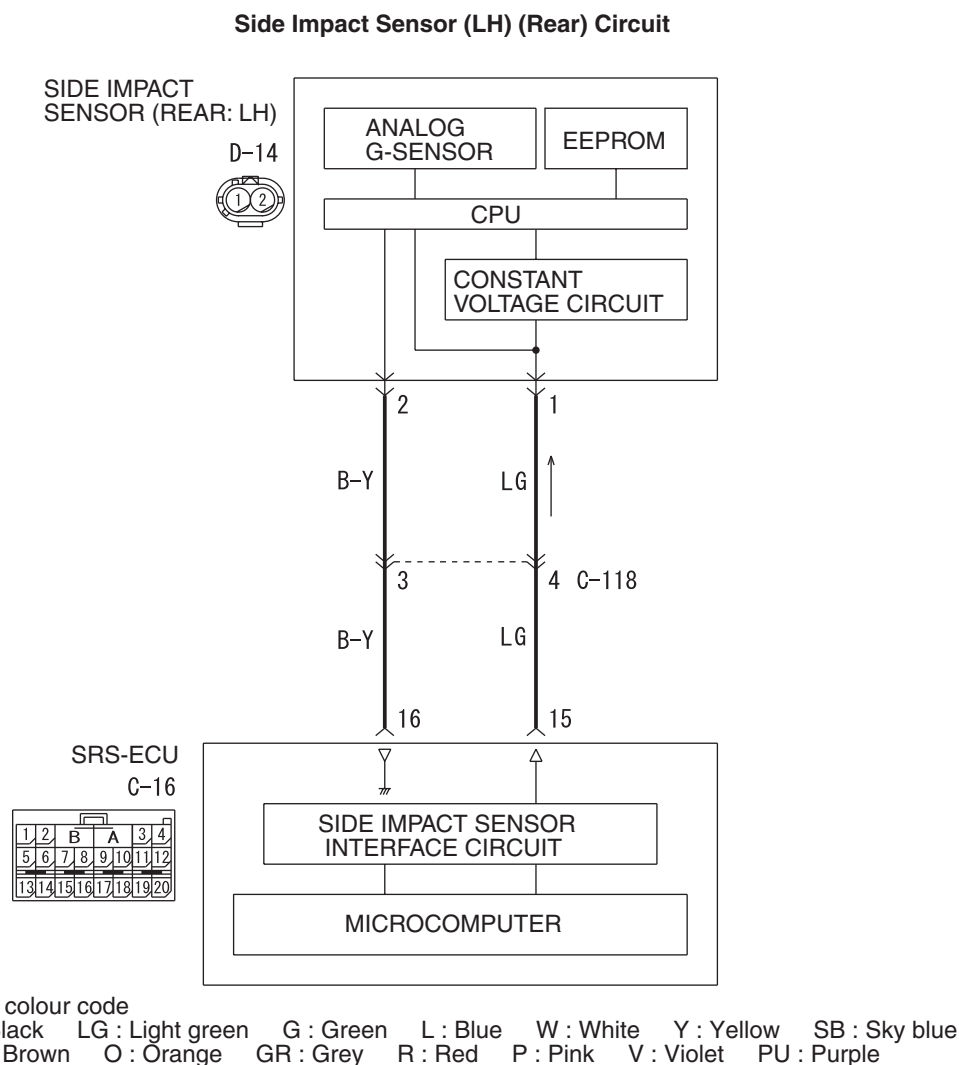
W5J52L004A

## Code No.5A: Side impact sensor (LH) (rear) voltage error

This diagnosis code will set when the power supply voltage to the side impact sensor (LH) (rear) remains less than a predetermined value for 5 seconds. However, if the system returns to normal condition, code number 5A will be erased automatically and the SRS warning lamp will go out.

- Damaged wiring harness or connectors
- Malfunction of the side impact sensor (LH) (rear)
- Malfunction of the SRS-ECU

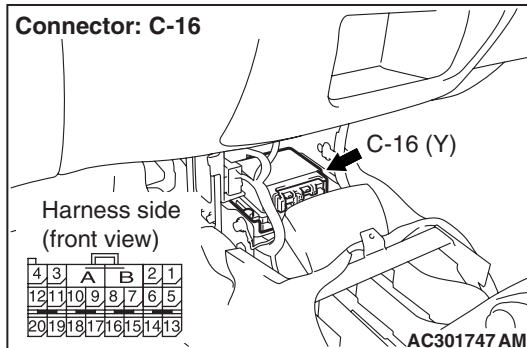
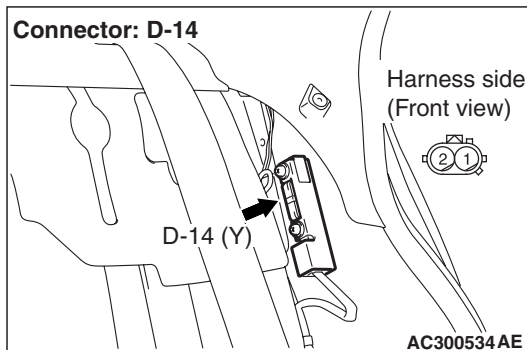
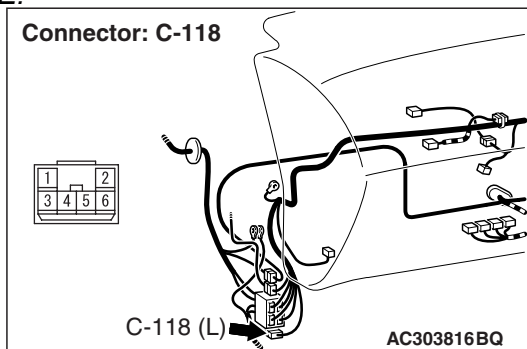
**STEP 1. Check the harness wires for open circuit or short circuit between SRS-ECU connector C-16 (terminal No.15 and 16) and side impact sensor (LH) (rear) connector D-14 (terminal No.1 and 2).**

*After inspecting intermediate connector C-118 inspect the wiring harness. If the intermediate connector C-118 is damaged, repair or replace it.*

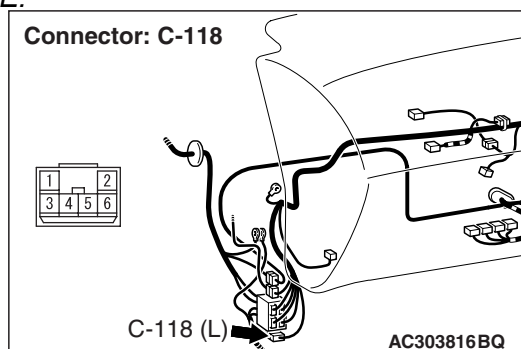
*After inspecting intermediate connector C-118 inspect the wiring harness. If the intermediate connector C-118 is damaged, repair or replace it.*

**NO** : Repair the harness wires between SRS-ECU connector C-16 (terminal No.15 and 16) and side impact sensor (LH) (rear) connector D-14 (terminal No.1 and 2).

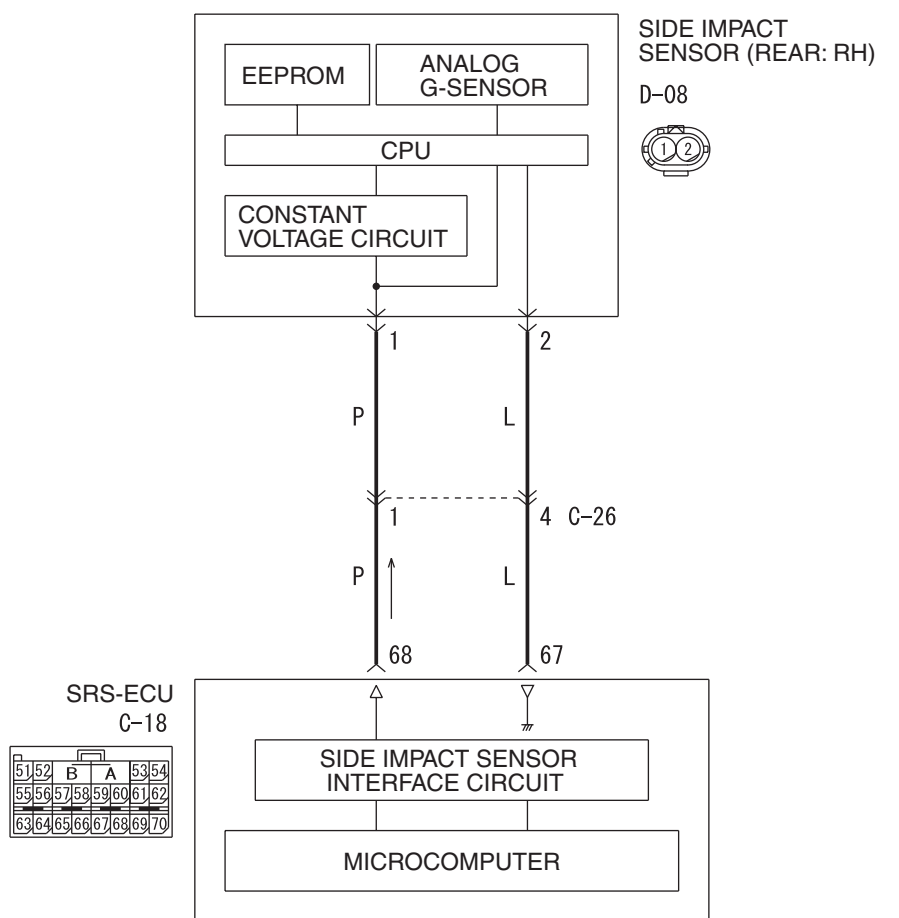
[P.00-13](#)).**Code No.6A: Side impact sensor (RH) (rear) voltage error****Side Impact Sensor (RH) (Rear) Circuit**

This diagnosis code is set if the power supply voltage of the side impact sensor (RH) (rear) drops below the rated value for a continuous period of 5 seconds or more. However, if the system returns to normal condition, code number 6A will be erased automatically and the SRS warning lamp will go out.

- Damaged wiring harnesses or connectors
- Malfunction of the side impact sensor (RH) (rear)
- Malfunction of the SRS-ECU

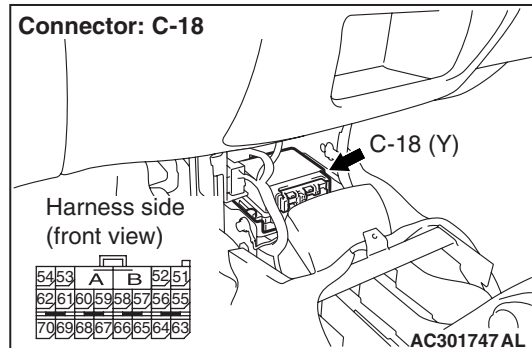
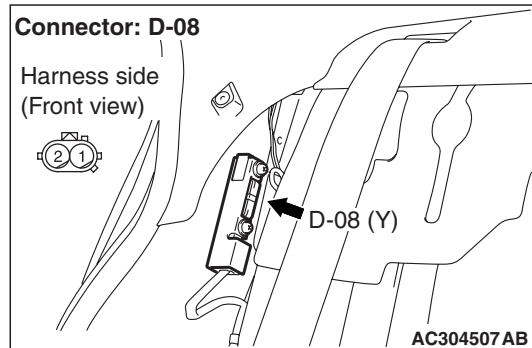
**STEP 1. Check the harness wires for open circuit or short circuit between SRS-ECU connector C-18 (terminal No.67 and 68) and side impact sensor (RH) (rear) connector D-08 (terminal No.1 and 2).**

*After inspecting intermediate connector C-26 inspect the wiring harness. If the intermediate connector C-26 is damaged, repair or replace it.*

**NO :** Repair the harness wires between SRS-ECU connector C-18 (terminal No.67 and 68) and side impact sensor (RH) (rear) connector D-08 (terminal No.1 and 2).
