## GROUP 52B

# SUPPLEMENTAL RESTRAINT SYSTEM (SRS)

## GENERAL INFORMATION

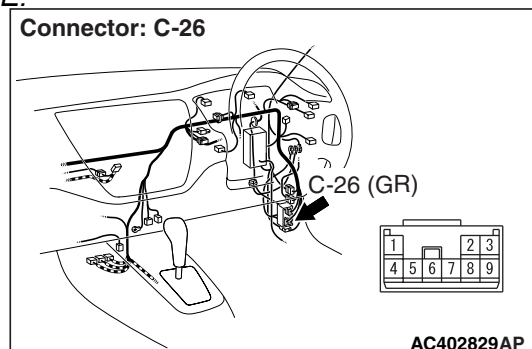
*After inspecting intermediate connector C-26 inspect the wiring harness. If the intermediate connector C-26 is damaged, repair or replace it.*

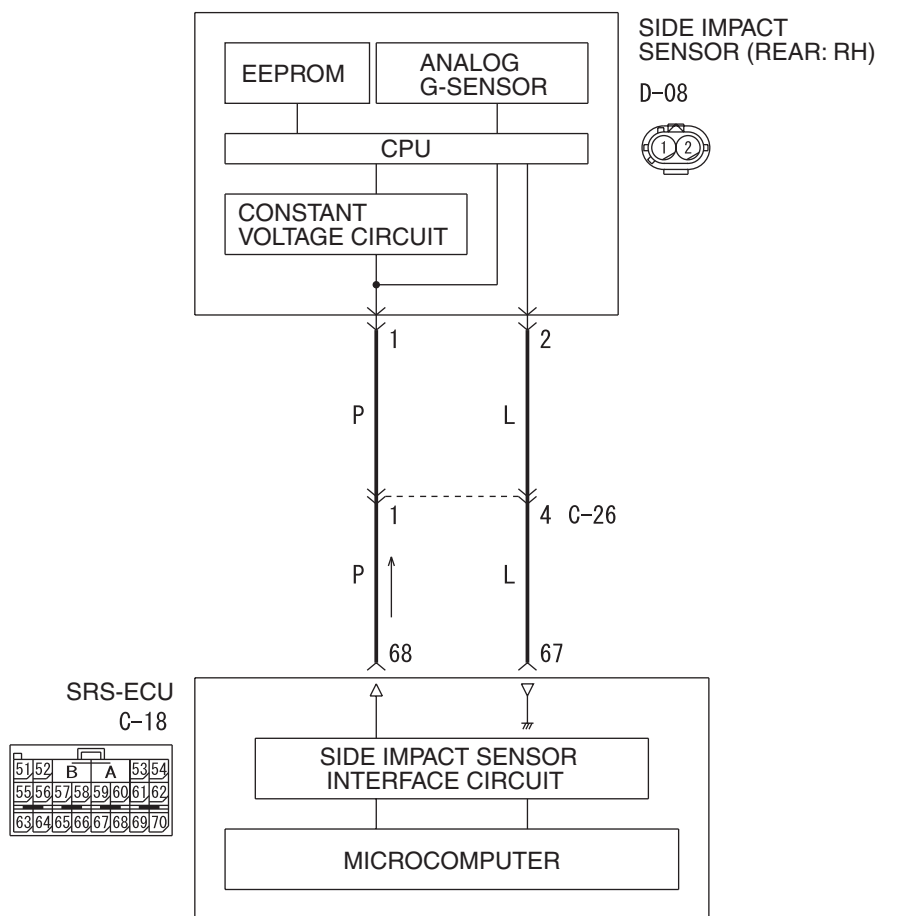
**Code No.6C: Side impact sensor (RH) (rear) communication error****Code No.6D: Side impact sensor (RH) (rear) communication impossible****Side Impact Sensor (RH) (Rear) Circuit**

- Damaged wiring harnesses or connectors
- Malfunction of the side impact sensor (RH) (rear)
- Malfunction of the SRS-ECU

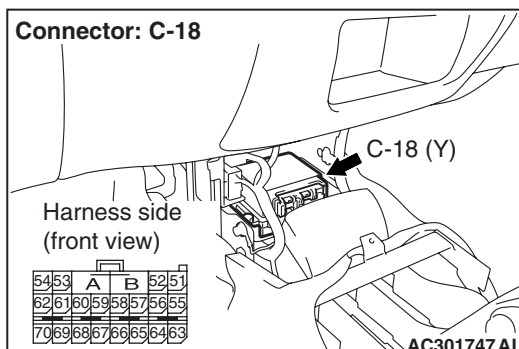
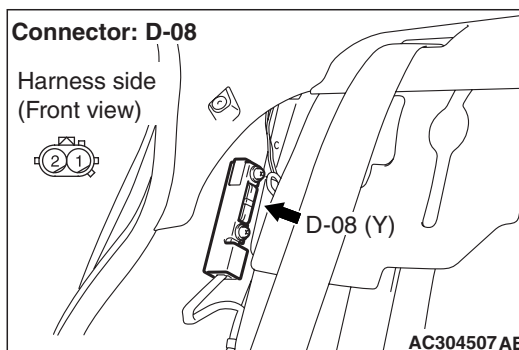
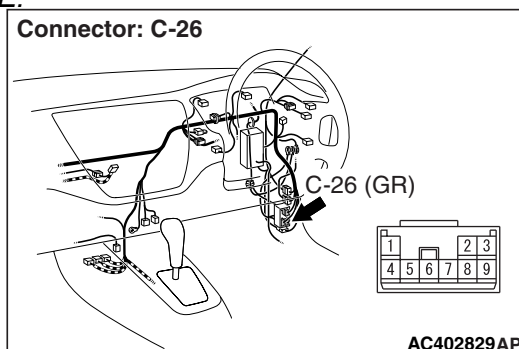
**STEP 2. Check the harness wires for open circuit or short circuit between SRS-ECU connector C-18 (terminal No.67 and 68) and side impact sensor (RH) (rear) connector D-08 (terminal No.1 and 2).**

*After inspecting intermediate connector C-26 inspect the wiring harness. If the intermediate connector C-26 is damaged, repair or replace it.*

**NO :** Repair the harness wires between SRS-ECU connector C-18 (terminal No.67 and 68) and side impact sensor (RH) (rear) connector D-08 (terminal No.1 and 2).

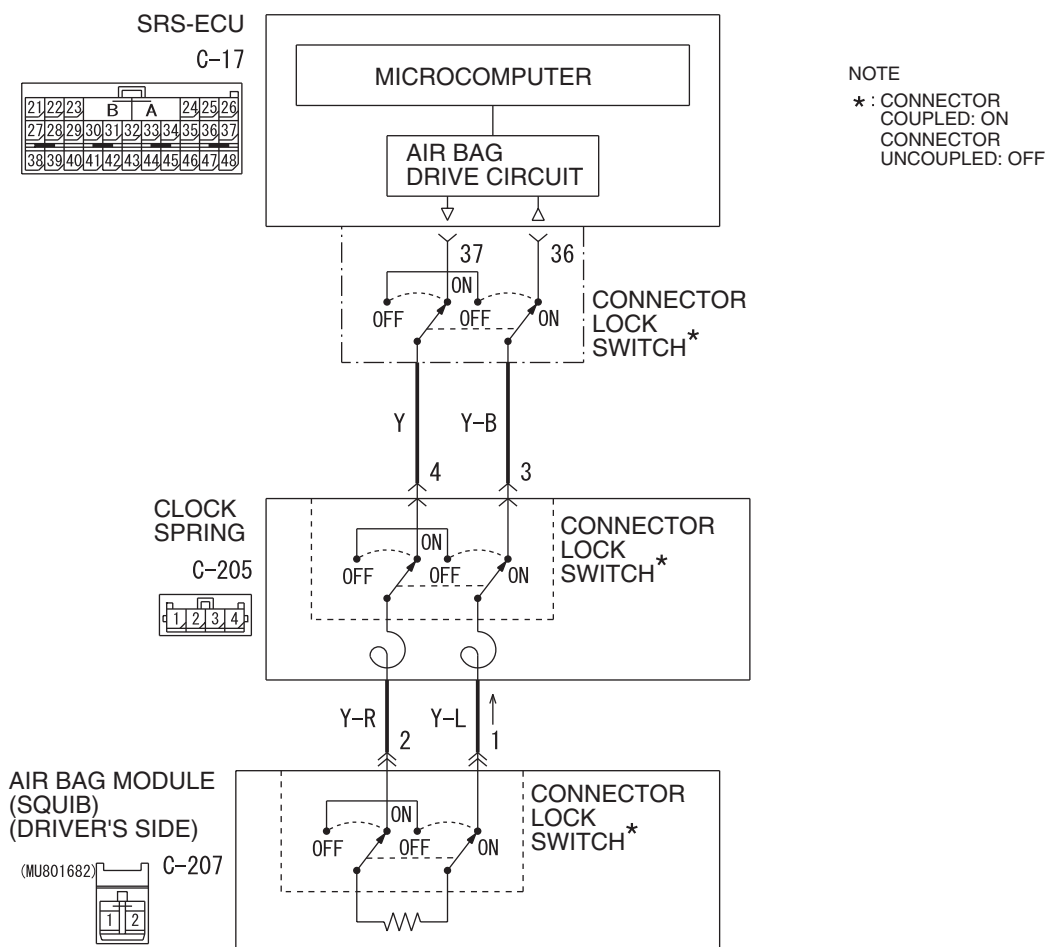
[P.00-13](#)).**Code No.21: Driver's air bag module (squib) system (short-circuited between terminals of the squib circuit)****Driver's Air Bag Module (Squib) Circuit**

- Improper engaged connector or defective short spring\*
- Short circuit in the clock spring
- Short circuit between the driver's air bag module (squib) circuit terminals
- Damaged connector(s)
- Malfunction of the SRS-ECU

*NOTE: \*: The squib circuit connectors integrate a "short" spring (which prevents the air bag from deploying unintentionally due to static electricity by shorting the positive wire to the earth wire in the squib circuit when the connectors are disconnected). Therefore, if connector C-17, C-205 or C-207 is damaged or improperly engaged, the short spring may not be released when the connector is connected.*

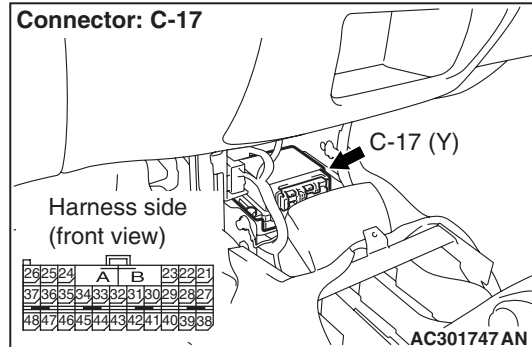
### STEP 2. Connector lock check: SRS-ECU connector C-17(M.U.T.-II/III diagnosis code)

- (2) Disconnect connectors C-17 and then reconnect them.
- (3) Connect the negative battery terminal.
- (4) Erase the diagnosis code memory, and check the diagnosis code.

**NO :** The procedure is complete. It is assumed that diagnosis code 21 set as connector C-17 was engaged improperly.

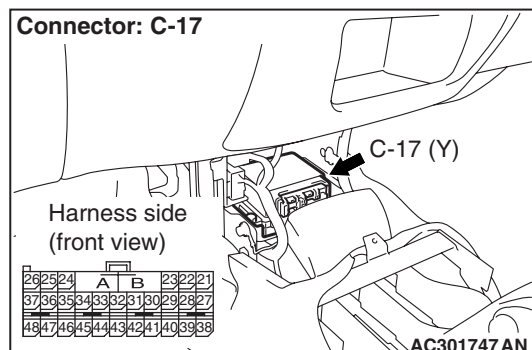
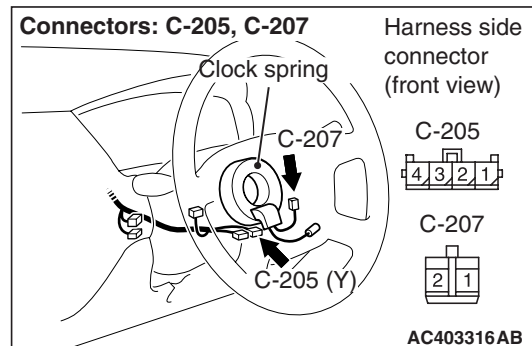
### STEP 3. Connector lock check: SRS-ECU connector C-17, clock spring connector C-205 and driver's air bag module connector C-207 (M.U.T.-II/III diagnosis code)

- (2) Disconnect connectors C-17, C-205 and C-207, and then reconnect them.

**NO :** The procedure is complete. It is assumed that diagnosis code 21 set as connector C-17, C-205 or C-207 was engaged improperly.

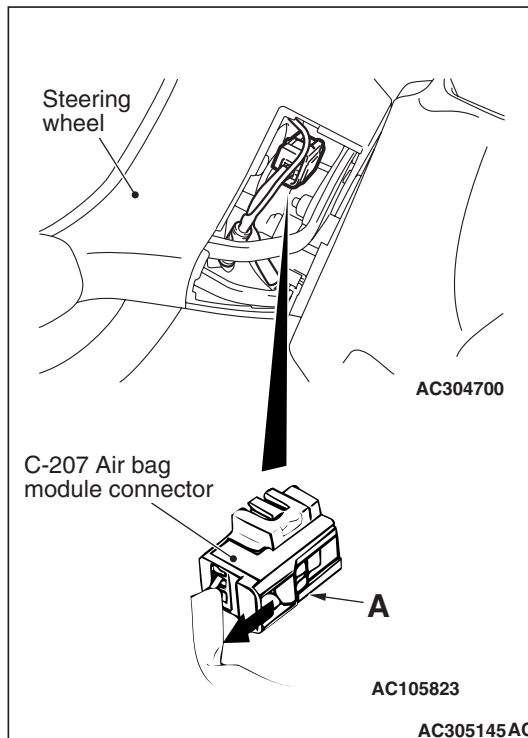
- (2) By sliding the A section (in the figure) of air bag module connector C-207 in the arrow direction, disconnect the connector.

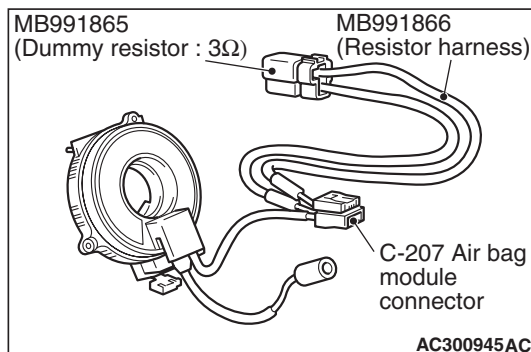
- (3) Connect special tool dummy resistor (MB991865) to special tool resistor harness (MB991866).

**NO :** Replace the driver's air bag module (Refer to P.52B-157).

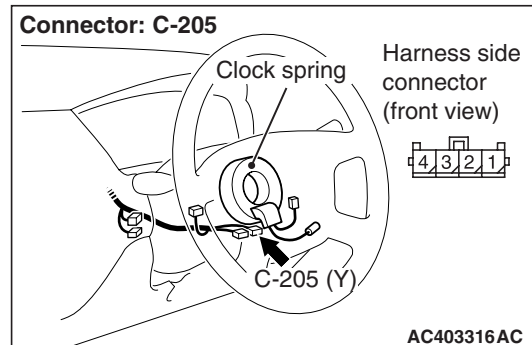
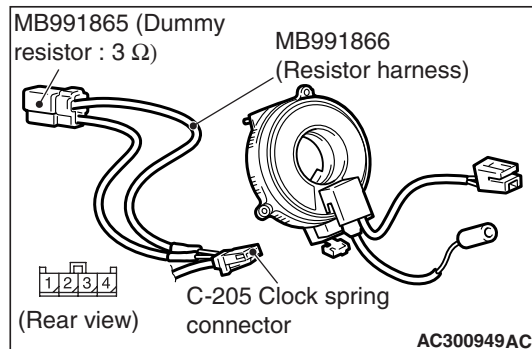
- (2) Disconnect the clock spring connector C-205.
- (3) Connect special tool dummy resistor (MB991865) to special tool resistor harness (MB991866).

**NO :** Replace the clock spring (Refer to [P.52B-157](#)).

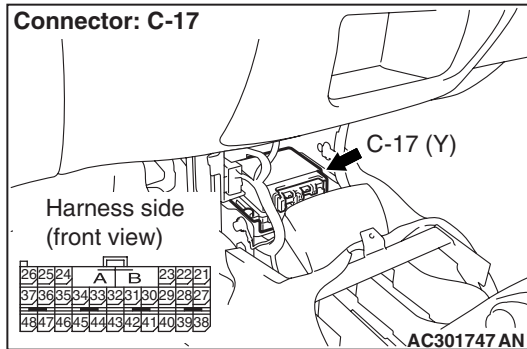
**STEP 6. Resistance measurement at the SRS-ECU connector C-17.**

(1) Disconnect SRS-ECU connector C-17.

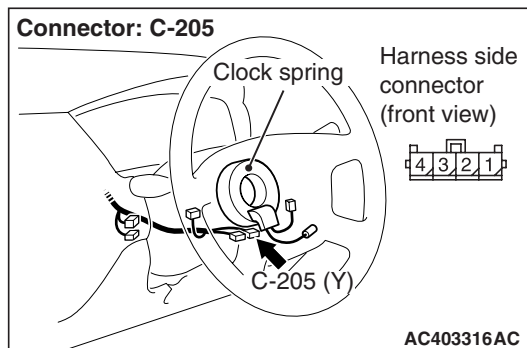
**To prevents the air bag from deploying unintentionally, disconnect the clock spring connector C-205 to short the squib circuit.**

(2) Disconnect the clock spring connector C-205.

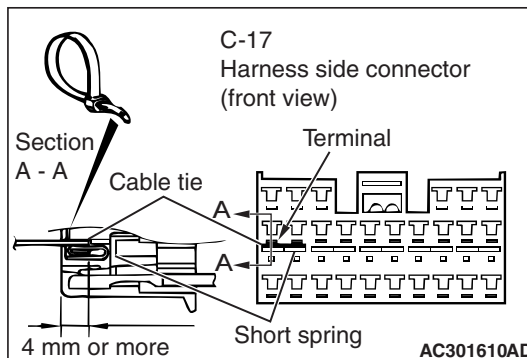
**Insert an insulator such as a cable tie to a depth of 4 mm or more, otherwise the short spring will not be released.**

(3) Insert a cable tie [3 mm wide, 0.5 mm thick] between terminals 36, 37 and the short spring to release the short spring.

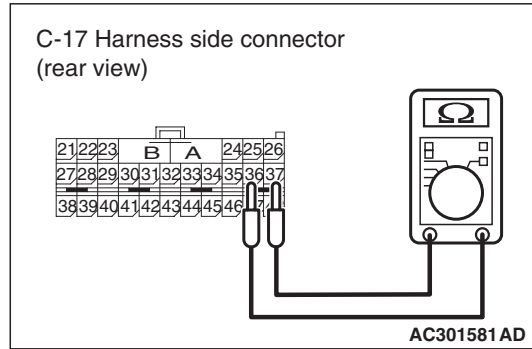
**Do not insert a test probe into the terminal from its front side directly as the connector contact pressure may be weakened.**

(4) Resistance measurement between C-17 harness side connector terminals 36 and 37.

**NO :** Repair the harness wires between SRS-ECU connector C-17 (terminal No.36 and 37) and clock spring connector C-205 (terminal No.3 and 4).

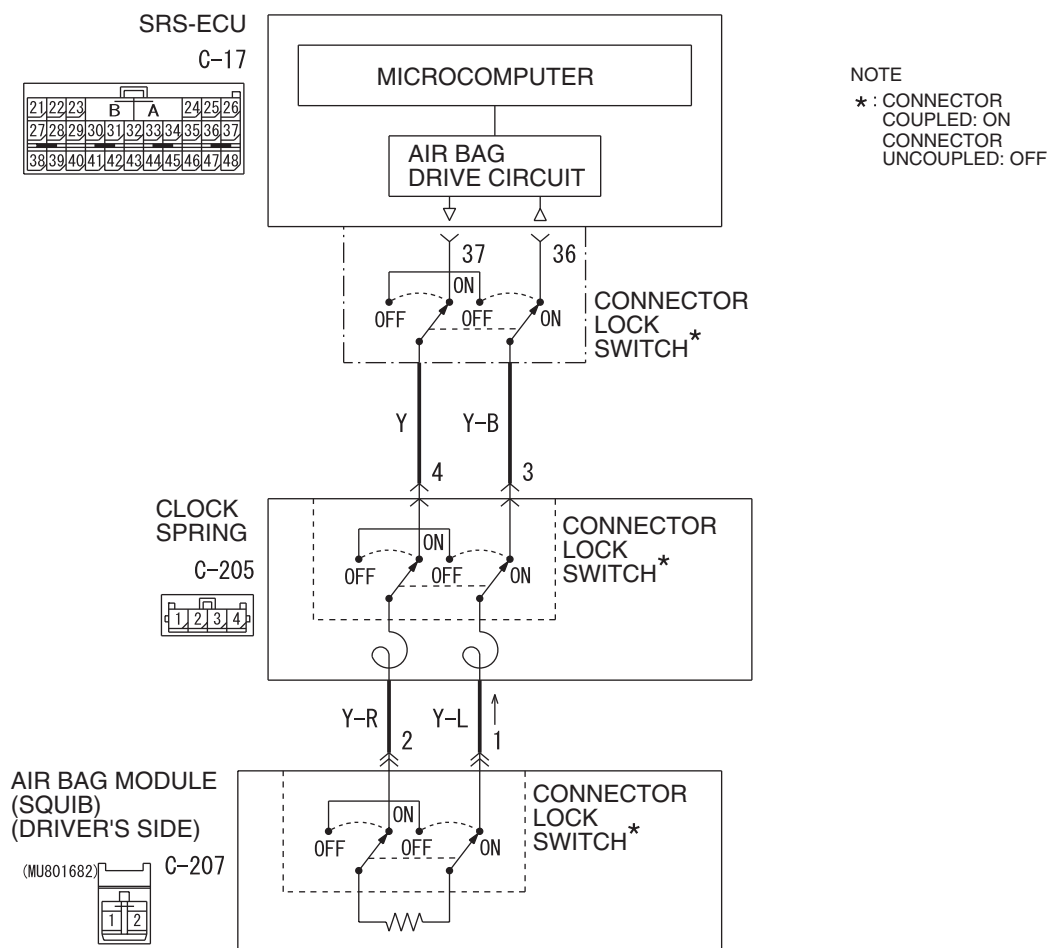
**Code No.22: Driver's air bag module (squib) system (open-circuited in the squib circuit)****Driver's Air Bag Module (Squib) Circuit**

- Open circuit in the clock spring
- Open circuit due to improper neutral position of the clock spring
- Open circuit in the driver's air bag module (squib) circuit
- Disengaged driver's air bag module (squib) connector
- Improper connector contact
- Malfunction of the SRS-ECU

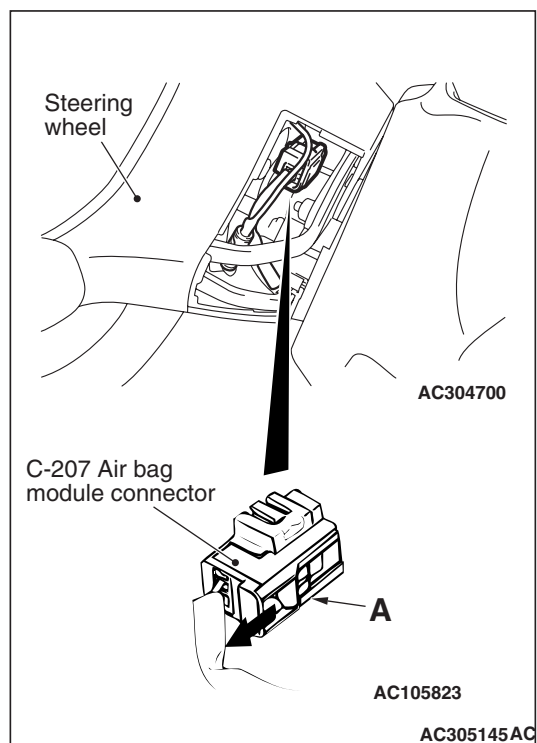
- (2) By sliding the A section (in the figure) of air bag module connector C-207 in the arrow direction, disconnect the connector.

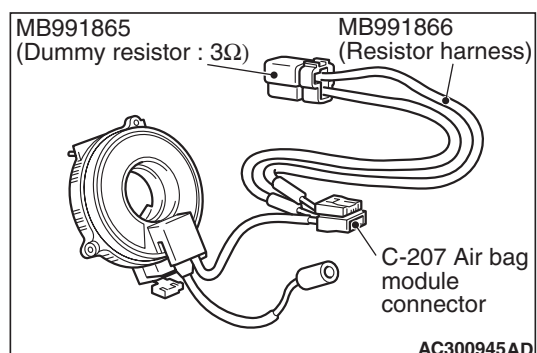
- (3) Connect special tool dummy resistor (MB991865) to special tool resistor harness (MB991866).

**NO :** Replace the driver's air bag module (Refer to [P.52B-157](#)).

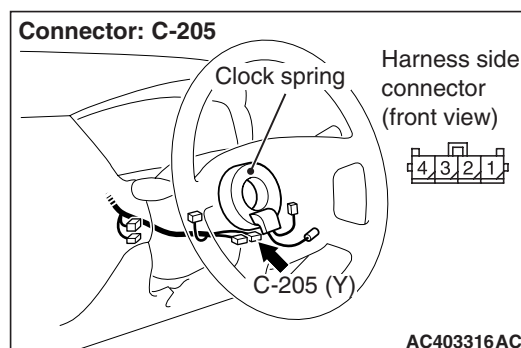
- (2) Disconnect the clock spring connector C-205.

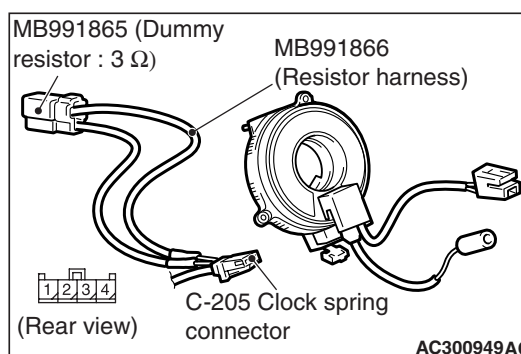
- (3) Connect special tool dummy resistor (MB991865) to special tool resistor harness (MB991866).

**NO :** Replace the clock spring (Refer to [P.52B-157](#)).

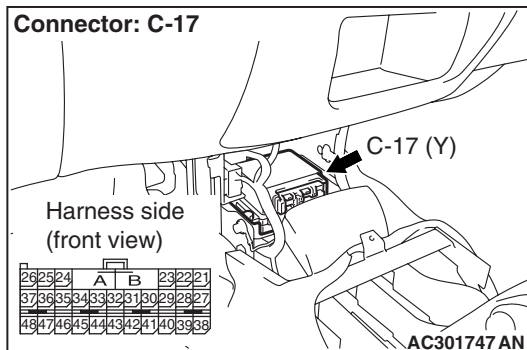
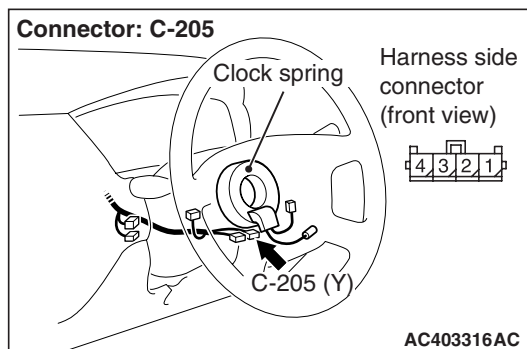
**STEP 3. Resistance measurement between the SRS-ECU connector C-17 (terminal No.36 and 37) and the clock spring connector C-205 (terminal No.3 and 4)**

- (1) Disconnect SRS-ECU connector C-17 and clock spring connector C-205.

**NO :** Repair the harness wires between SRS-ECU connector C-17 (terminal No.36 and 37) and clock spring connector C-205 (terminal No.3 and 4).

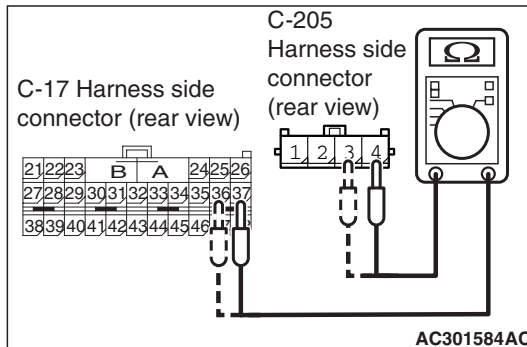
**Do not insert a test probe into the terminal from its front side directly as the connector contact pressure may be weakened.**

- (2) Resistance measurement between the following terminals.

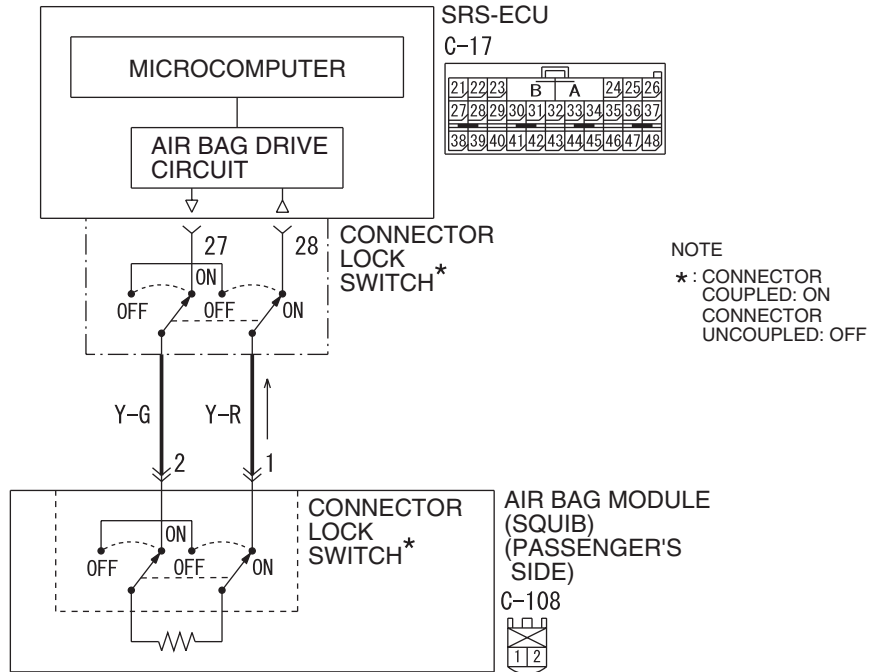
**Passenger's (Front) Air Bag Module (Squib) Circuit**

- Improper engaged connector or defective short spring\*
- Short circuit between the passenger's (front) air bag module (squib) circuit terminals
- Damaged connector(s)
- Malfunction of the SRS-ECU

**NOTE:** \*: The squib circuit connectors integrate a "short" spring (which prevents the air bag from deploying unintentionally due to static electricity by shorting the positive wire to the earth wire in the squib circuit when the connectors are disconnected). Therefore, if connector C-17 or C-108 is damaged or improperly engaged, the short spring may not be released when the connector is connected.

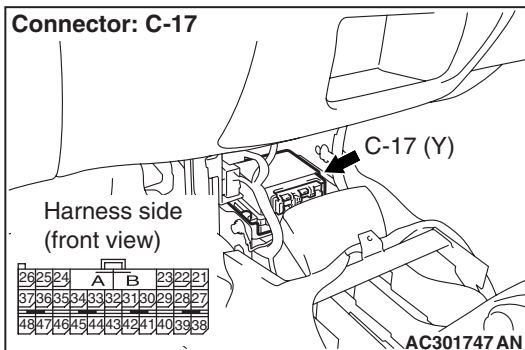
## STEP 2. Connector lock check: SRS-ECU connector C-17 (M.U.T.-II/III diagnosis code)

- (2) Disconnect the connectors C-17 and then reconnect them.
- (3) Connect the negative battery terminal.
- (4) Erase the diagnosis code memory, and check the diagnosis code.

**NO :** The procedure is complete. It is assumed that diagnosis code 24 set as connector C-17 was engaged improperly.

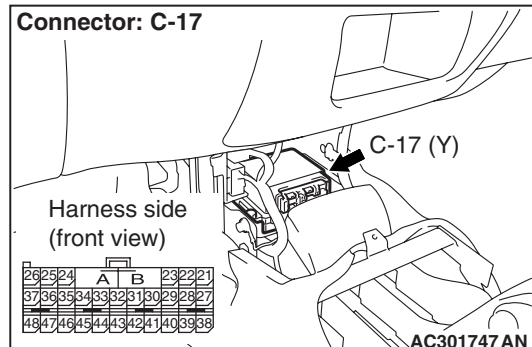
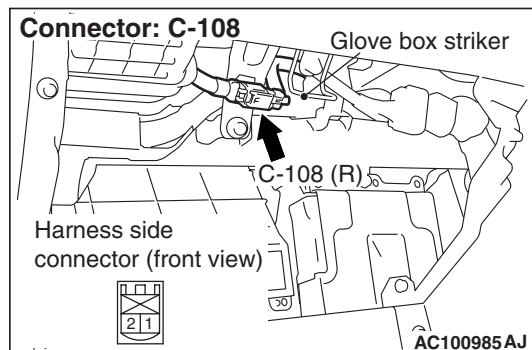
## STEP 3. Connector lock check: SRS-ECU connector C-17 and passenger's (front) air bag module connector C-108. (M.U.T.-II/III diagnosis code)

- (2) Disconnect connectors C-17 and C-108, and then reconnect them.
- (3) Connect the negative battery terminal.
- (4) Erase the diagnosis code memory, and check the diagnosis code.

**NO :** The procedure is complete. It is assumed that diagnosis code 24 set as connector C-17 or C-108 was engaged improperly.

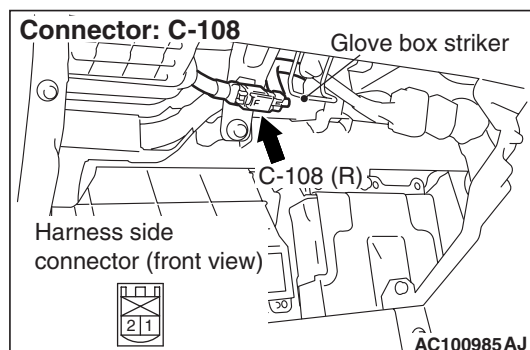
(2) Disconnect passenger's (front) air bag module connector C-108.

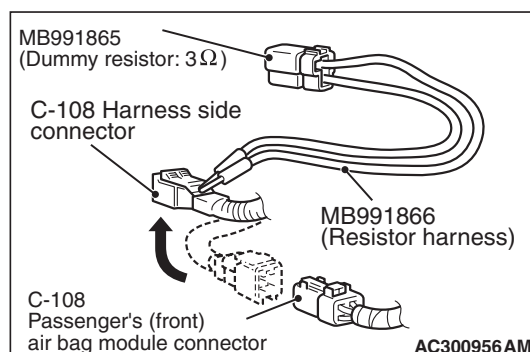
(3) Connect special tool dummy resistor (MB991865) to special tool resistor harness (MB991866).

**NO :** Replace the passenger's (front) air bag module (Refer to [P.52B-157](#)).

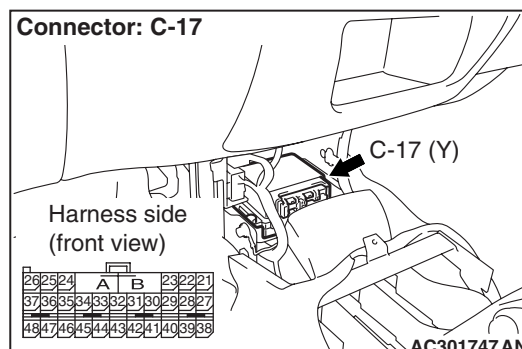
**STEP 5. Resistance measurement at SRS-ECU connector C-17.**

(1) Disconnect SRS-ECU connector C-17.

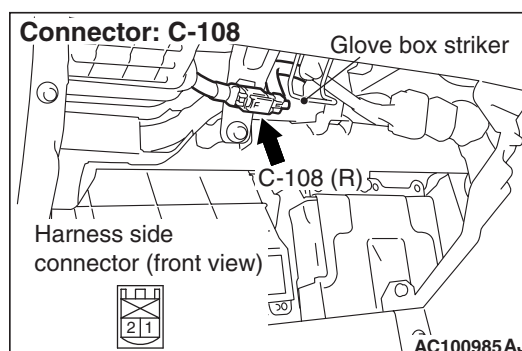
**To prevent the air bag from deploying unintentionally, disconnect the passenger's (front) air bag module connector C-108 to short the squib circuit.**

(2) Disconnect the passenger's (front) air bag module connector C-108.

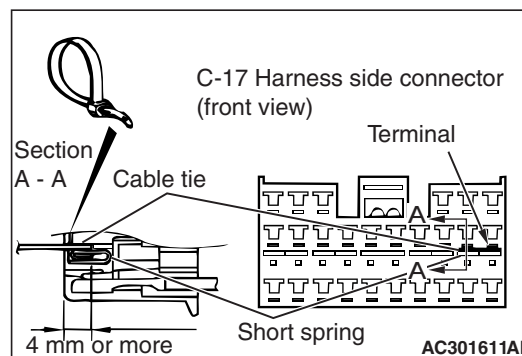
**Insert an insulator such as a cable tie to a depth of 4 mm or more, otherwise the short spring will not be released.**

(3) Insert a cable tie [3 mm wide, 0.5 mm thick] between terminals 27, 28 and the short spring to release the short spring.

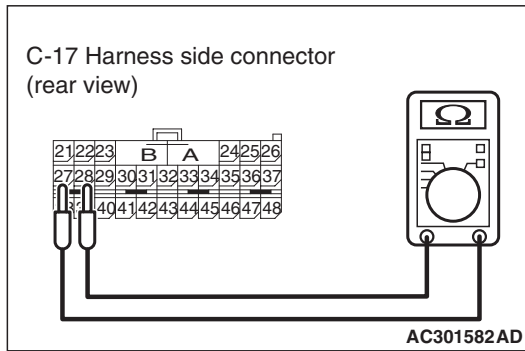
**Do not insert a test probe into the terminal from its front side directly as the connector contact pressure may be weakened.**

(4) Resistance measurement between C-17 harness side connector terminals 27 and 28.

**NO :** Repair the harness wires between SRS-ECU connector C-17 (terminal No.27 and 28) and passenger's (front) air bag module connector C-108 (terminal No.2 and 1).

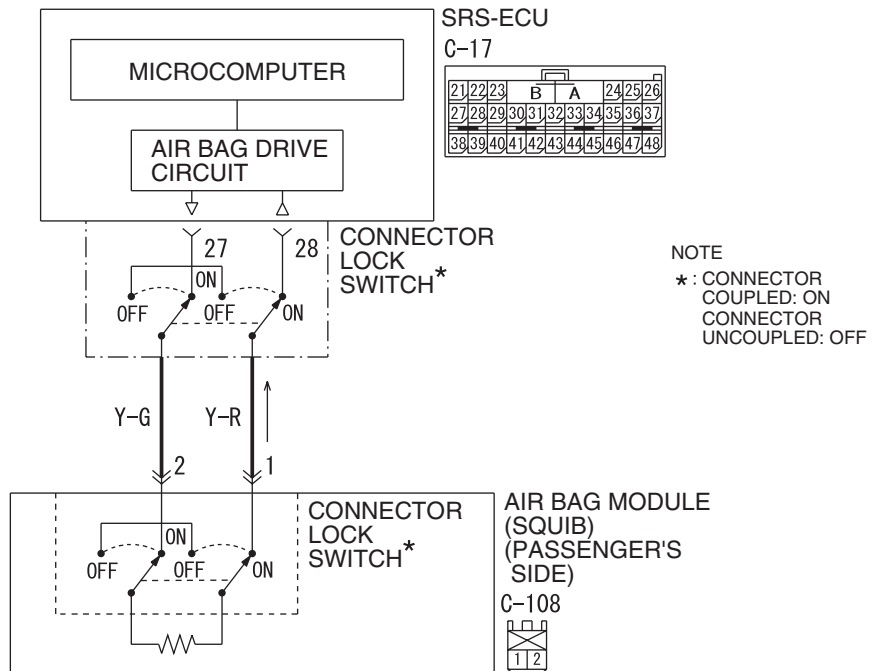
#### Passenger's (Front) Air Bag Module (Squib) Circuit

- Open circuit in the passenger's (front) air bag module (squib) circuit
- Improper connector contact
- Malfunction of the SRS-ECU

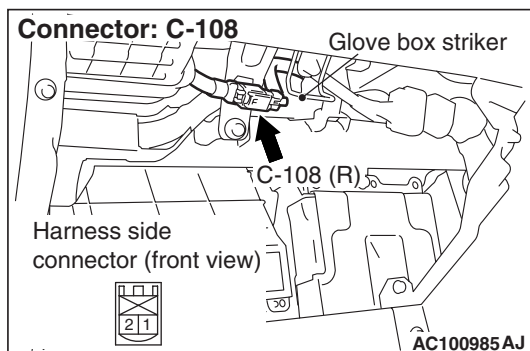
- (2) Disconnect passenger's (front) air bag module connector C-108.

**NO** : Replace the passenger's (front) air bag module (Refer to [P.52B-157](#)).

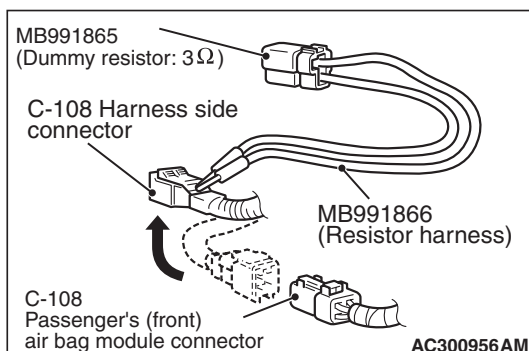
- (3) Connect special tool dummy resistor (MB991865) to special tool resistor harness (MB991866).

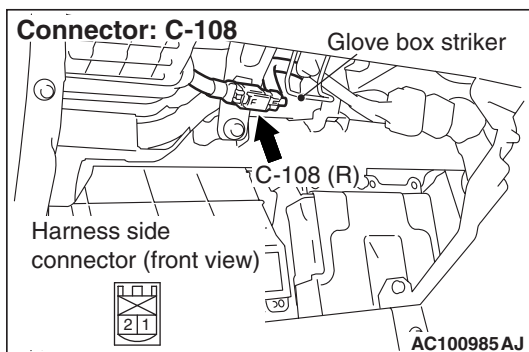
### STEP 2. Resistance measurement between SRS-ECU connector C-17 (terminal No.27 and 28) and the passenger's (front) air bag module connector C-108 (terminal No.1 and 2).

- (1) Disconnect passenger's (front) air bag module connector C-108.

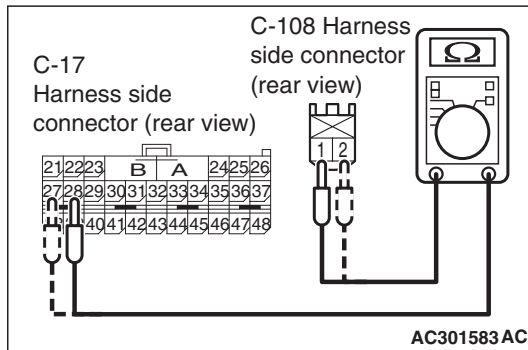
(2) Disconnect SRS-ECU connector C-17.

**Do not insert a test probe into the terminal from its front side directly as the connector contact pressure may be weakened.**

(3) Resistance measurement between the following terminals.

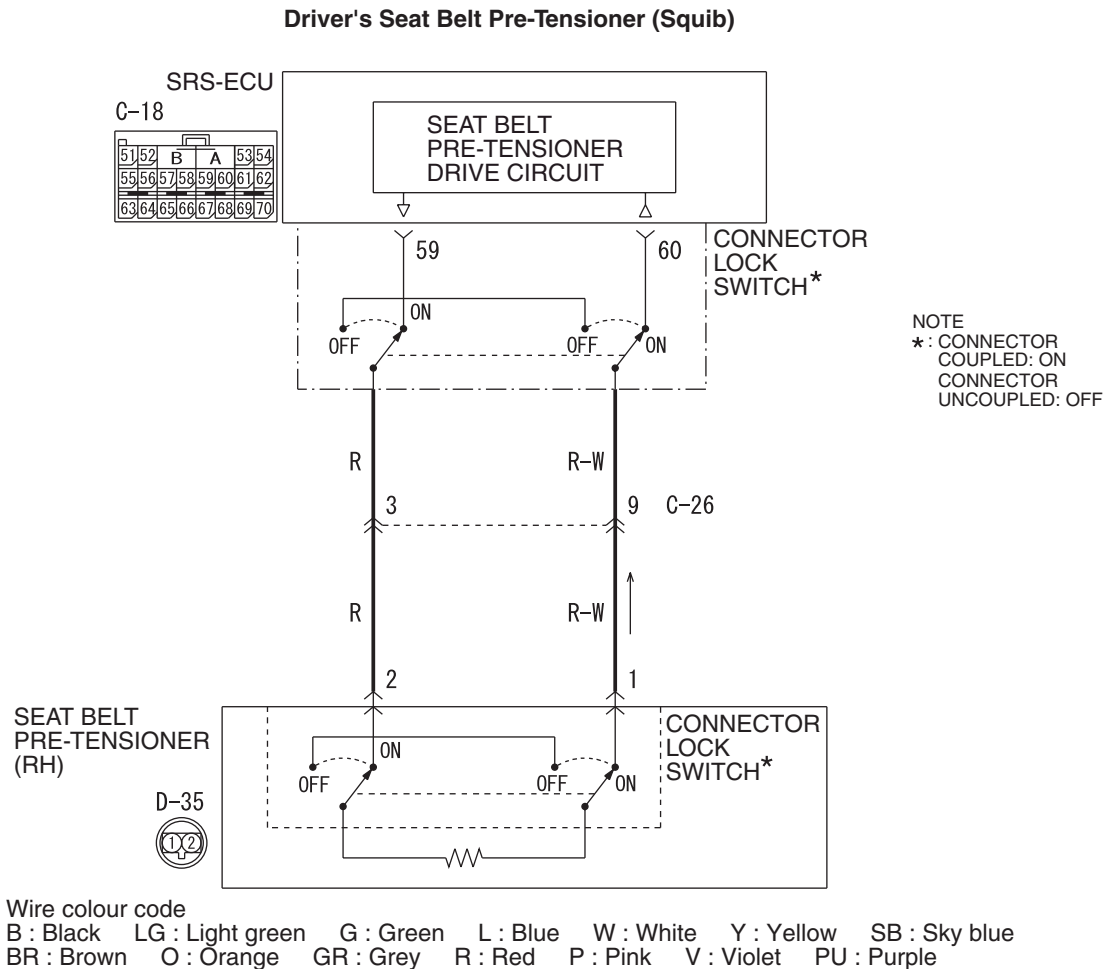
W5J52L001A

**Code No.26: Driver's seat belt pre-tensioner (squib) system (short-circuited between terminals of the squib circuit)**

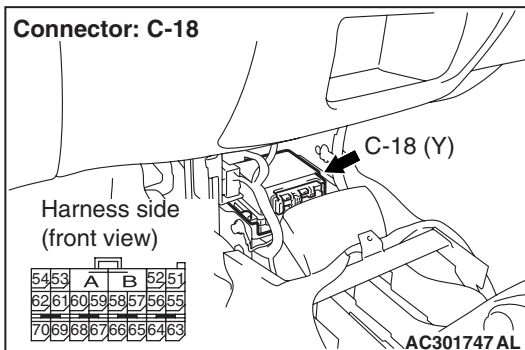
## STEP 2. Connector lock check: SRS-ECU connector C-18 (M.U.T.-II/III diagnosis code)

- (2) Disconnect the connectors C-18 and then reconnect them.
- (3) Connect the negative battery terminal.
- (4) Erase the diagnosis code memory, and check the diagnosis code.

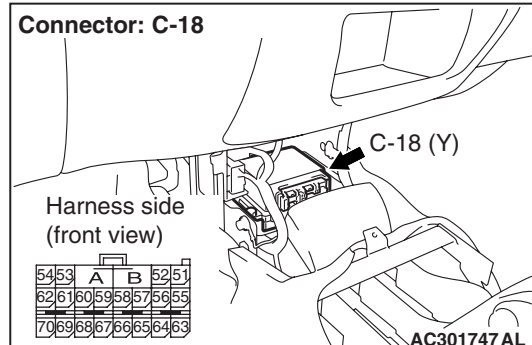
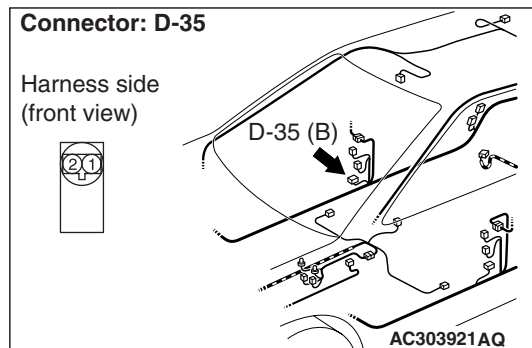
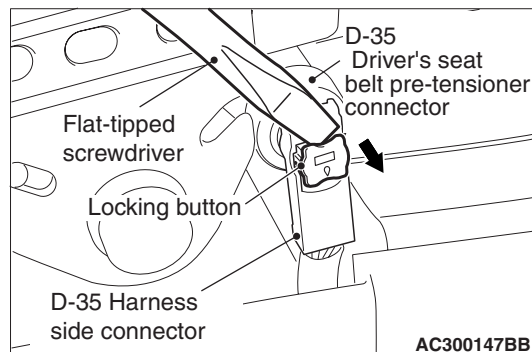
## STEP 3. Connector lock check: SRS-ECU connector C-18 and driver's seat belt pre-tensioner connector D-35 (M.U.T.-II/III diagnosis code)

- (2) Disconnect connectors C-18 or D-35, and then reconnect them. For connector D-35, use a flat-tipped screwdriver to pull out the locking button at the harness side connector, and then disconnect the connector.
- (3) Connect the negative battery terminal.
- (4) Erase the diagnosis code memory, and check the diagnosis code.

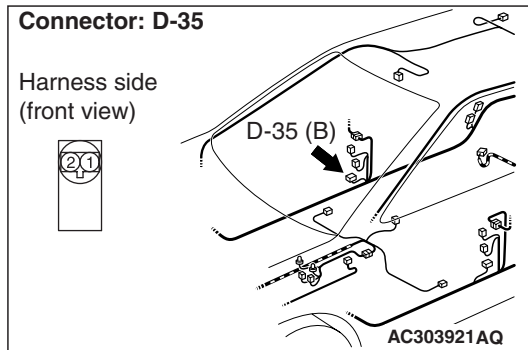
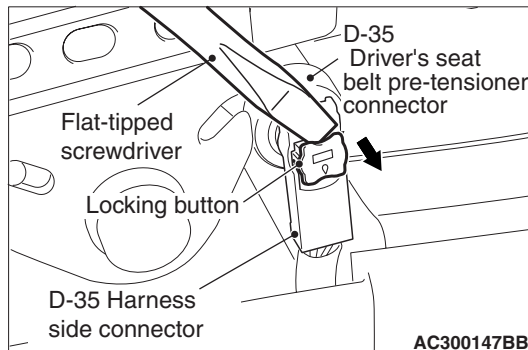
- (2) Disconnect driver's seat belt pre-tensioner connector D-35. Use a flat-tipped screwdriver to pull out the locking button at the harness side connector, and then disconnect the connector.

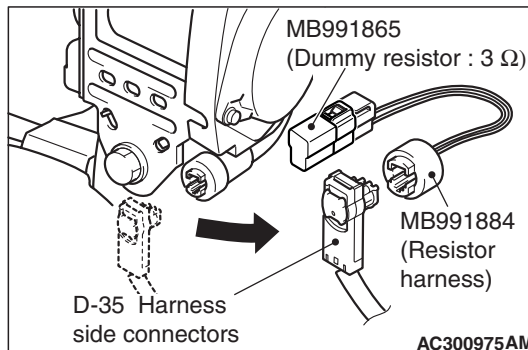
- (3) Connect special tool dummy resistor (MB991865) to special tool resistor harness (MB991884).  
 (4) Connect special tool (MB991884) to the D-35 harness side connector.  
 (5) Connect the negative battery terminal.  
 (6) Erase diagnosis code memory, and then check the diagnosis code.

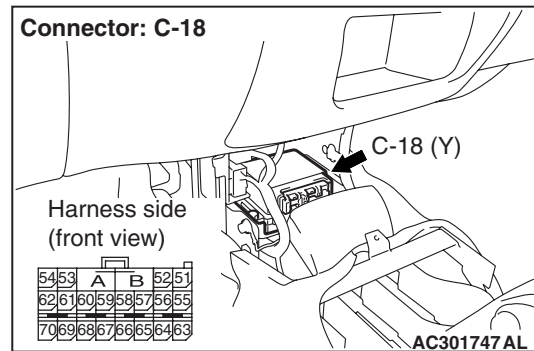
**STEP 5. Resistance measurement at the SRS-ECU connector C-18.**

- (1) Disconnect SRS-ECU connector C-18.

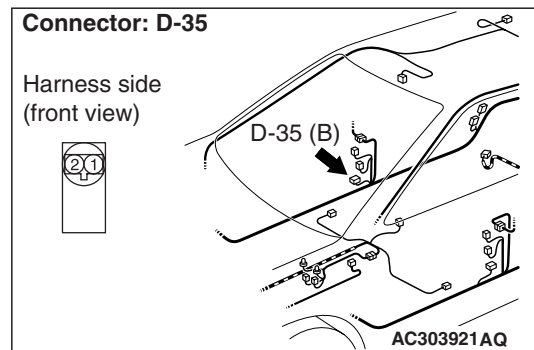
**To prevent the air bag from deploying unintentionally, disconnect the driver's seat belt pre-tensioner connector D-35 to short the squib circuit.**

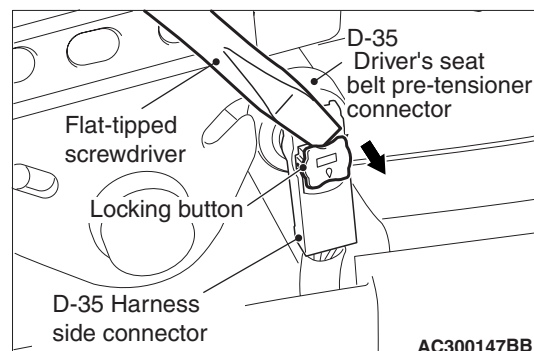
- (2) Disconnect driver's seat belt pre-tensioner connector D-35. Use a flat-tipped screwdriver to pull out the locking button at the harness side connector, and then disconnect the connector.

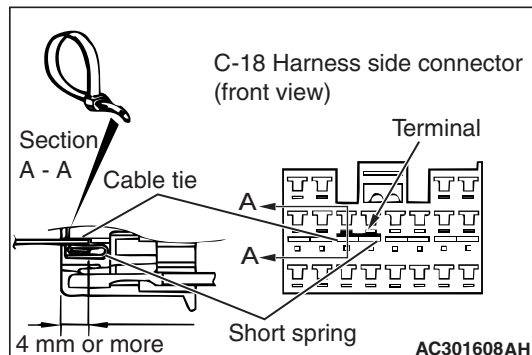
**Insert an insulator such as a cable tie to a depth of 4mm or more, otherwise the short spring will not be released.**

- (3) Insert a cable tie [3 mm wide, 0.5 mm thick] between terminals 59, 60 and the short spring to release the short spring.

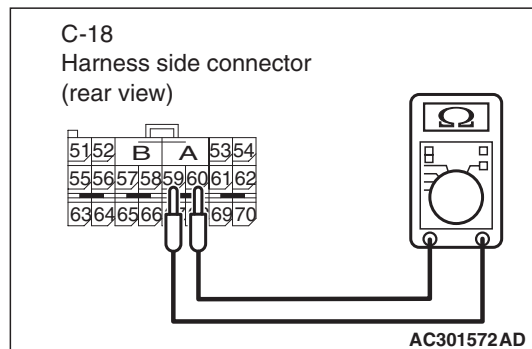
**Do not insert a test probe into the terminal from its front side directly as the connector contact pressure may be weakened.**

- (4) Resistance measurement between C-18 harness side connector terminals 59 and 60.

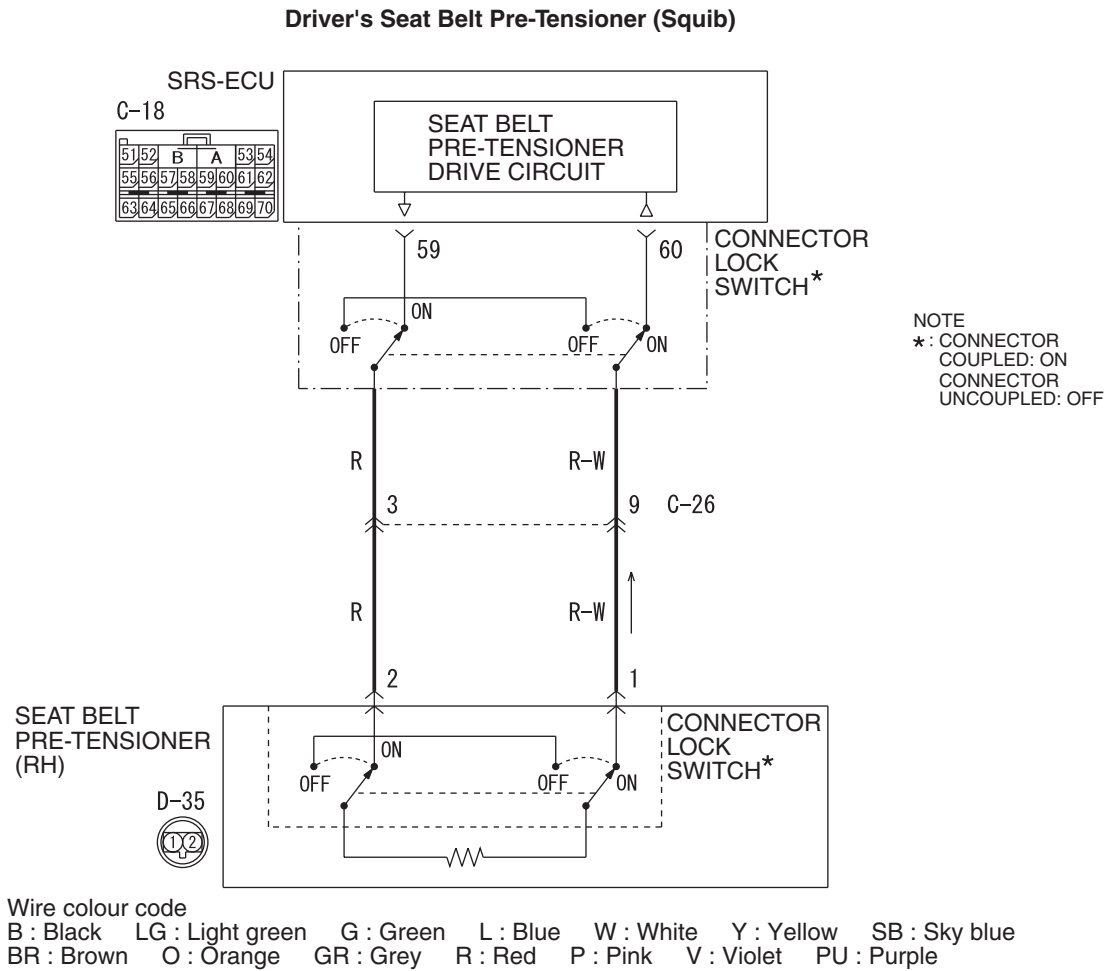
W5J52L001A

**Code No.27: Driver's seat belt pre-tensioner (squib) system (open-circuited in the squib circuit)**

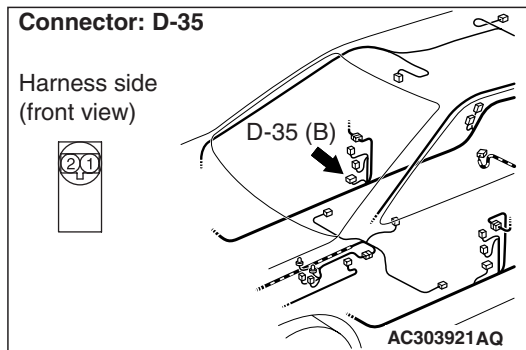
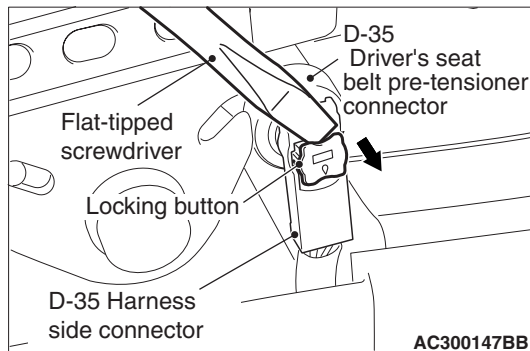
(2) Disconnect driver's seat belt pre-tensioner connector D-35. Use a flat-tipped screwdriver to pull out the locking button at the harness side connector, and then disconnect the connector.

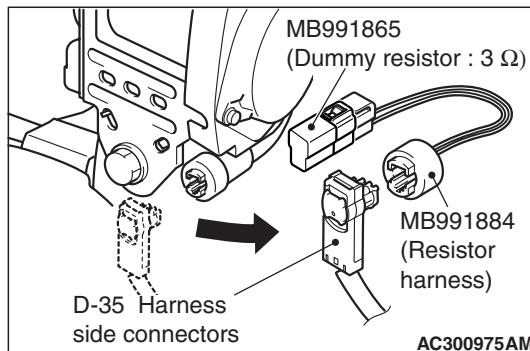
(3) Connect special tool dummy resistor (MB991865) to special tool resistor harness (MB991884).  
(4) Connect special tool (MB991884) to the D-35 harness side connector.

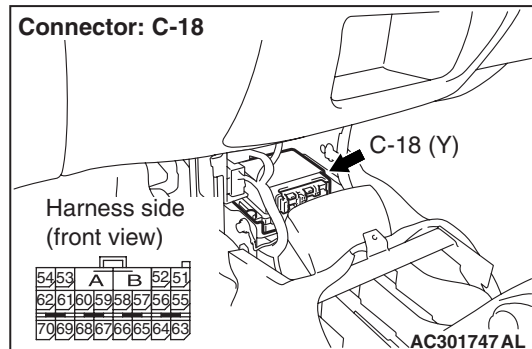
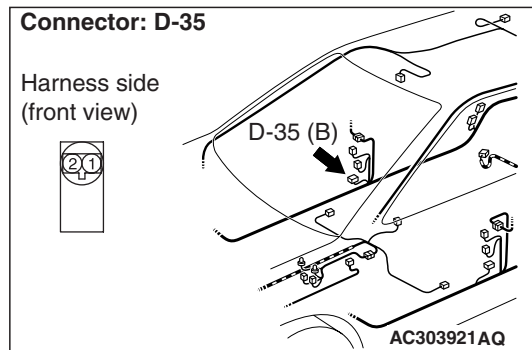
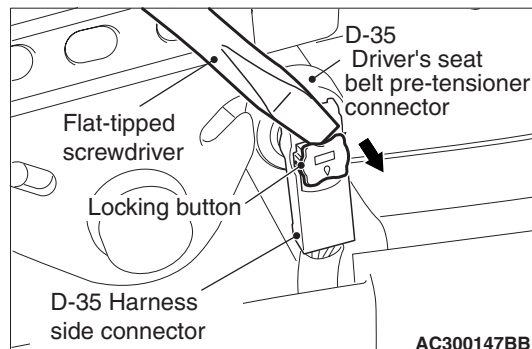
**STEP 2. Resistance measurement between SRS-ECU connector C-18 (terminal No.59 and 60) and the driver's seat belt pre-tensioner D-35 (terminal No.1 and 2).**

(1) Disconnect SRS-ECU connector C-18 and driver's seat belt pre-tensioner connector D-35, and measure at the wiring harness side. For connector D-35, use a flat-tipped screwdriver to pull out the locking button at the harness side connector, and then disconnect the connector.

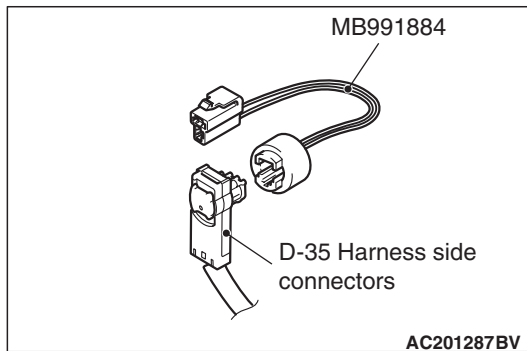
- (2) Connect D-35 harness side connector to special tool resistor harness (MB991884).

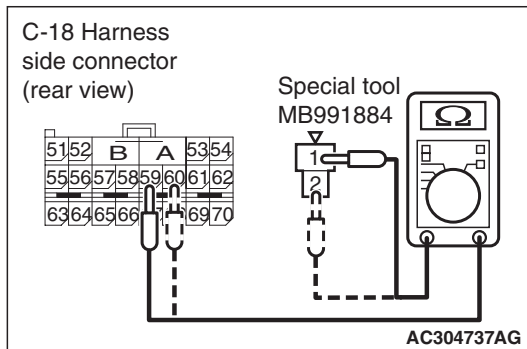
**Do not insert a test probe into the terminal from its front side directly as the connector contact pressure may be weakened.**

- (3) Resistance measurement between the following terminals.
- SRS-ECU connector C-18 terminal No.59 and special tool terminal No.1
  - SRS-ECU connector C-18 terminal No.60 and special tool terminal No.2

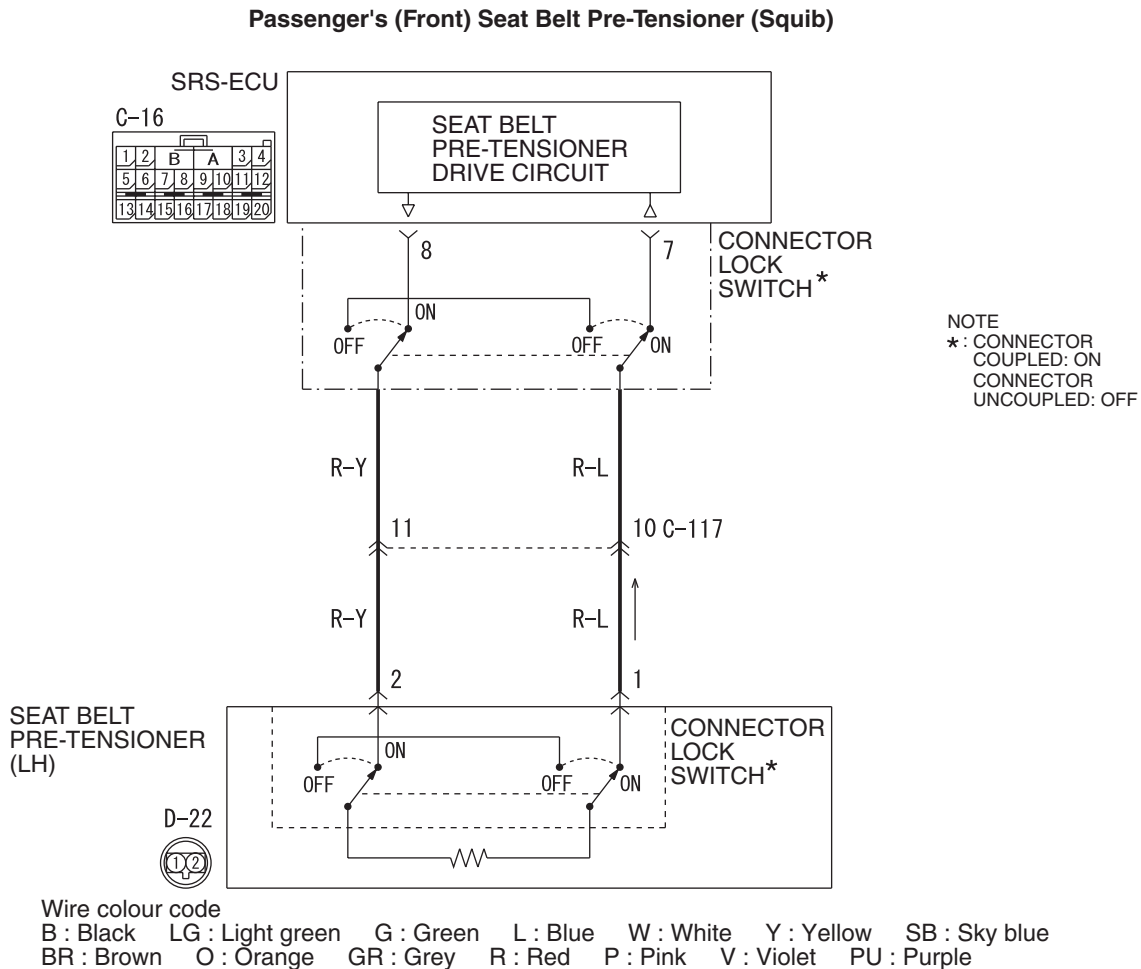
W5J52L000A

**Code No.28: Passenger's (front) seat belt pre-tensioner (squib) system (short-circuit between terminals of the squib circuit)**

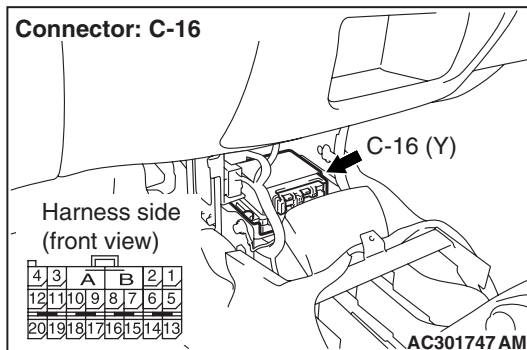
### STEP 2. Connector lock check: SRS-ECU connector C-16 (M.U.T.-II/III diagnosis code)

- (2) Disconnect the connectors C-16 and then reconnect them.
- (3) Connect the negative battery terminal.
- (4) Erase the diagnosis code memory, and check the diagnosis code.

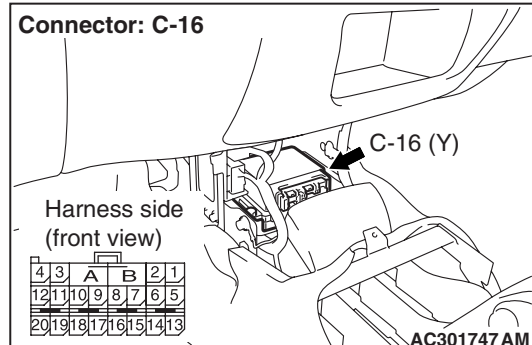
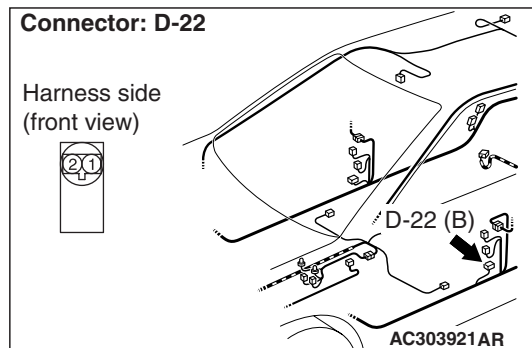
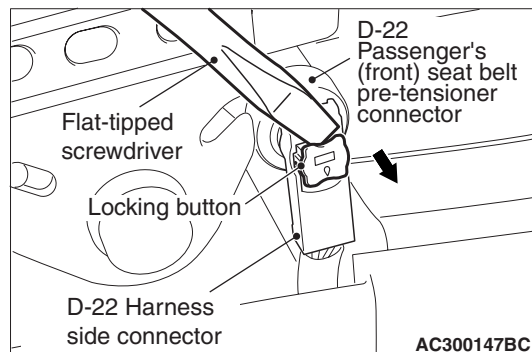
### STEP 3. Connector lock check: SRS-ECU connector C-16 and passenger's (front) seat belt pre-tensioner connector D-22 (M.U.T.-II/III diagnosis code)

- (2) Disconnect connectors C-16 and D-22, and then reconnect them. For connector D-22, use a flat-tipped screwdriver to pull out the locking button at the harness side connector, and then disconnect the connector.
- (3) Connect the negative battery terminal.
- (4) Erase the diagnosis code memory, and check the diagnosis code.

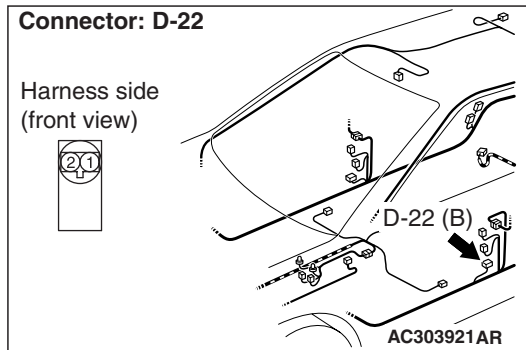
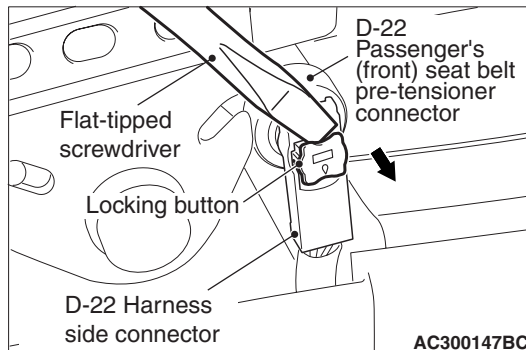
- (2) Disconnect passenger's (front) seat belt pre-tensioner connector D-22. Use a flat-tipped screwdriver to pull out the locking button at the harness side connector, and then disconnect the connector.
