## GROUP 52B

# SUPPLEMENTAL RESTRAINT SYSTEM (SRS)

## GENERAL INFORMATION

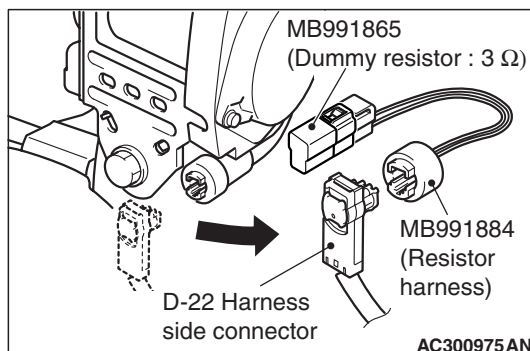
- (3) Connect special tool dummy resistor (MB991865) to special tool resistor harness (MB991884).  
 (4) Connect special tool (MB991884) to the D-22 harness side connector.  
 (5) Connect the negative battery terminal.  
 (6) Erase diagnosis code memory, and then check the diagnosis code.

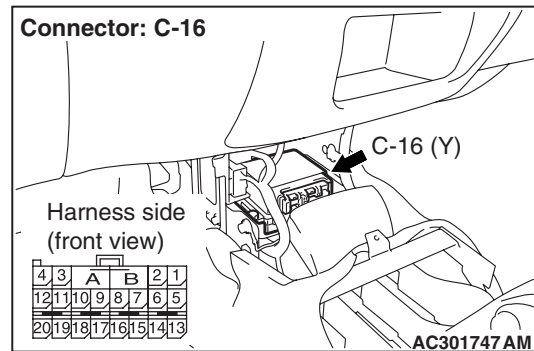
**STEP 5. Resistance measurement at the SRS-ECU connector C-16.**

- (1) Disconnect SRS-ECU connector C-16.

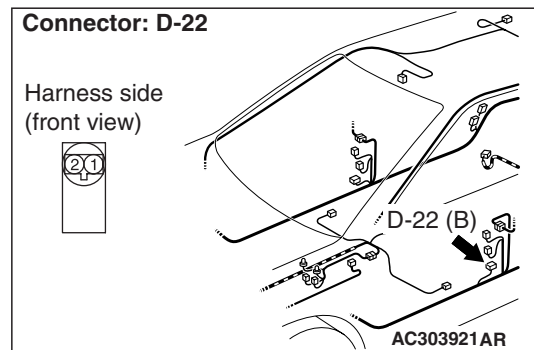
**To prevent the air bag from deploying unintentionally, disconnect the passenger's (front) seat belt pre-tensioner connector D-22 to short the squib circuit.**

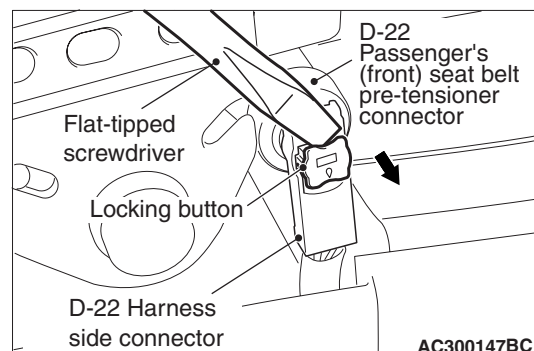
- (2) Disconnect passenger's (front) seat belt pre-tensioner connector D-22. Use a flat-tipped screwdriver to pull out the locking button at the harness side connector, and then disconnect the connector.

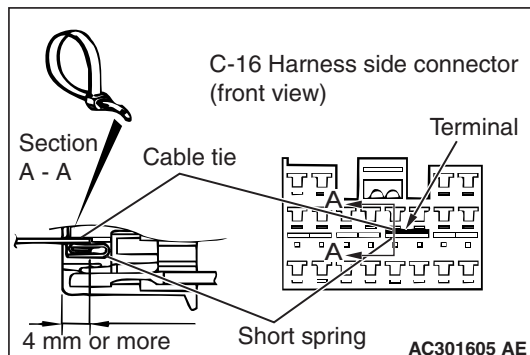
**Insert an insulator such as a cable tie to a depth of 4 mm or more, otherwise the short spring will not be released.**

- (3) Insert a cable tie [3 mm wide, 0.5 mm thick] between terminals 7, 8 and the short spring to release the short spring.

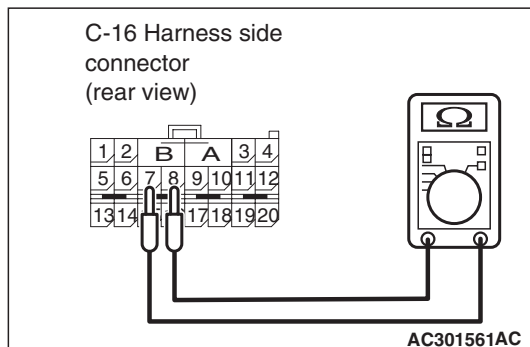
**Do not insert a test probe into the terminal from its front side directly as the connector contact pressure may be weakened.**

- (4) Resistance measurement between C-16 harness side connector terminals 7 and 8.

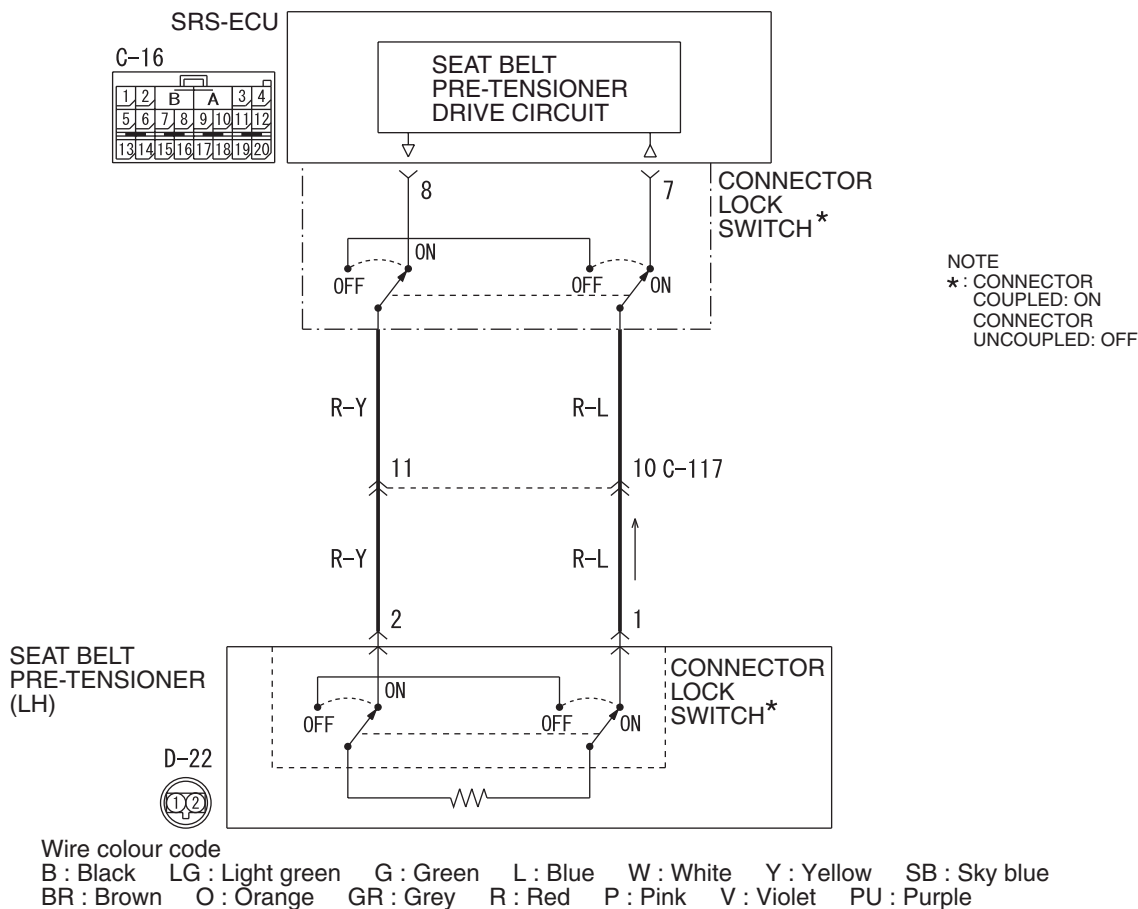
W5J52L000A

**Code No.29: Passenger's (front) seat belt pre-tensioner (squib) system (open-circuited in the squib circuit)**

### Passenger's (Front) Seat Belt Pre-Tensioner (Squib)

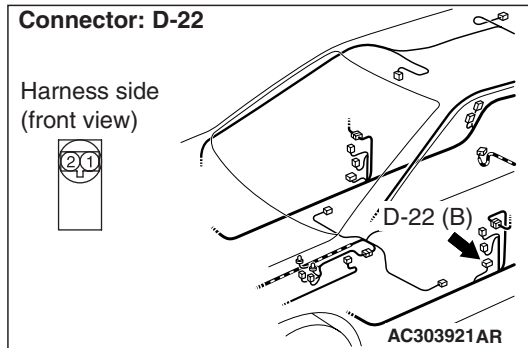
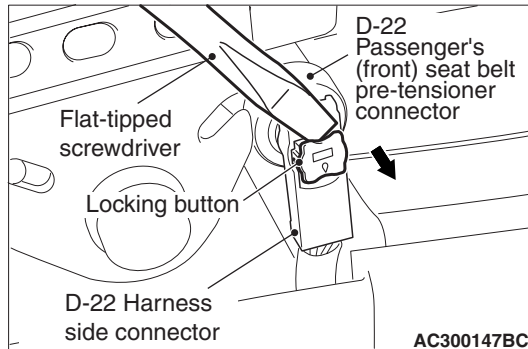
(2) Disconnect passenger's (front) seat belt pre-tensioner connector D-22. Use a flat-tipped screwdriver to pull out the locking button at the harness side connector, and then disconnect the connector.

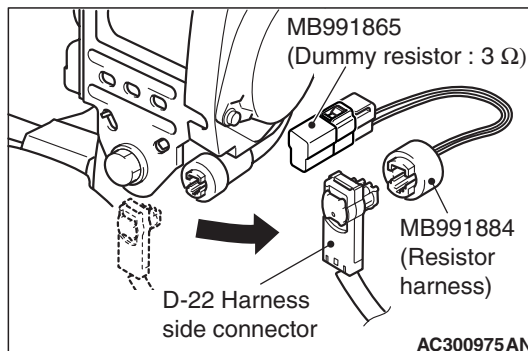
- (3) Connect special tool dummy resistor (MB991865) to special tool resistor harness (MB991884).
- (4) Connect special tool (MB991884) to the D-22 harness side connector.
- (5) Connect the negative battery terminal.
- (6) Erase diagnosis code memory, and then check the diagnosis code.

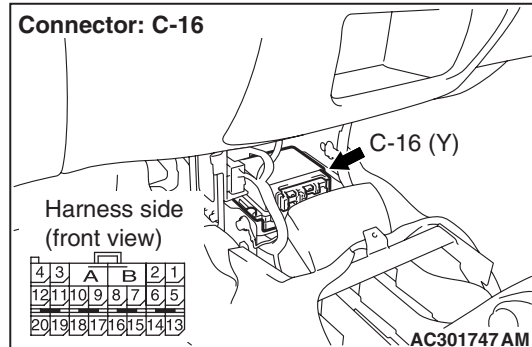
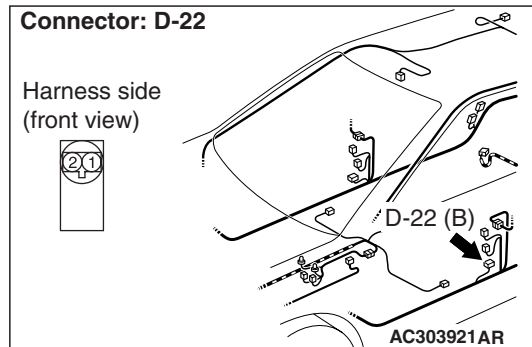
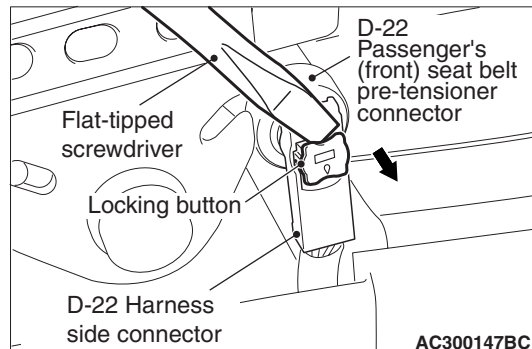
### STEP 2. Resistance measurement between SRS-ECU connector C-16 (terminal No.7 and 8) and the passenger's (front) seat belt pre-tensioner connector D-22 (terminal No.1 and 2).

- (1) Disconnect SRS-ECU connector C-16 and passenger's (front) seat belt pre-tensioner connector or D-22. For connector D-22, use a flat-tipped screwdriver to pull out the locking button at the harness side connector, and then disconnect the connector.

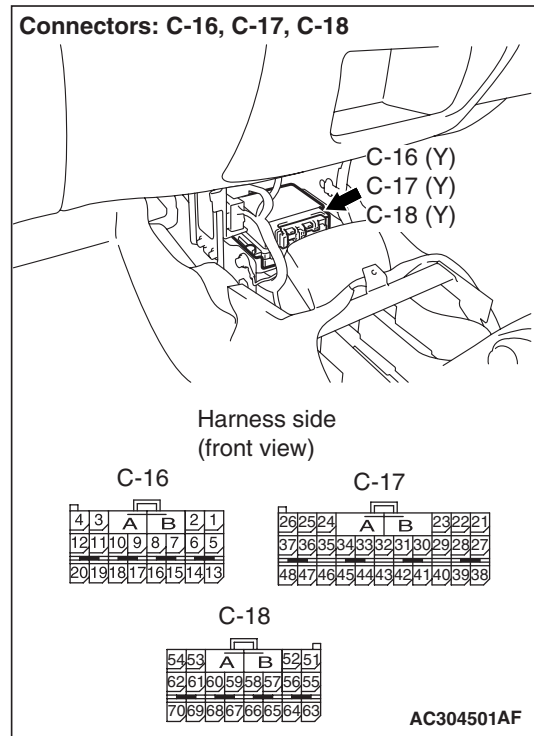
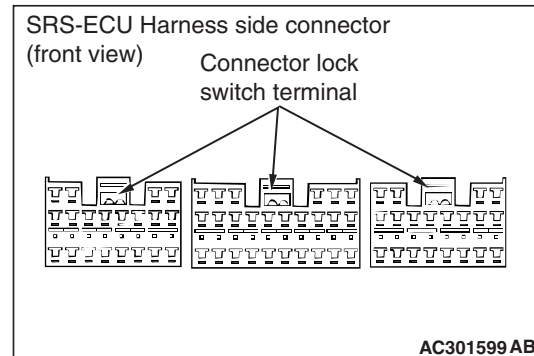
### STEP 2. Connector lock check: SRS-ECU connector C-16, C-17 and C-18

- (1) Disconnect SRS-ECU connectors C-16, C-17 and C-18.
- (2) Check the connector lock switch terminal inside the harness side connector for improper contact or deformation.

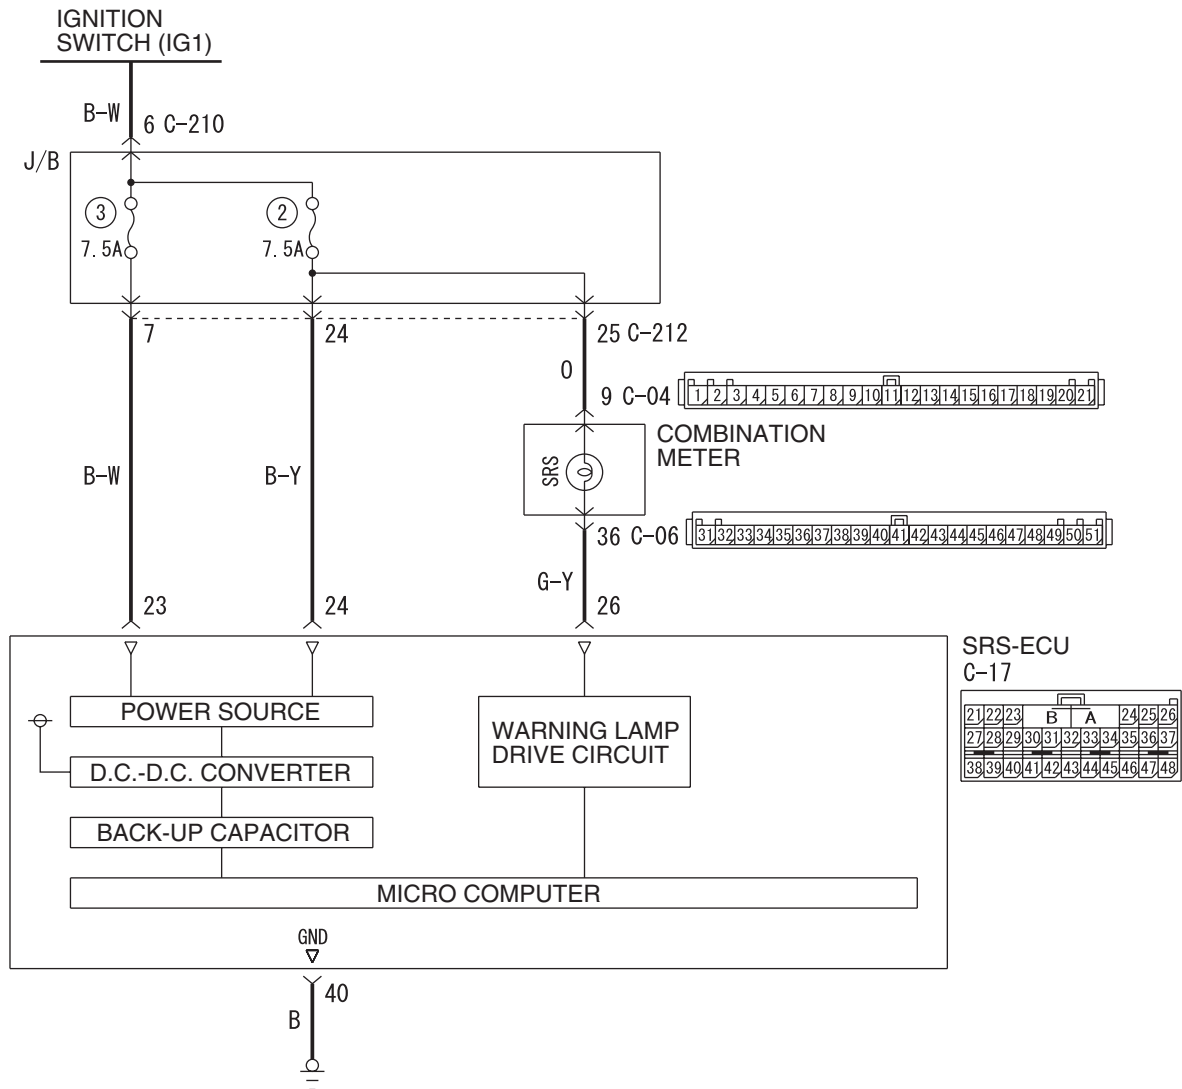
**IG1 Power Supply Circuit System**

This diagnosis code is set if the voltage between the IG1 terminals (fuse No.2 circuit) and earth is lower than a predetermined value for a continuous period of 5 second or more. However, if the system returns to normal condition, code number 41 will be erased automatically and the SRS warning lamp will go out.

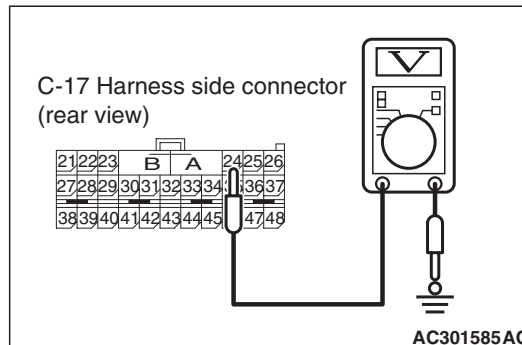
**Do not insert a test probe into the terminal from its front side directly as the connector contact pressure may be weakened.**

(5) Voltage measurement between C-17 harness side connector terminal 24 and body earth.

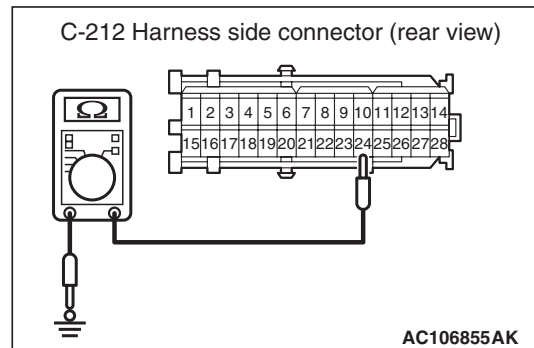
**Do not insert a test probe into the terminal from its front side directly as the connector contact pressure may be weakened.**

- (2) Resistance measurement between terminal 24 and body earth.

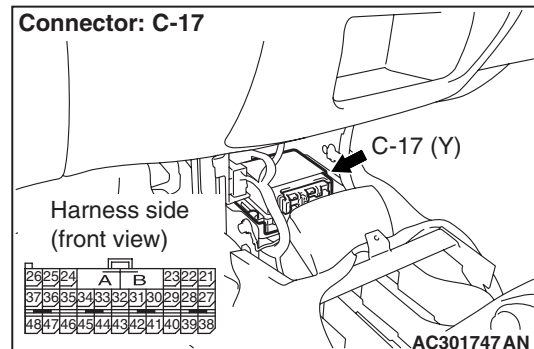
**STEP 7. Resistance measurement at the SRS-ECU connector C-17.**

- (1) Disconnect SRS-ECU connector or C-17, and measure at the wiring harness side.

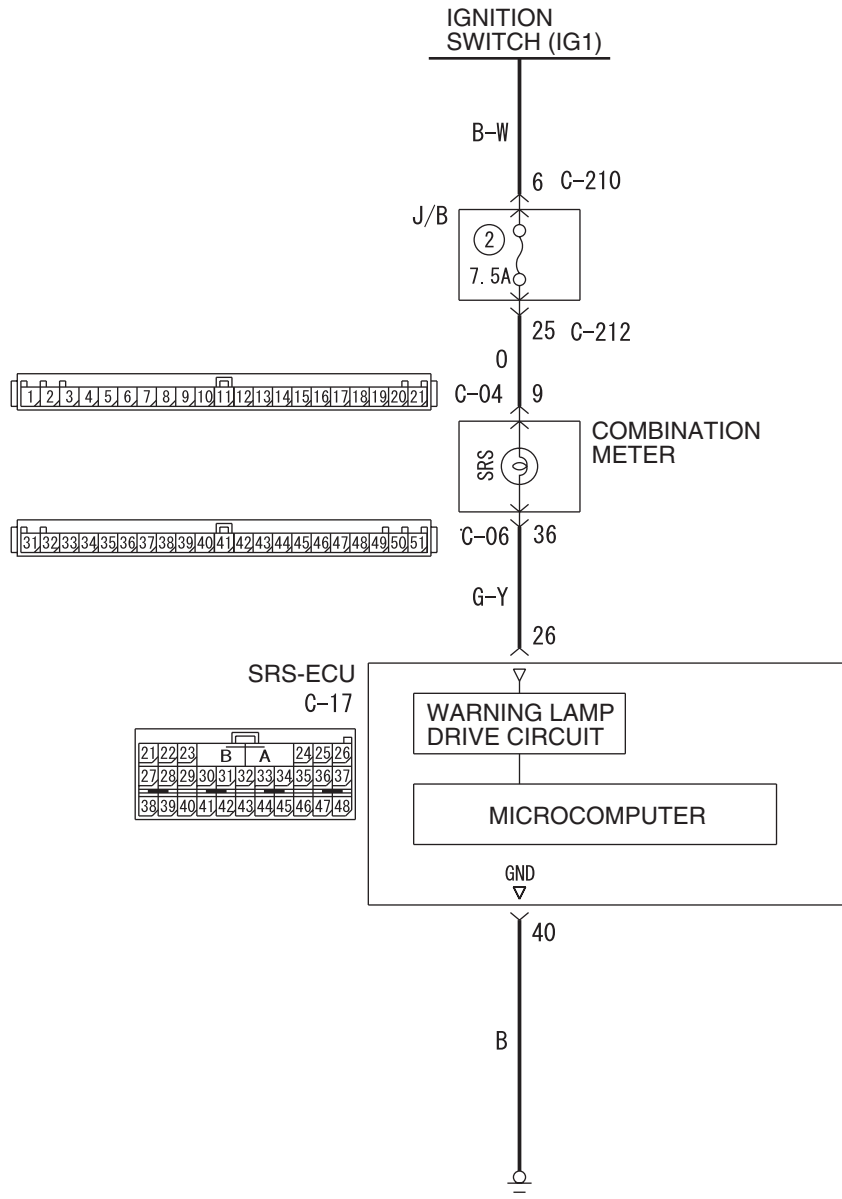
**SRS Warning Lamp Drive Circuit**

**Code No.43: SRS warning lamp circuit open-circuited (Lamp does not illuminate.)**

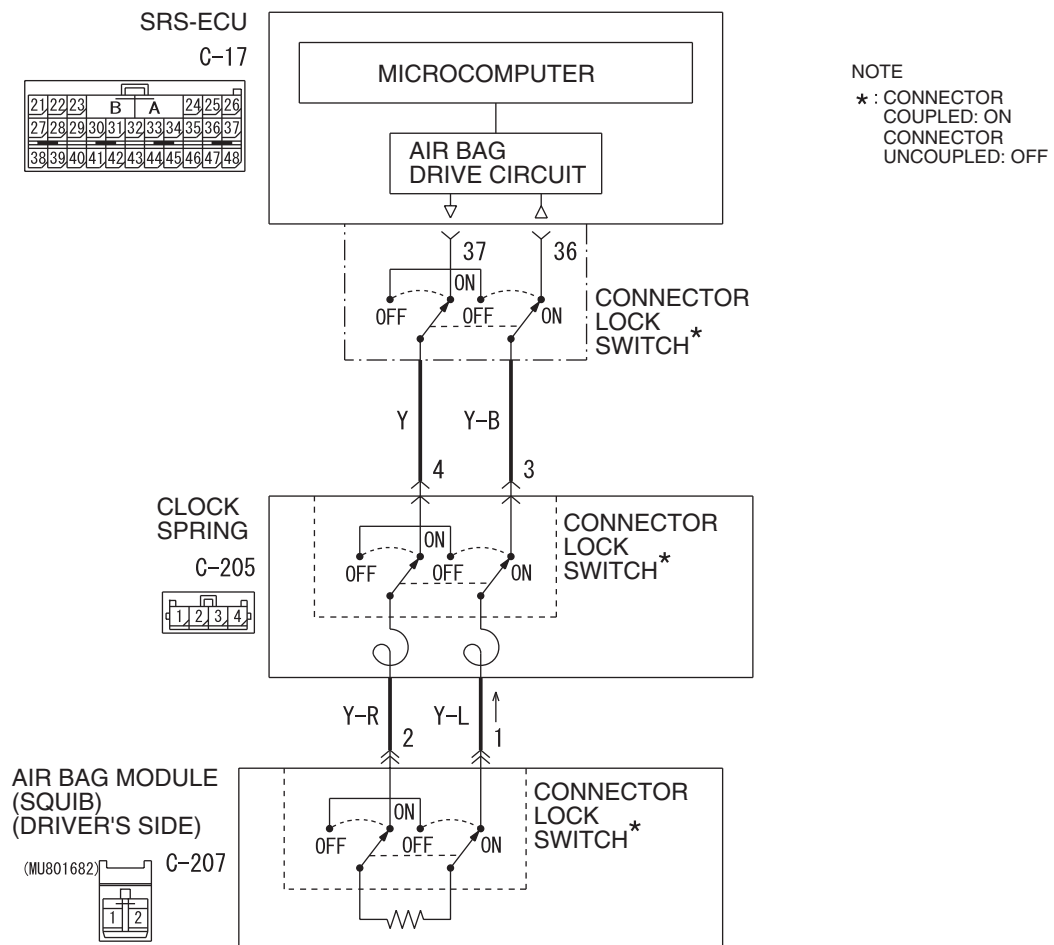
**Driver's Air Bag Module (Squib) Circuit**

### Code No.61: Driver's air bag module (squib) system (short-circuited to the power supply)

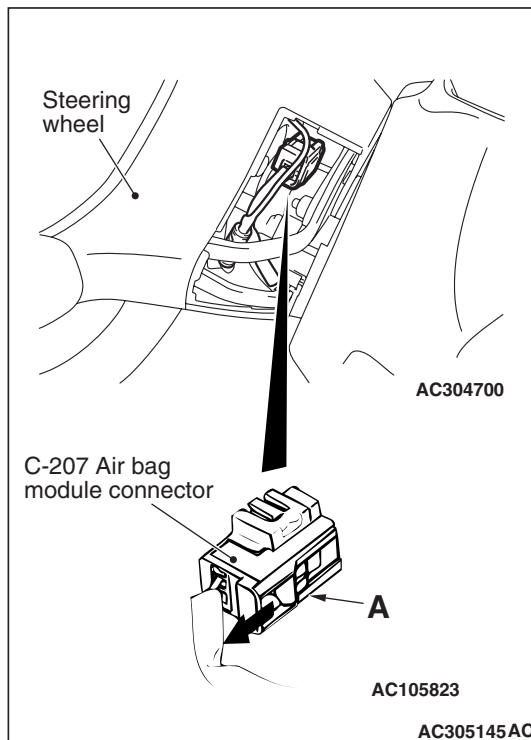
- (2) By sliding the A section (in the figure) of air bag module connector C-207 in arrow direction, disconnect the connector.

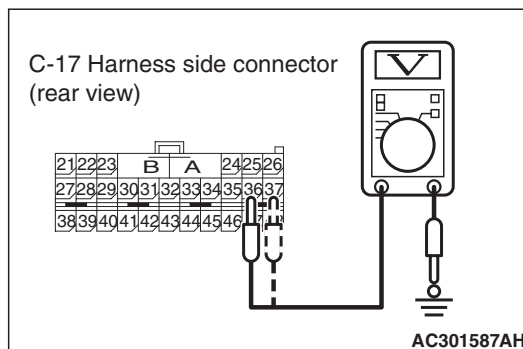
**Do not insert a test probe into the terminal from its front side directly as the connector contact pressure may be weakened.**

(4) Voltage measurement between C-17 harness side connector terminals 36, 37 and body earth.

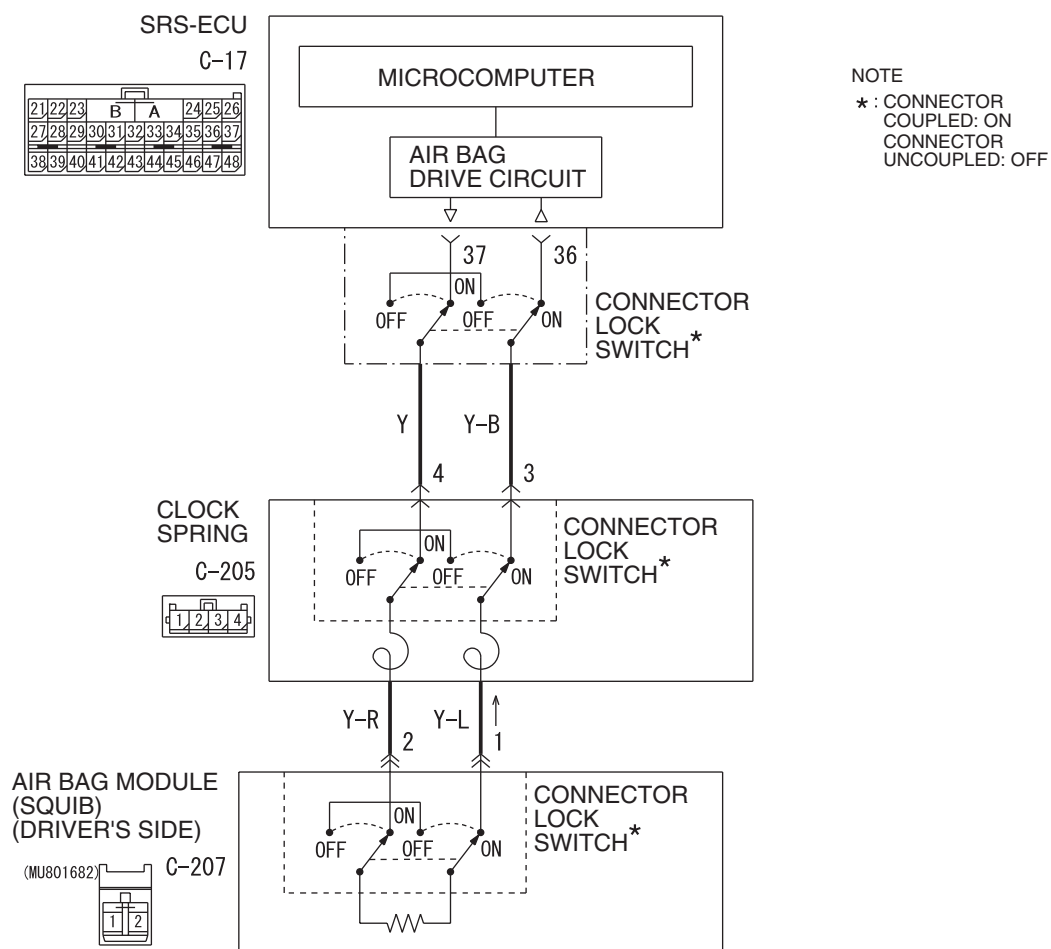
[P.00-13](#)).**Code No.62: Driver's air bag module (squib) system (short-circuited to the earth)****Driver's Air Bag Module (Squib) Circuit**

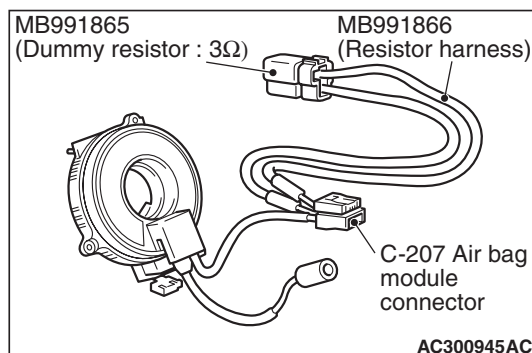
(2) By sliding the A section (in the figure) of air bag module connector C-207 in arrow direction, disconnect the connector.

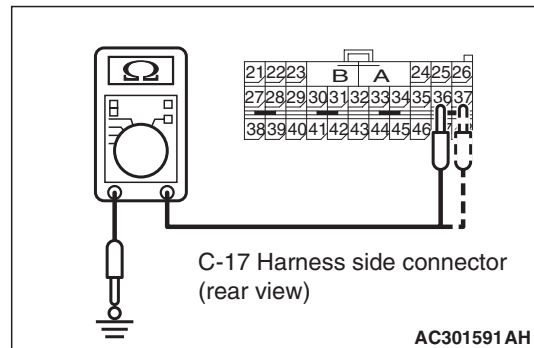
**Do not insert a test probe into the terminal from its front side directly as the connector contact pressure may be weakened.**

- (3) Check for continuity between C-17 harness side connector terminals 36, 37 and body earth.

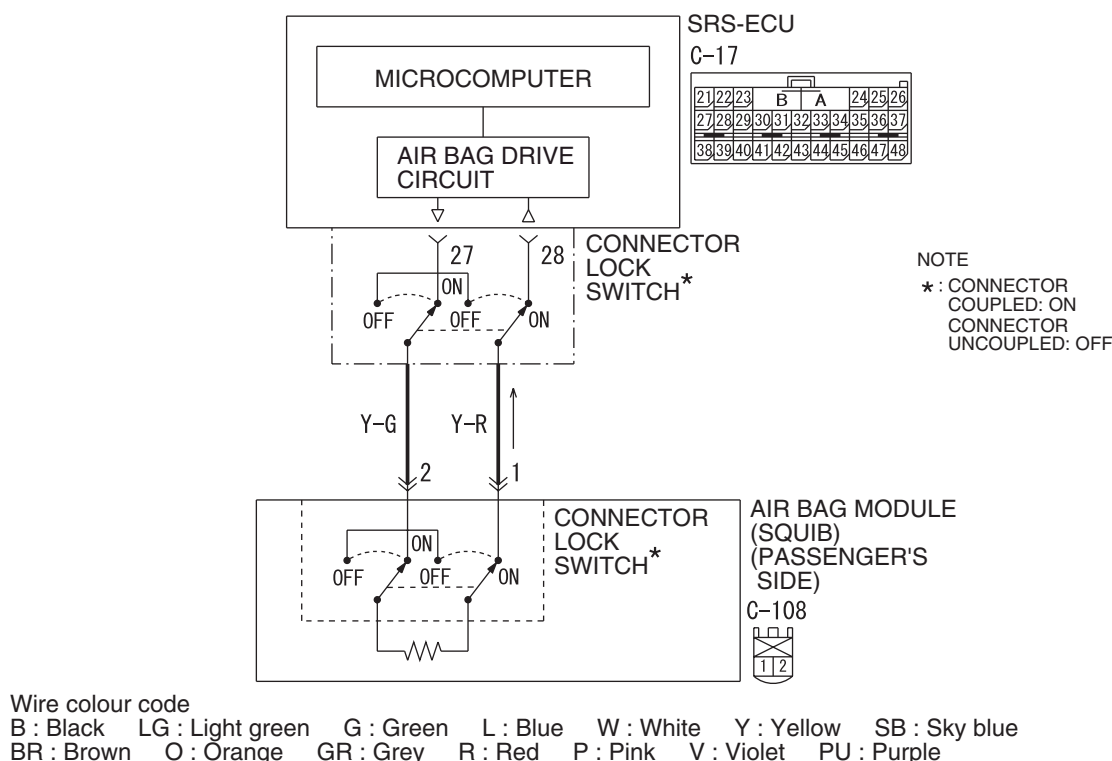
W5J52L009A

**Passenger's (Front) Air Bag Module (Squib) Circuit**

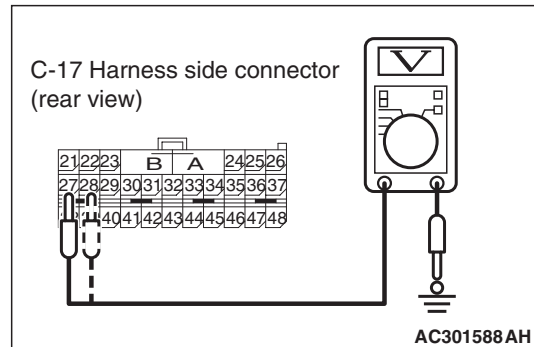
**Do not insert a test probe into the terminal from its front side directly as the connector contact pressure may be weakened.**

(4) Voltage measurement between C-17 harness side connector terminals 27, 28 and body earth.

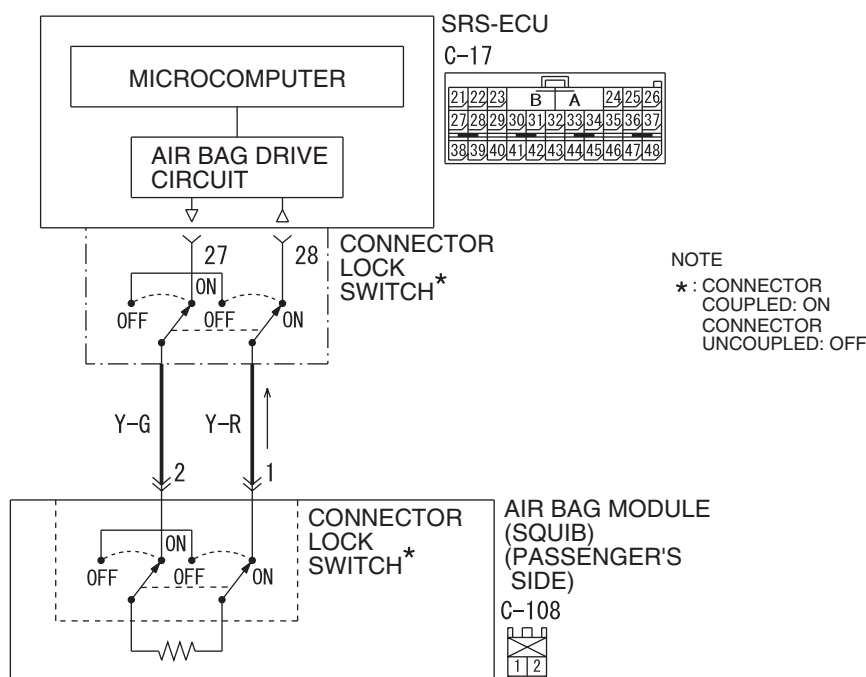
**Passenger's (Front) Air Bag Module (Squib) Circuit**

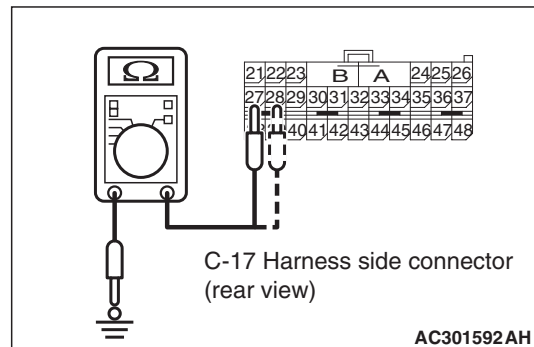
**Do not insert a test probe into the terminal from its front side directly as the connector contact pressure may be weakened.**

(3) Resistance measurement between C-17 harness side connector terminals 27, 28 and body earth.

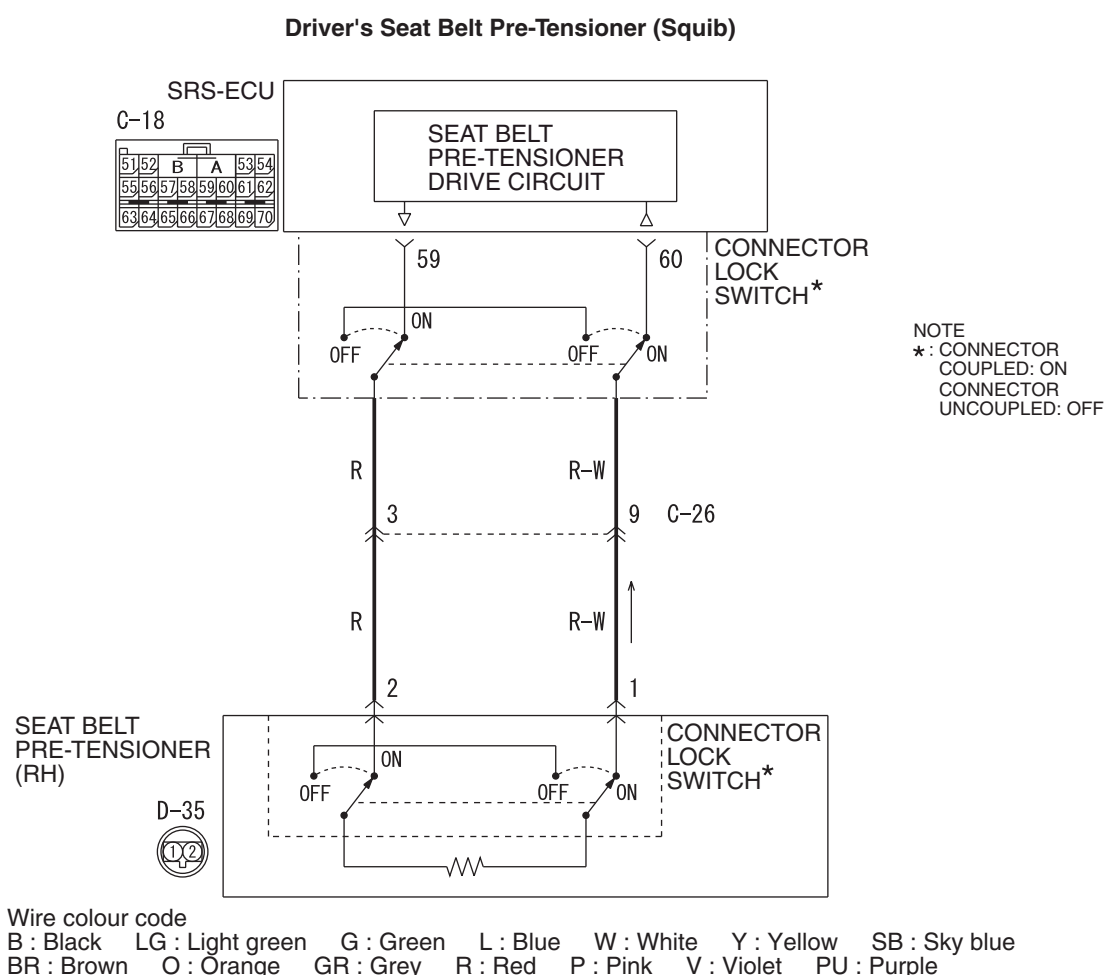
W5J52L001A

**Code No.66: Driver's seat belt pre-tensioner (squib) system (short-circuited to the power supply)**

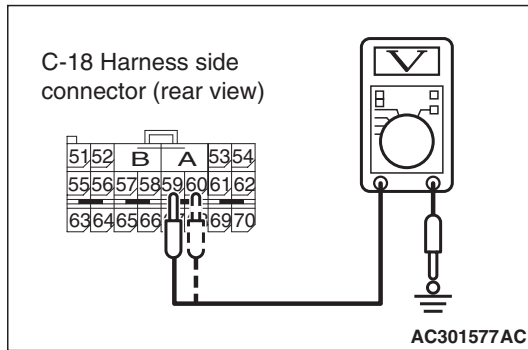
**Do not insert a test probe into the terminal from its front side directly as the connector contact pressure may be weakened.**

(4) Voltage measurement between C-18 harness side connector terminals 59, 60 and body earth.

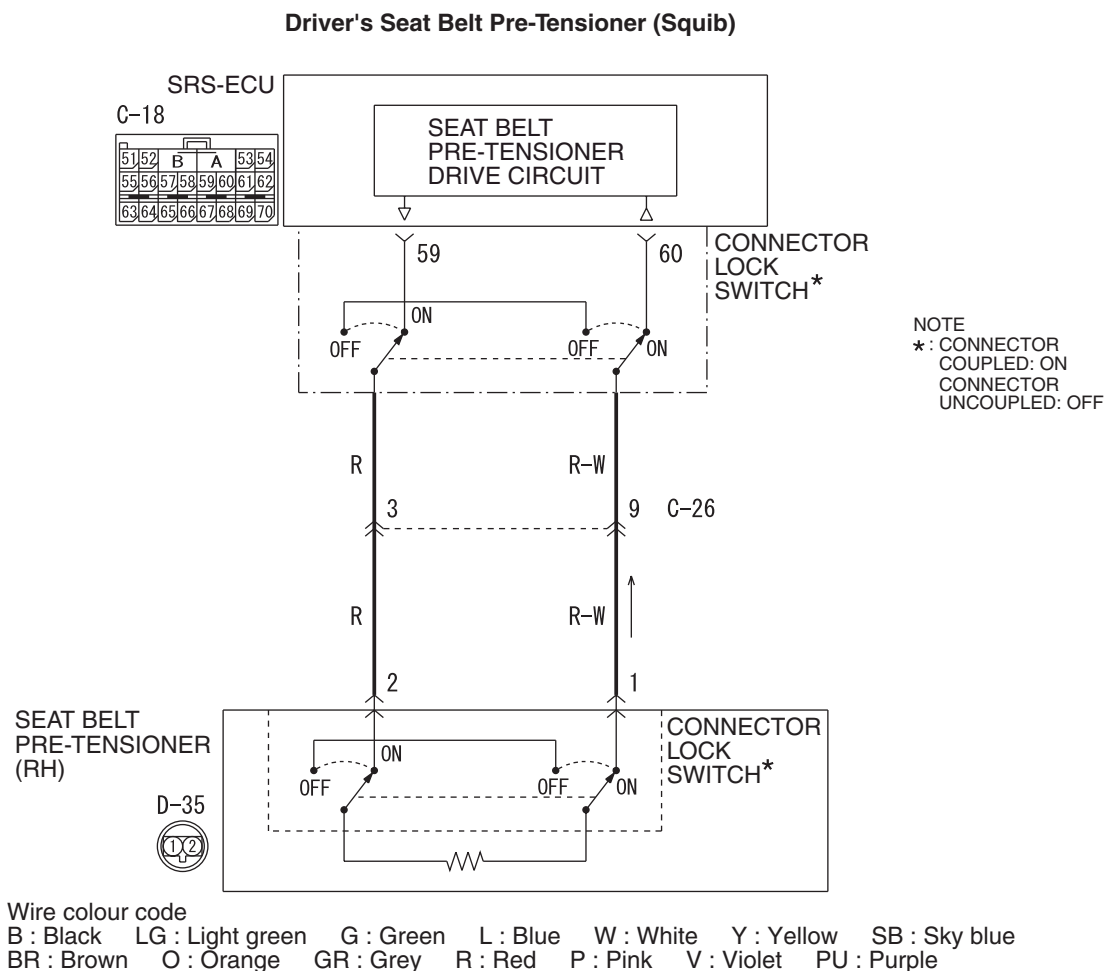
W5J52L001A

**Code No.67: Driver's seat belt pre-tensioner (squib) system (short-circuited to the earth)**

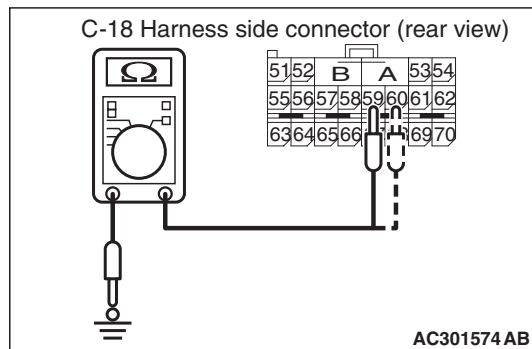
**Do not insert a test probe into the terminal from its front side directly as the connector contact pressure may be weakened.**

(3) Resistance measurement between C-18 harness side connector terminals 59, 60 and body earth.

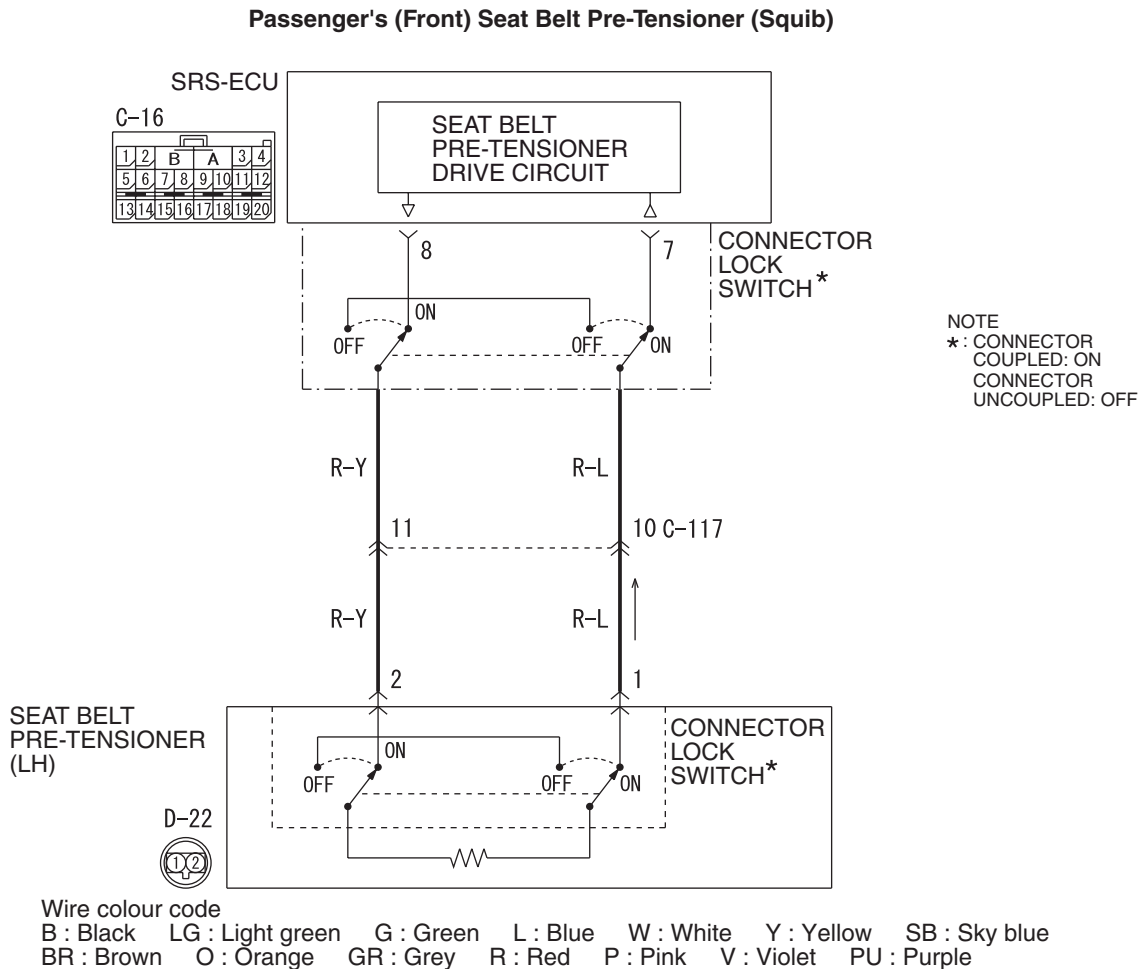
W5J52L000A

**Code No.68: Passenger's (front) seat belt pre-tensioner (squib) system (short-circuited to the power supply)**

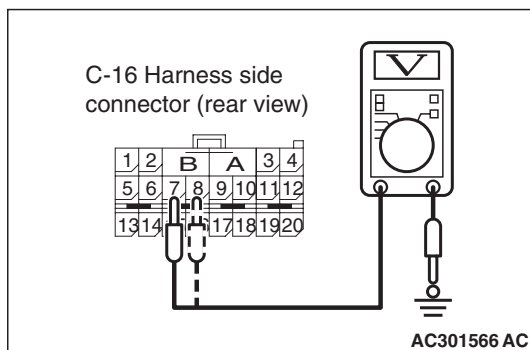
**Do not insert a test probe into the terminal from its front side directly as the connector contact pressure may be weakened.**

(4) Voltage measurement between C-16 harness side connector terminals 7, 8 and body earth.

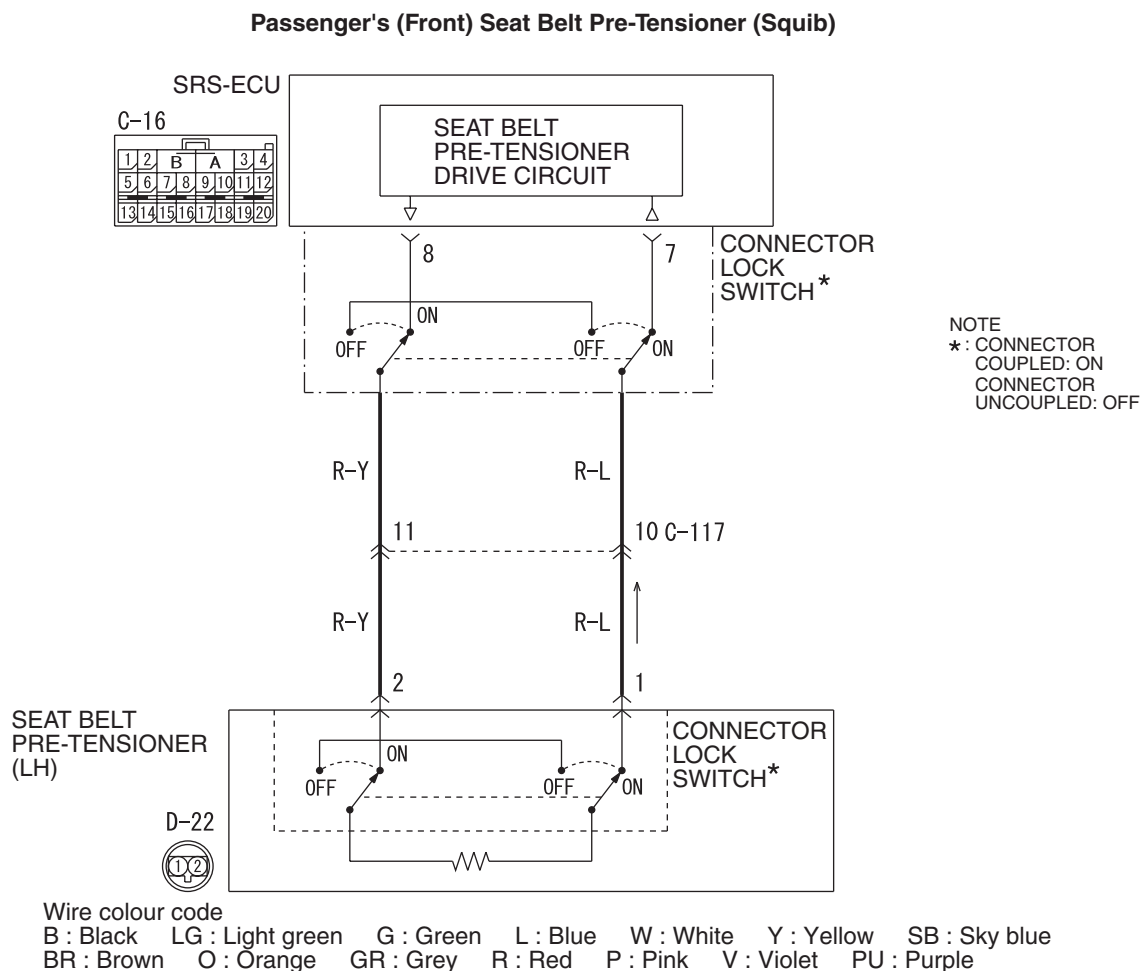
W5J52L000A

**Code No.69: Passenger's (front) seat belt pre-tensioner (squib) system (short-circuited to the earth)**

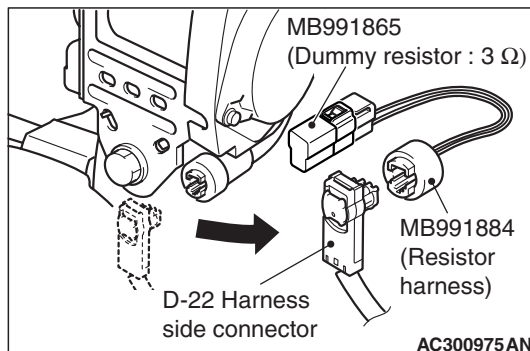
- (3) Connect special tool dummy resistor (MB991865) to special tool resistor harness (MB991884).
- (4) Connect special tool (MB991884) to the D-22 harness side connector.
- (5) Connect the negative battery terminal.

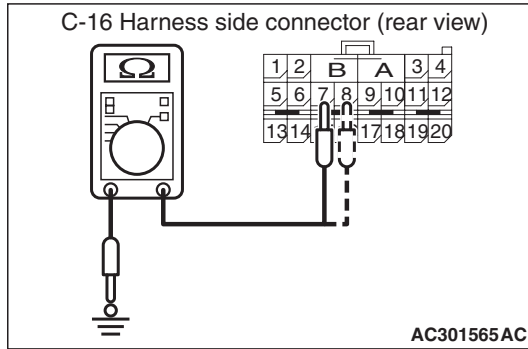
**Do not insert a test probe into the terminal from its front side directly as the connector contact pressure may be weakened.**

(3) Resistance measurement between C-16 harness side connector terminals 7, 8 and body earth.

**NO :** Repair the harness wires between SRS-ECU connector C-16 (terminal No.7 and 8) and passenger's (front) seat belt pre-tensioner connector D-22 (terminal No.1 and 2).

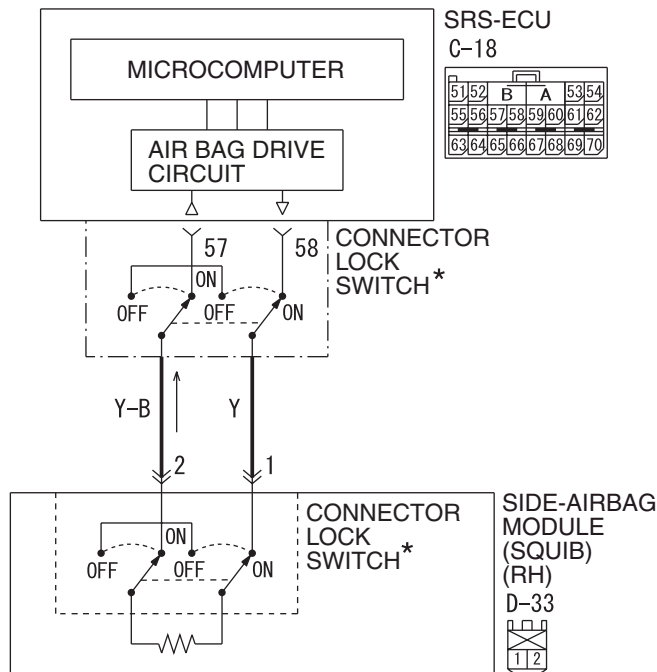
### Side-Airbag Module (RH) (Squib) Circuit

- The SRS-ECU judges how severe a collision is by detecting signals from the left and right side impact sensors. If the impact is over a predetermined level, the SRS-ECU sends an ignition signal. At this time, if the side-airbag safing G-sensor is on, the SRS side-airbag will inflate.
- The ignition signal is input to the side-airbag module to inflate the side-airbag.

- Improper engaged connector or defective short spring\*
- Short between the side-airbag module (squib) (RH) circuit terminals
- Damaged connector(s)
- Malfunction of the SRS-ECU

*NOTE: \*: The squib circuit connectors integrate a "short" spring (which prevents the air bag from deploying unintentionally due to static electricity by shorting the positive wire to the earth wire in the squib circuit when the connectors are disconnected). Therefore, if connector C-18 or D-33 is damaged or improperly engaged, the short spring may not be released when the connector is connected.*

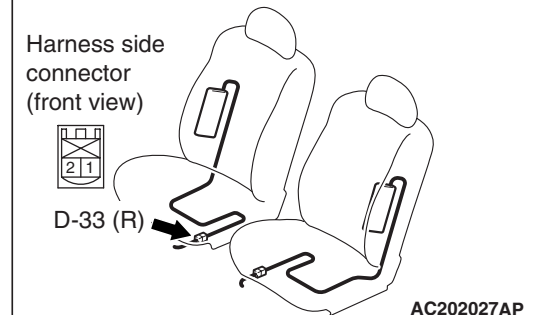
#### Connector: D-33

- (2) Disconnect connectors C-18 and D-33 and then reconnect them.

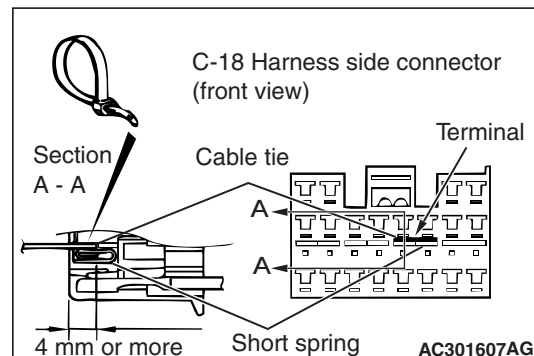
**Insert an insulator such as a cable tie to a depth of 4mm or more, otherwise the short spring will not be released.**

- (3) Insert a cable tie [3 mm wide, 0.5 mm thick] between terminals 57, 58 and the short spring to release the short spring.

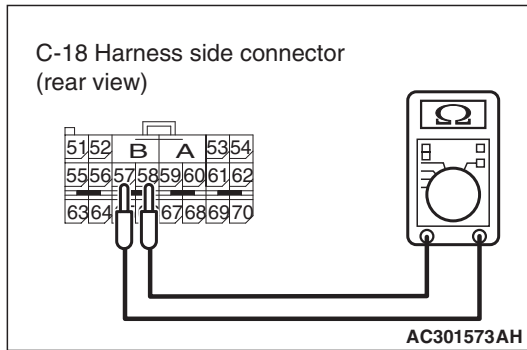
**Do not insert a test probe into the terminal from its front side directly as the connector contact pressure may be weakened.**

(5) Resistance measurement between C-18 harness side connector terminals 57 and 58.

**NO :** Repair the harness wires between SRS-ECU connector C-18 (terminal No.57 and 58) and side-airbag module (RH) connector D-33 (terminal No.1 and 2).

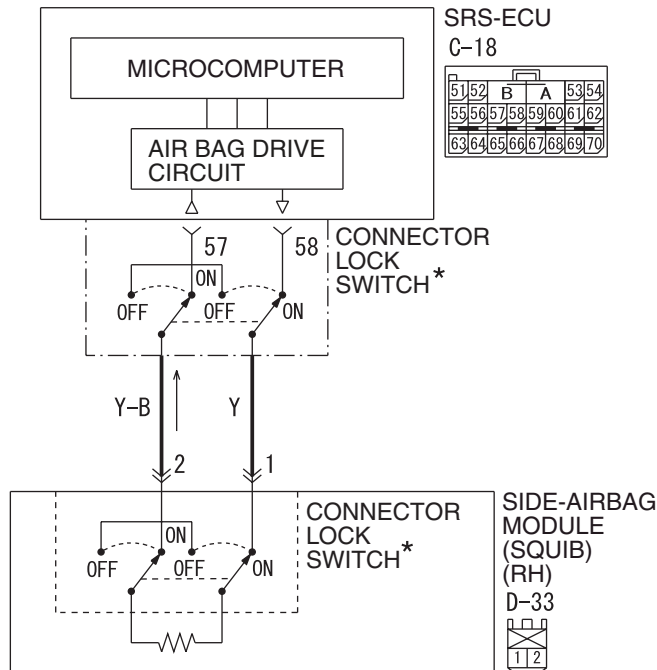
**Side-Airbag Module (RH) (Squib) Circuit**

\* : CONNECTOR  
COUPLED: ON  
CONNECTOR  
UNCOUPLD: OFF

- Open circuit in the side-airbag module (squib) (RH) circuit
- Improper connector contact
- Malfunction of the SRS-ECU

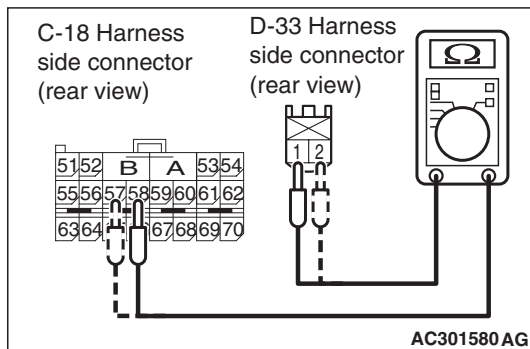
**Do not insert a test probe into the terminal from its front side directly as the connector contact pressure may be weakened.**

(3) Resistance measurement between the following terminals.

**NO :** Repair the harness wires between SRS-ECU connector C-18 (terminal No.57 and 58) and side-airbag module (RH) connector D-33 (terminal No.1 and 2).

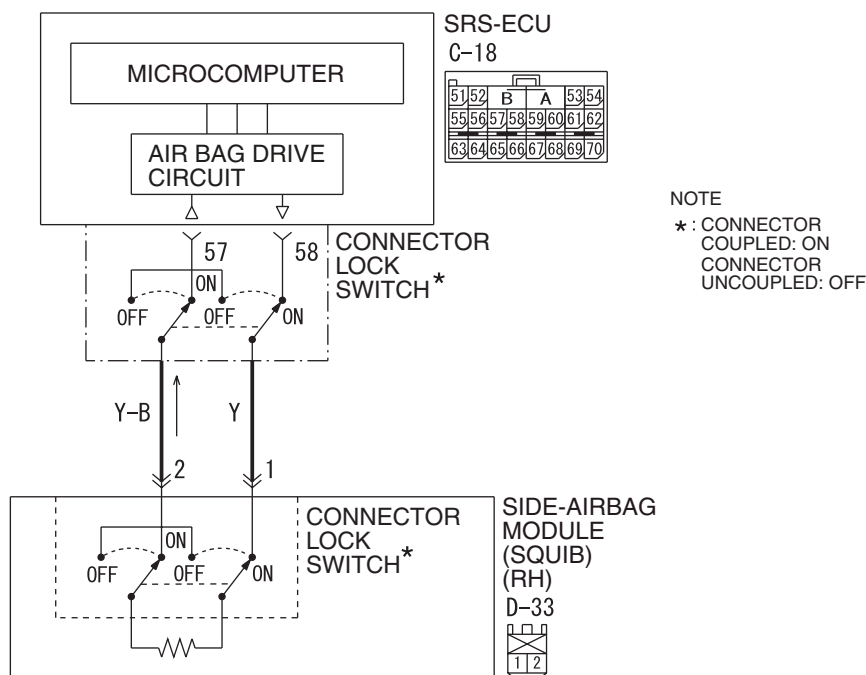
W5J52L011A

**Code No.75: Side-airbag module (squib) (RH) system (short-circuited to the power supply)****Side-Airbag Module (RH) (Squib) Circuit**

- Damaged wiring harnesses or connectors
- Short to the power supply in the side-airbag module (squib) (RH) harness
- Malfunction of the SRS-ECU

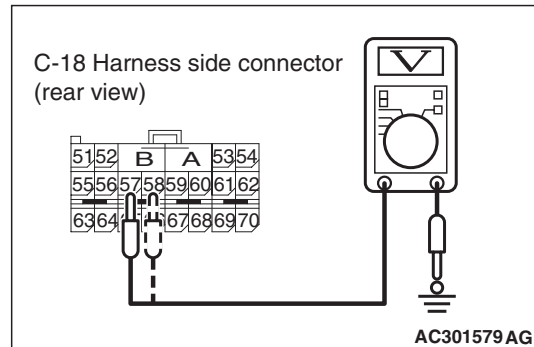
**Do not insert a test probe into the terminal from its front side directly as the connector contact pressure may be weakened.**

- (4) Voltage measurement between C-18 harness side connector terminals 57, 58 and body earth.

**NO :** Repair the harness wires between SRS-ECU connector C-18 (terminal No.57 and 58) and side-airbag module (RH) connector D-33 (terminal No.1 and 2).

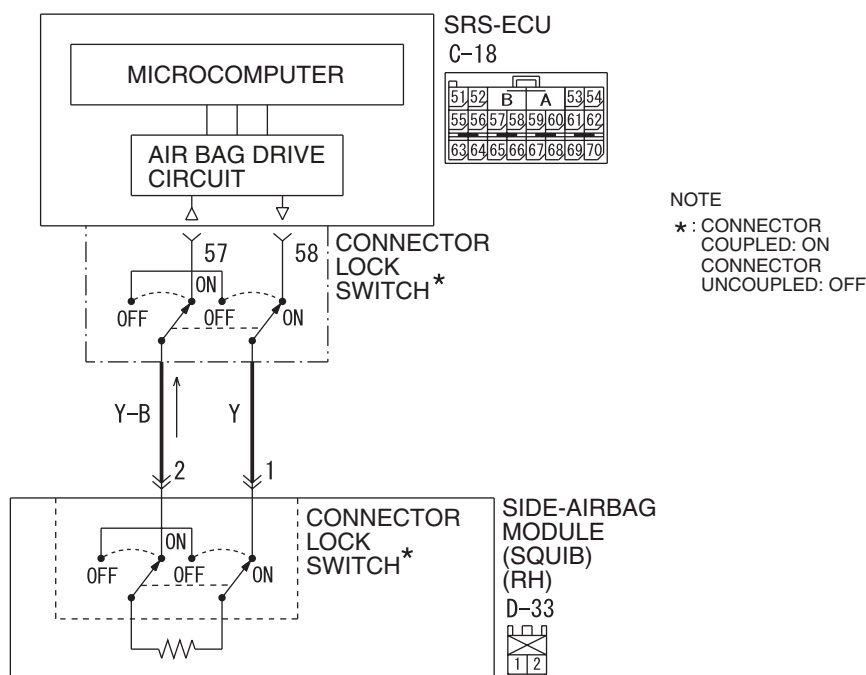
W5J52L011A

[P.00-13](#)).**Code No.76: Side-airbag module (squib) (RH) system (short-circuited to the earth)****Side-Airbag Module (RH) (Squib) Circuit**

- Damaged wiring harnesses or connectors
- Short to earth in the side-airbag module (squib) (RH) harness
- Malfunction of the SRS-ECU

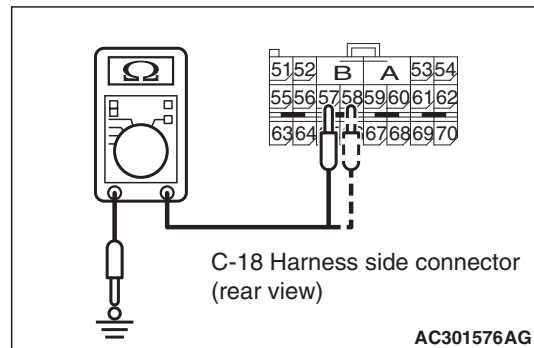
**Do not insert a test probe into the terminal from its front side directly as the connector contact pressure may be weakened.**

(3) Resistance measurement between C-18 harness side connector terminals 57, 58 and body earth.

**NO :** Repair the harness wires between SRS-ECU connector C-18 (terminal No.57 and 58) and side-airbag module (RH) connector D-33 (terminal No.1 and 2).
