## GROUP 52B

# SUPPLEMENTAL RESTRAINT SYSTEM (SRS)

## GENERAL INFORMATION

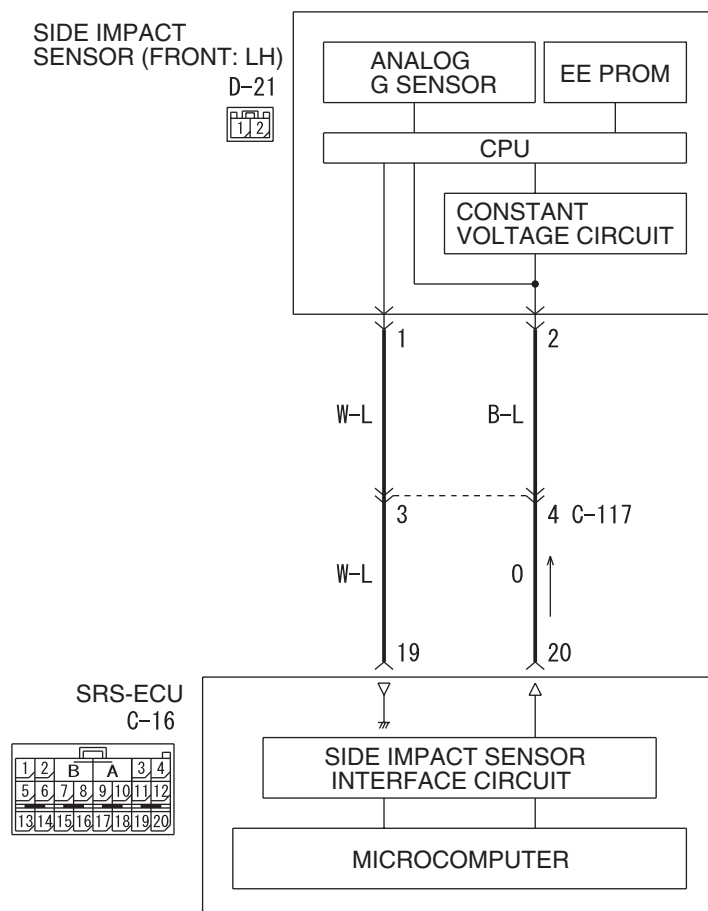
[P.00-13](#)).**Code No.79: Side impact sensor (LH) (front) communication error****Code No.93: Side impact sensor (LH) (front) communication impossible****Side Impact Sensor (LH) (Front) Power Supply Circuit**

B : Black   LG : Light green   G : Green   L : Blue   W : White   Y : Yellow   SB : Sky blue  
 BR : Brown   O : Orange   GR : Grey   R : Red   P : Pink   V : Violet   PU : Purple

- Damaged wiring harnesses or connectors
- Malfunction of the side impact sensor (LH) (front)
- Malfunction of the SRS-ECU

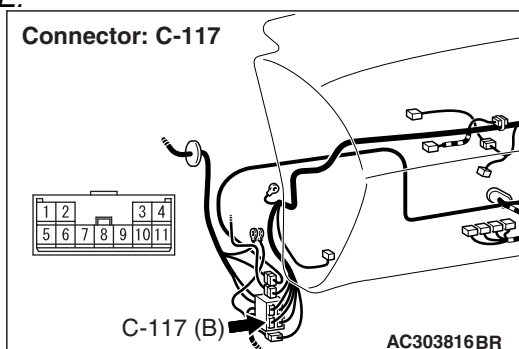
**STEP 2. Check the harness wires for open circuit or short circuit between SRS-ECU connector C-16 (terminal No.19 and 20) and side impact sensor (LH) (front) connector D-21 (terminal No.1 and 2).**

*After inspecting intermediate connector C-117 inspect the wiring harness. If the intermediate connector C-117 is damaged, repair or replace it.*

**NO :** Repair the harness wires between SRS-ECU connector C-16 (terminal No.19 and 20) and side impact sensor (LH) connector D-21 (terminal No.1 and 2).

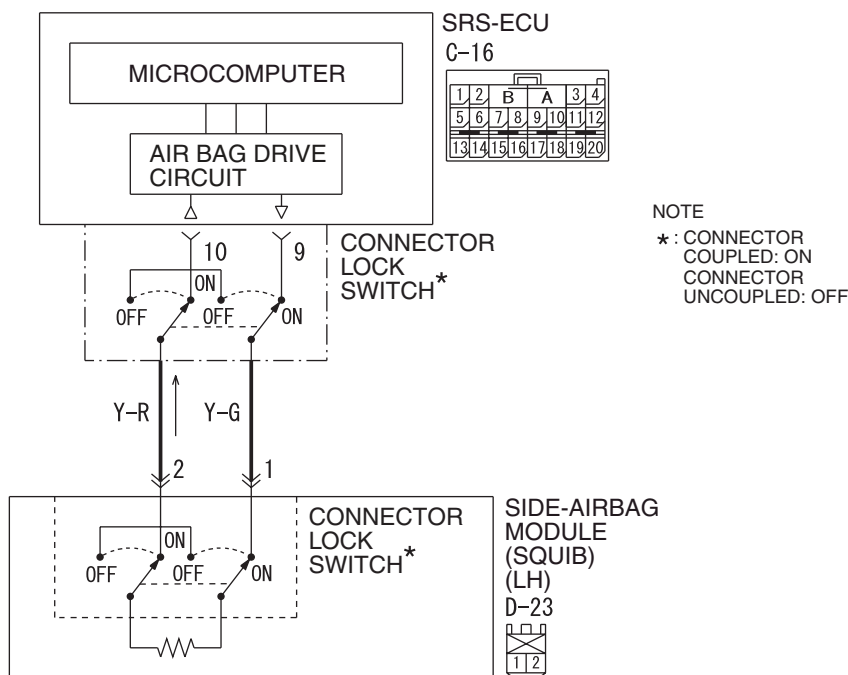
W5J52L010A

[P.00-13](#)).**Code No.81: Side-airbag module (squib) (LH) system (short-circuited between terminals of the squib circuit)****Side-airbag Module (LH) (Squib) Circuit**

- Improper engaged connector or defective short spring\*
- Short circuit between the side-airbag module (squib) (LH) circuit terminals
- Damaged connector(s)
- Malfunction of the SRS-ECU

**NOTE:** \*: The squib circuit connectors integrate a "short" spring (which prevents the air bag from deploying unintentionally due to static electricity by shorting the positive wire to the earth wire in the squib circuit when the connectors are disconnected). (Refer to P.52B-3). Therefore, if connector C-16 or D-23 is damaged or improperly engaged, the short spring may not be released when the connector is connected.

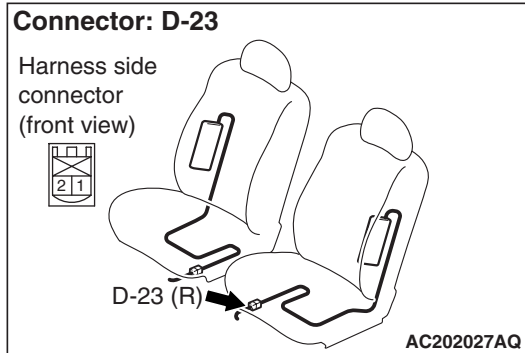
- (1) Disconnect the negative battery terminal.

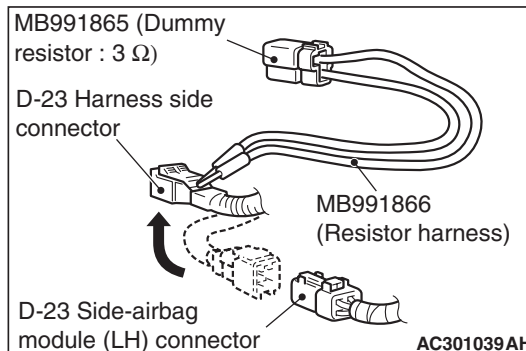
- (2) Disconnect the side-airbag module (LH) connector D-23.

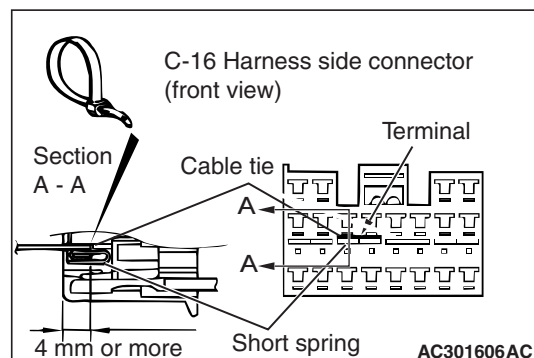
**Insert an insulator such as a cable tie to a depth of 4mm or more, otherwise the short spring will not be released.**

- (3) Insert a cable tie [3 mm wide, 0.5 mm thick] between terminals 9, 10 and the short spring to release the short spring.

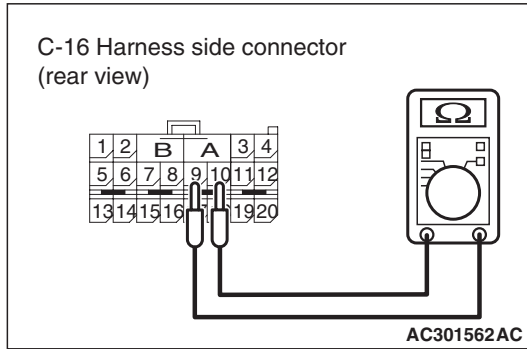
**Do not insert a test probe into the terminal from its front side directly as the connector contact pressure may be weakened.**

(4) Check for continuity between C-16 harness side connector terminals 9 and 10.

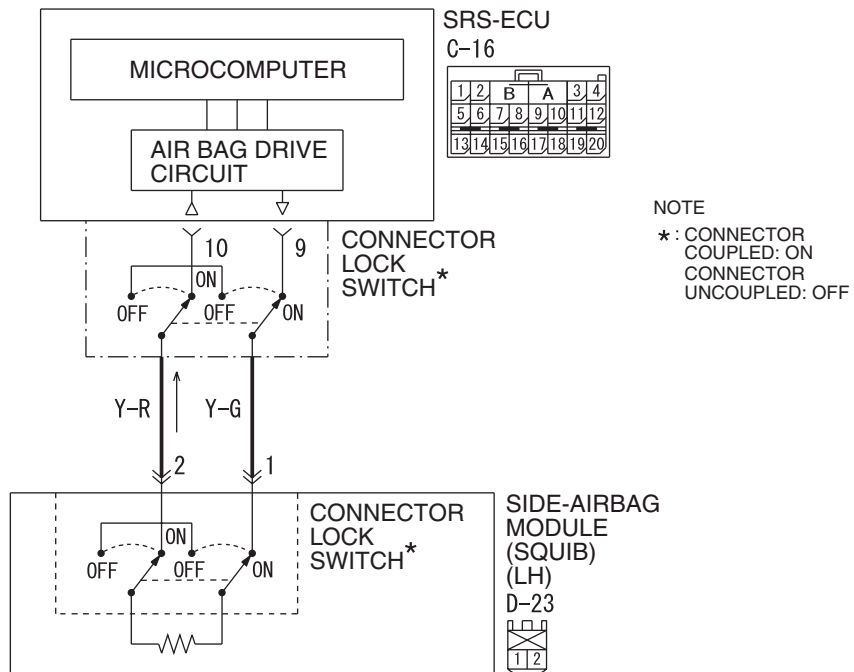
**Side-airbag Module (LH) (Squib) Circuit**

- Open circuit in the side-airbag module (squib) (LH) circuit
- Improper connector contact
- Malfunction of the SRS-ECU

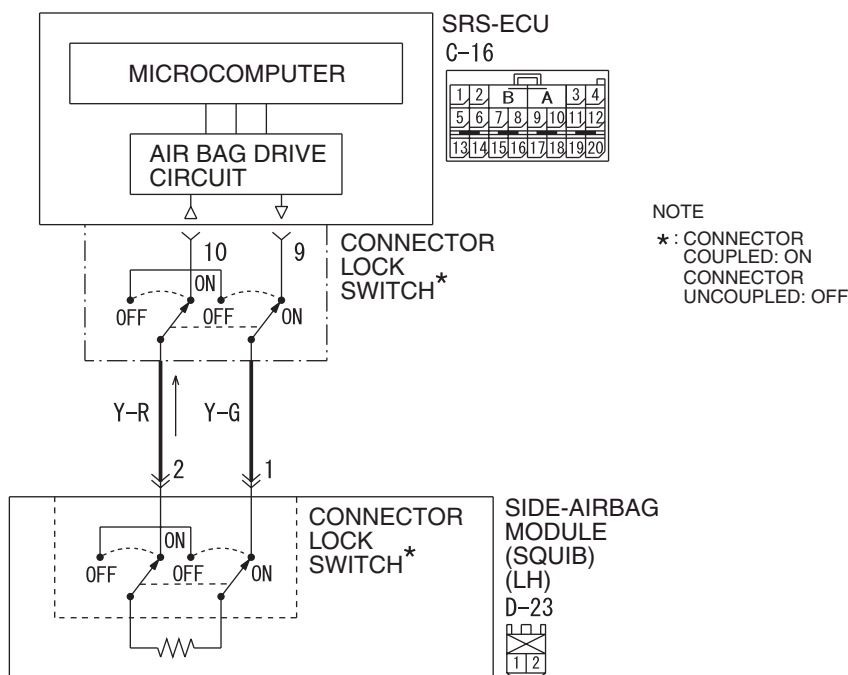
**Code No.85: Side-airbag module (squib) (LH) system (short-circuited to the power supply)****Side-airbag Module (LH) (Squib) Circuit**

- Damaged wiring harnesses or connectors
- Short to the power supply in the side-airbag module (squib) (LH) harness
- Malfunction of the SRS-ECU

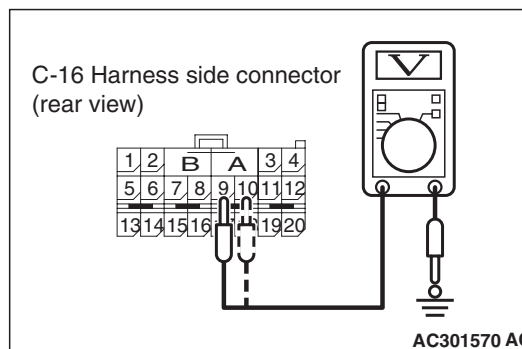
**Do not insert a test probe into the terminal from its front side directly as the connector contact pressure may be weakened.**

- (4) Voltage measurement between C-16 harness side connector terminals 9, 10 and body earth.

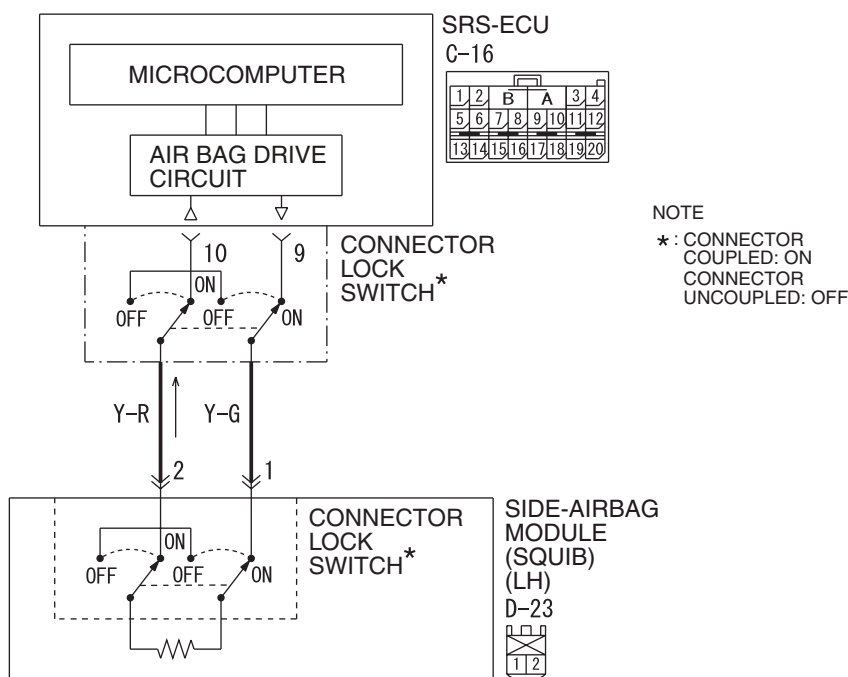
[P.00-13](#)).**Code No.86: Side-airbag module (squib) (LH) system (short-circuited to the earth)****Side-airbag Module (LH) (Squib) Circuit**

- Damaged wiring harnesses or connectors
- Short to earth in the left hand side-airbag module (squib) (LH) harness
- Malfunction of the SRS-ECU

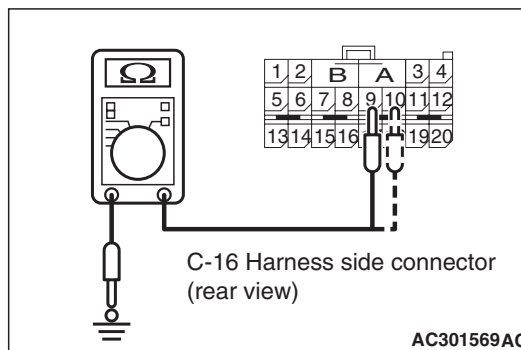
**Do not insert a test probe into the terminal from its front side directly as the connector contact pressure may be weakened.**

(3) Check for continuity between C-16 harness side connector terminals 9, 10 and body earth.

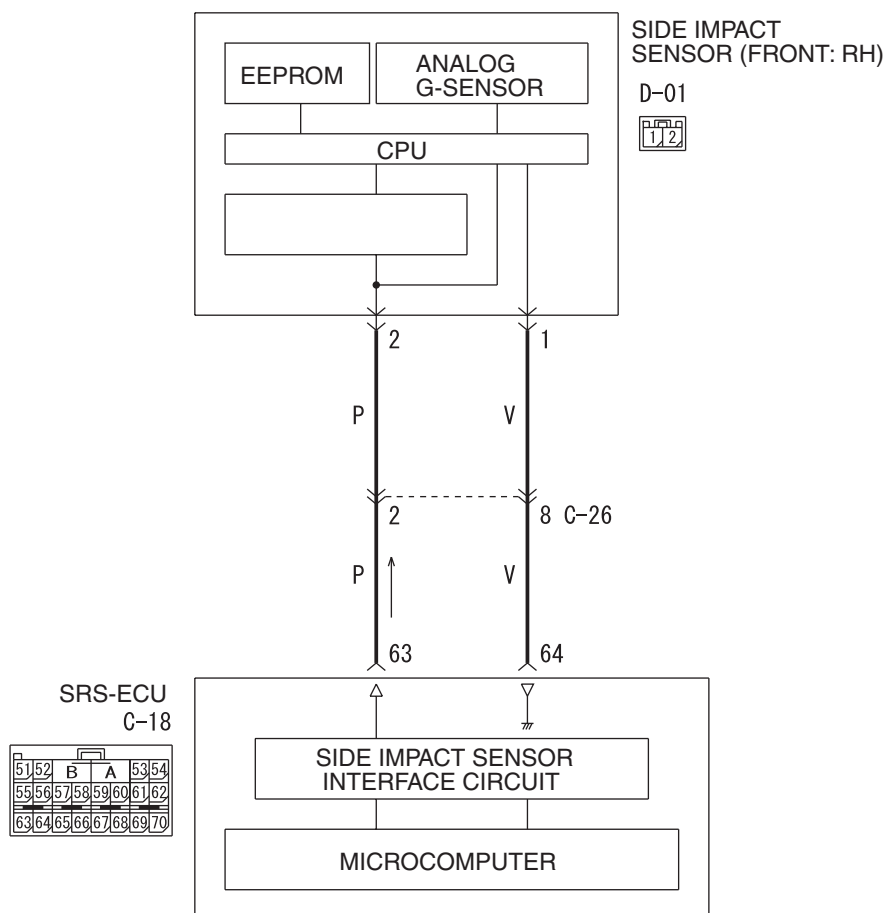
[P.00-13](#)).**Code No.89: Side impact sensor (RH) (front) communication error****Code No.96: Side impact sensor (RH) (front) communication impossible****Side Impact Sensor (RH) (Front) Circuit**

- Damaged wiring harnesses or connectors
- Malfunction of the side impact sensor (RH) (front)
- Malfunction of the SRS-ECU

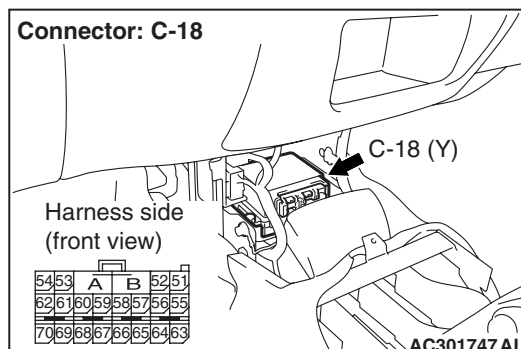
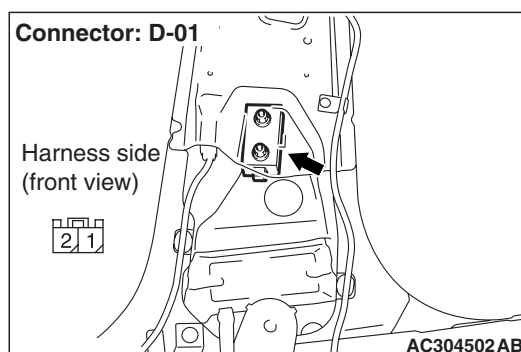
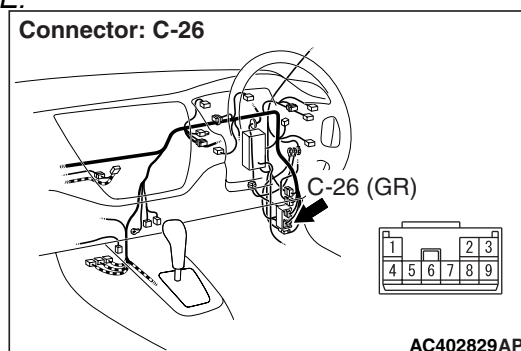
**STEP 2. Check the harness wires for open circuit or short circuit between SRS-ECU connector C-18 (terminal No.63 and 64) and side impact sensor (RH) (front) connector D-01 (terminal No.1 and 2).**

*After inspecting intermediate connector C-26 inspect the wiring harness. If the intermediate connector C-26 is damaged, repair or replace it.*

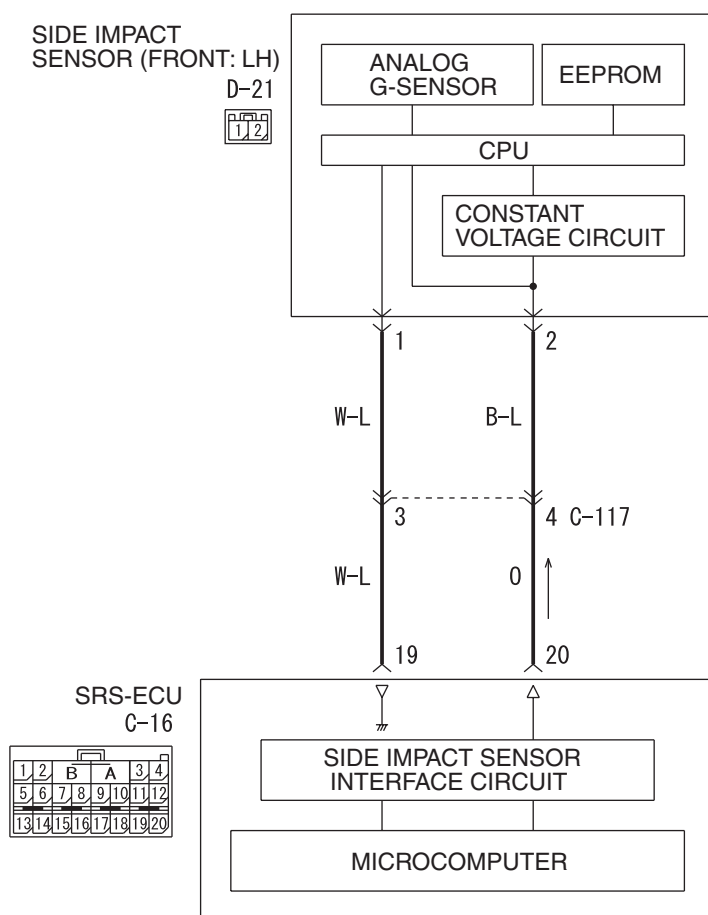
[P.00-13](#)).**Code No.91: Side impact sensor (LH) (front) voltage error****Side Impact Sensor (LH) (Front) Power Supply Circuit**

This diagnosis code will set when the power supply voltage to the side impact sensor (LH) (front) remains less than a predetermined value for 5 seconds. However, if the system returns to normal condition, code number 91 will be erased automatically and the SRS warning lamp will go out.

- Damaged wiring harness or connectors
- Malfunction of the side air bag module (LH) (front)
- Malfunction of the SRS-ECU

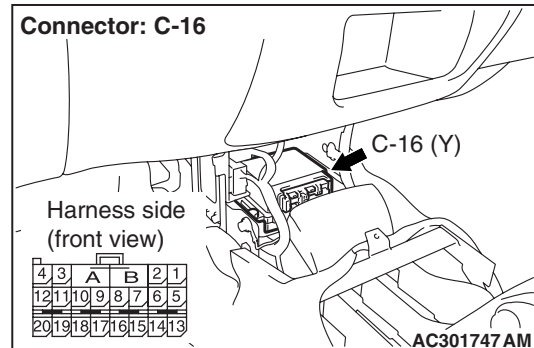
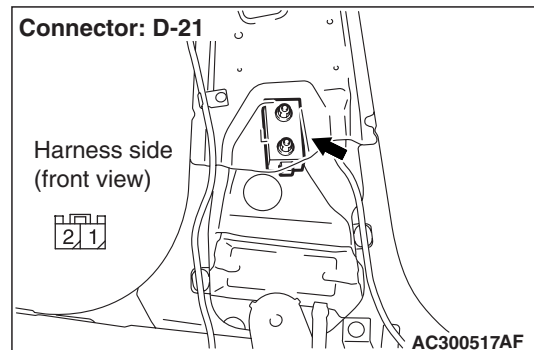
**STEP 1. Check the harness wires for open circuit or short circuit between SRS-ECU connector C-16 (terminal No.19 and 20) and side impact sensor (LH) (front) connector D-21 (terminal No.1 and 2).**

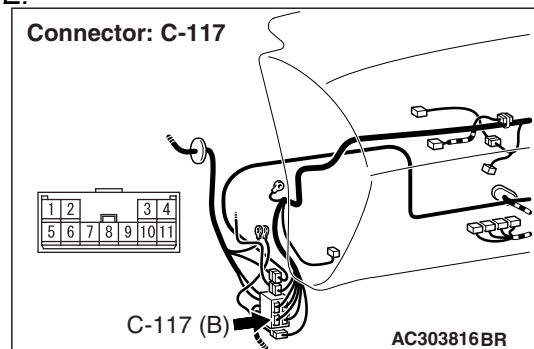
*After inspecting intermediate connector C-117 inspect the wiring harness. If the intermediate connector C-117 is damaged, repair or replace it.*

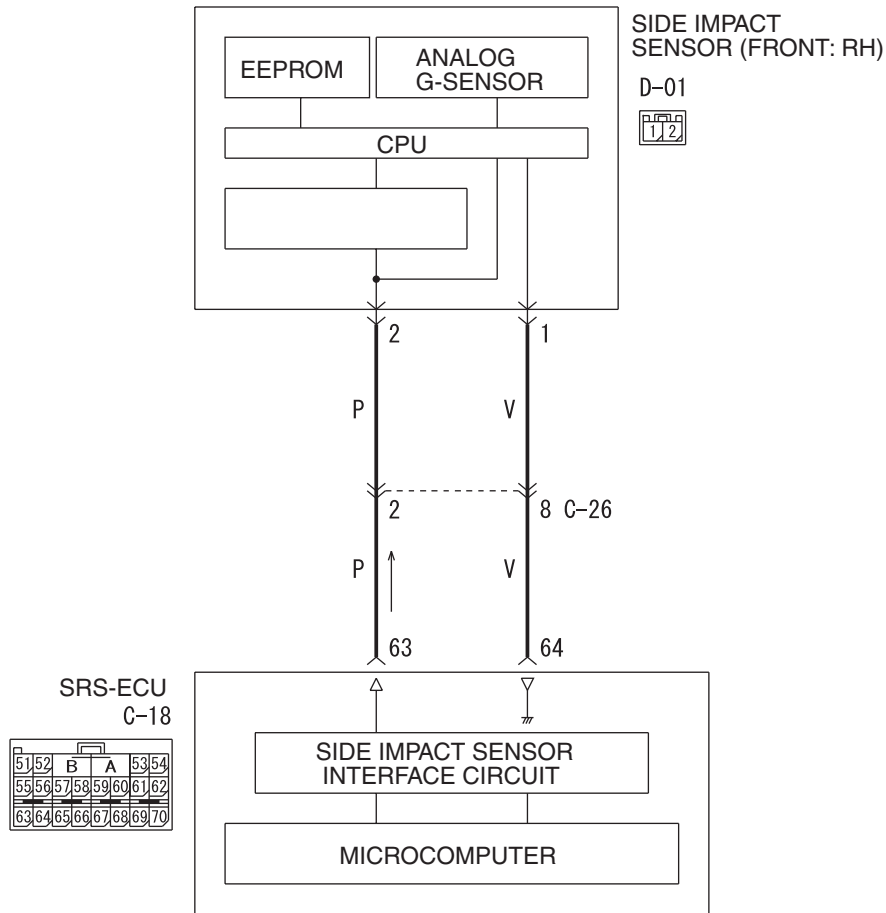
**Side Impact Sensor (RH) (Front) Circuit**

This diagnosis code is set if the power supply voltage of the side impact sensor (RH) (front) drops below the rated value for a continuous period of 5 seconds or more. However, if the system returns to normal condition, code number 94 will be erased automatically and the SRS warning lamp will go out.

- Damaged wiring harnesses or connectors
- Malfunction of the side air bag module (RH) (front)
- Malfunction of the SRS-ECU

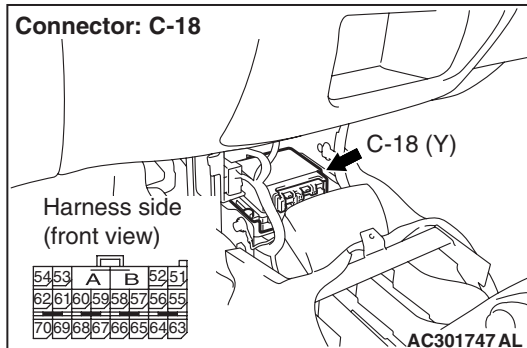
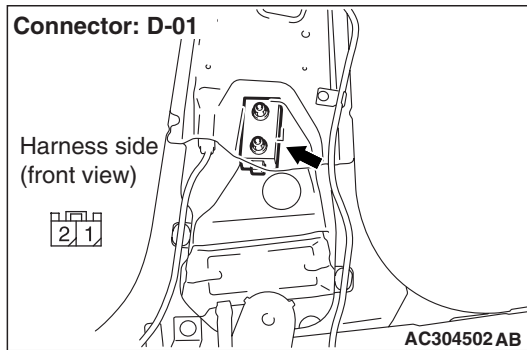
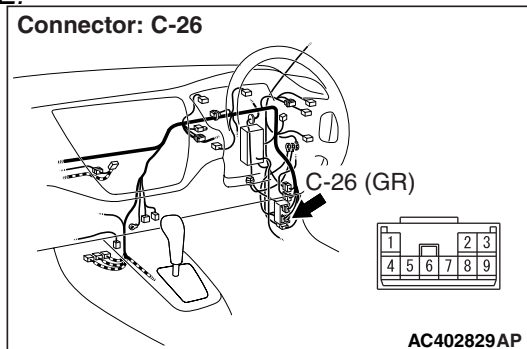
**STEP 1. Check the harness wires for open circuit or short circuit between SRS-ECU connector C-18 (terminal No.63 and 64) and side impact sensor (RH) (front) connector D-01 (terminal No.1 and 2).**

*After inspecting intermediate connector C-26 inspect the wiring harness. If the intermediate connector C-26 is damaged, repair or replace it.*

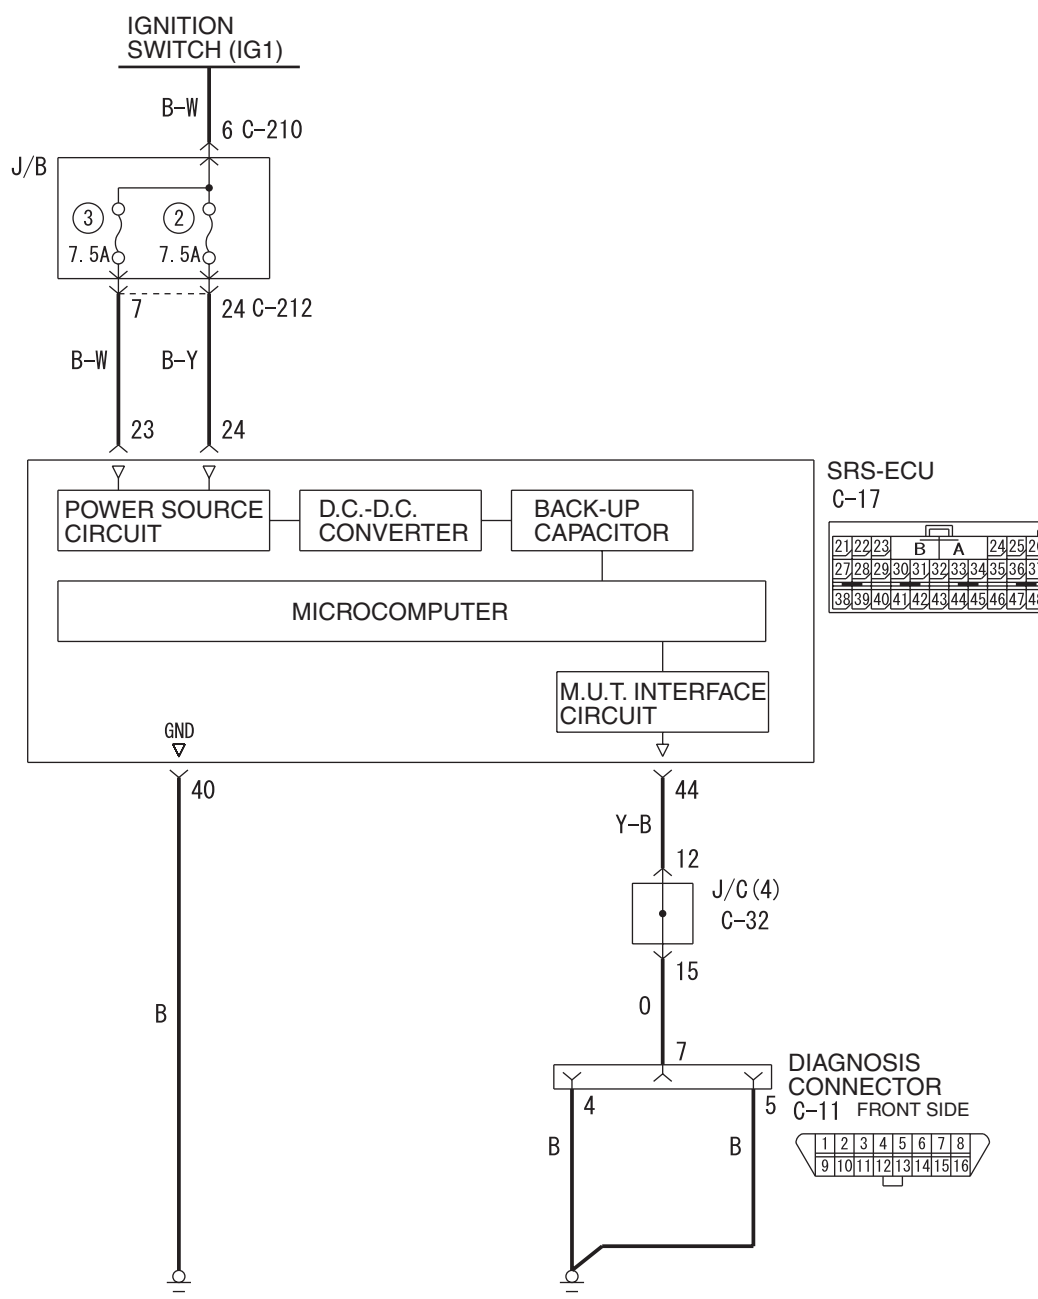
**INSPECTION PROCEDURE 1: Communication with M.U.T.-II MB991502 or M.U.T.-III MB991955 is not possible (Communication is not possible with SRS).**

- The SRS-ECU is powered from the ignition switch (IG1).
- The SRS-ECU power is supplied from two circuits. Even if one circuit is shut off, the air bag can inflate.
- The SRS system diagnosis can be done by connecting M.U.T.-II MB991502 or M.U.T.-III MB991955 to the diagnosis connector.

If communication is not possible with the SRS only, the cause is probably an open circuit in the diagnosis output circuit of the SRS or in the power circuit (including earth circuit).

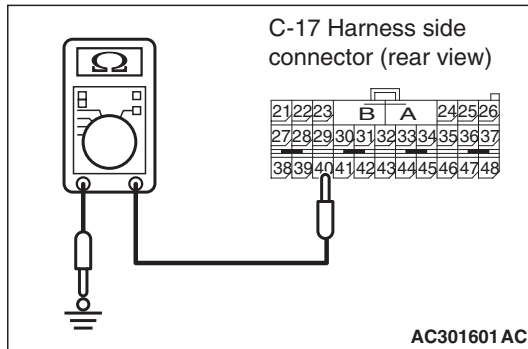
**Do not insert a test probe into the terminal from its front side directly as the connector contact pressure may be weakened.**

- (2) Check for continuity between terminal 40 and body earth.

**NO :** Check the harness wire for open circuit between SRS-ECU connector C-17 (terminal No.40) and earth, and repair if necessary.

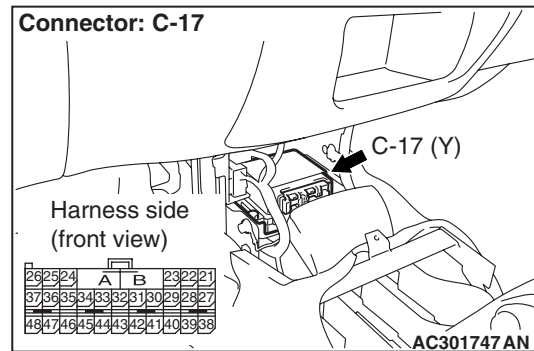
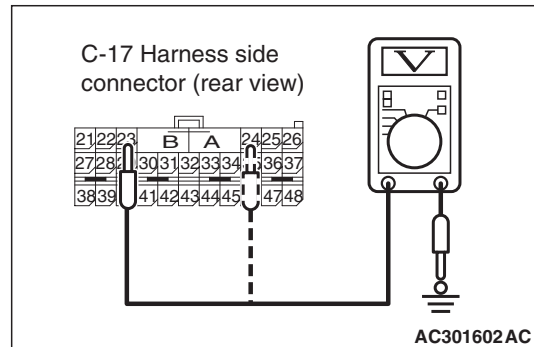
**STEP 4. Voltage measurement the power supply circuit to the SRS-ECU connector C-17.**

- (1) Disconnect SRS-ECU connector C-17 and measure at the wiring harness side.  
(2) Connect the negative battery terminal.  
(3) Turn the ignition switch to the "ON" position.

**Do not insert a test probe into the terminal from its front side directly as the connector contact pressure may be weakened.**

- (4) Voltage measurement between terminals 23, 24 and body earth.

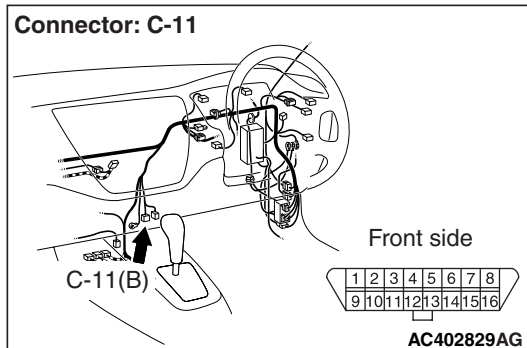
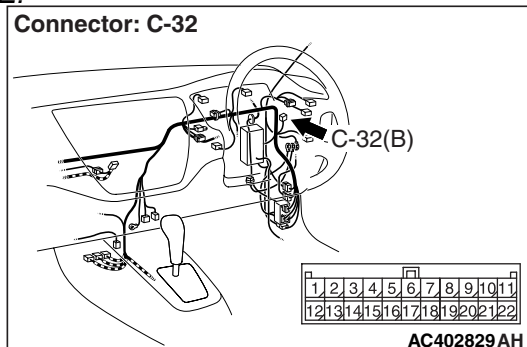
**STEP 5. Check the harness wires between SRS-ECU connector C-17 and diagnosis connector C-11.**

*Prior to the wiring harness inspection, check junction block connector C-32, and repair if necessary.*

**NO :** Check the harness wires for open or short circuit between SRS-ECU connector C-17 (terminal No.44) and diagnosis connector C-11 (terminal No.7) and repair if necessary.

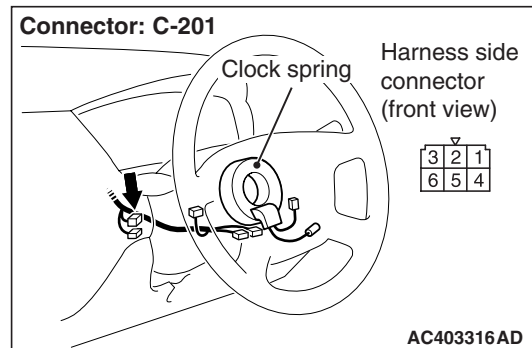
**STEP 6. Check the connectors between SRS-ECU connector C-17 and ignition switch connector C-201.**

*Prior to the wiring harness inspection, check junction block connectors C-210 and C-212, and repair if necessary.*

**NO** : Check the harness wires for open or short  
circuit between SRS-ECU connector C-17  
and ignition switch connector C-201, and  
repair if necessary.

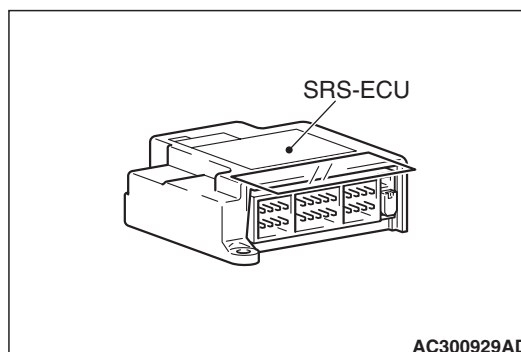
**SRS-ECU**

1. Check the SRS-ECU case and brackets for dents, cracks or deformation.
2. Check the connector for damage, and the terminals for deformation.
3. Check the SRS-ECU and bracket for installation condition.

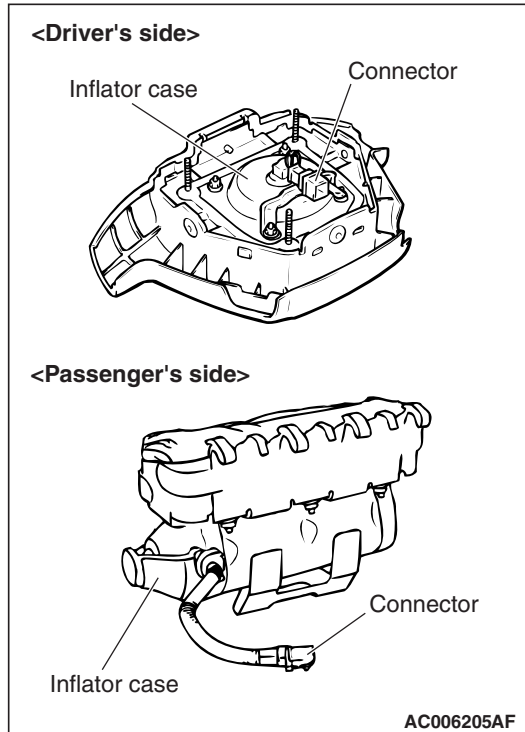
1. Check the pad cover for dents, cracks or deformation.
2. Check the connector for damage, terminals deformities, and the harness for binding.
3. Check the air bag inflator case for dents, cracks or deformities.
4. Check the air bag modules for proper installation.

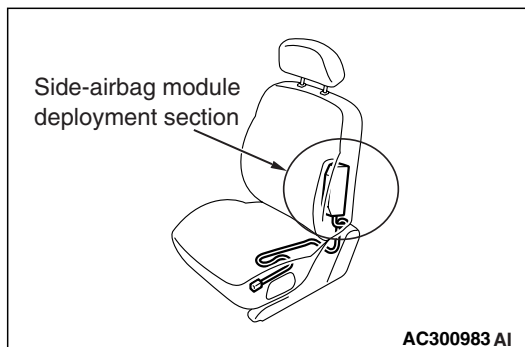
## FRONT SEATBACK ASSEMBLY (SIDE-AIRBAG MODULE)

1. Check the side-airbag module deployment section in the seat for dents and deformation.
2. Check the connectors for damage, the terminals for deformation, and the harness for binds.

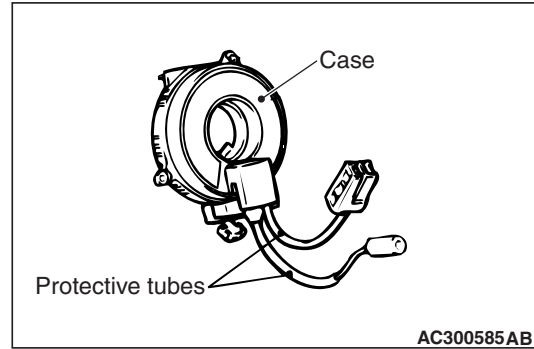
1. Check the clock spring connectors and protective tube for damage, and the terminals for deformation.
2. Visually check the case for damage.

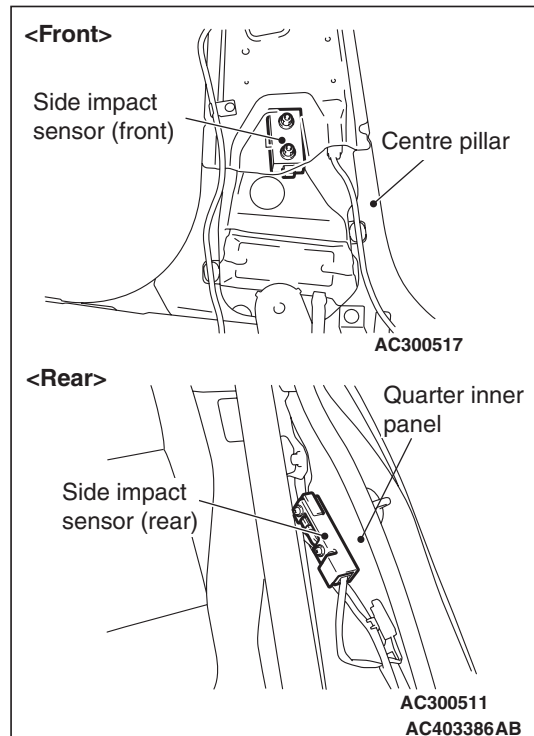
1. Check the centre pillar for deformation or rust.
2. Check the side impact sensors for dents, cracks, deformation and rust.
3. Check the connector for damage and the terminals for deformation.

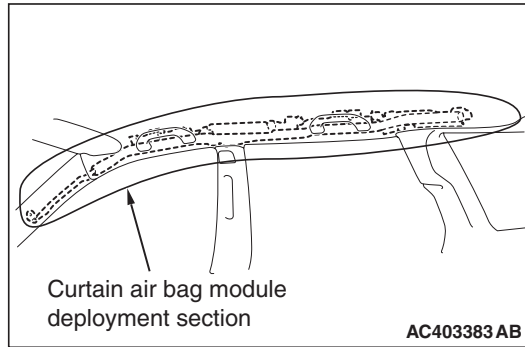
## CURTAIN AIR BAG MODULES

1. Check that the curtain air bag deployment part of the headlining is normal.
2. Check the inflator surface for cracks, dents or deformations.
3. Check the air bag for breakage.
4. Check the connector for damage, the terminal for deformation and the harness for binding.

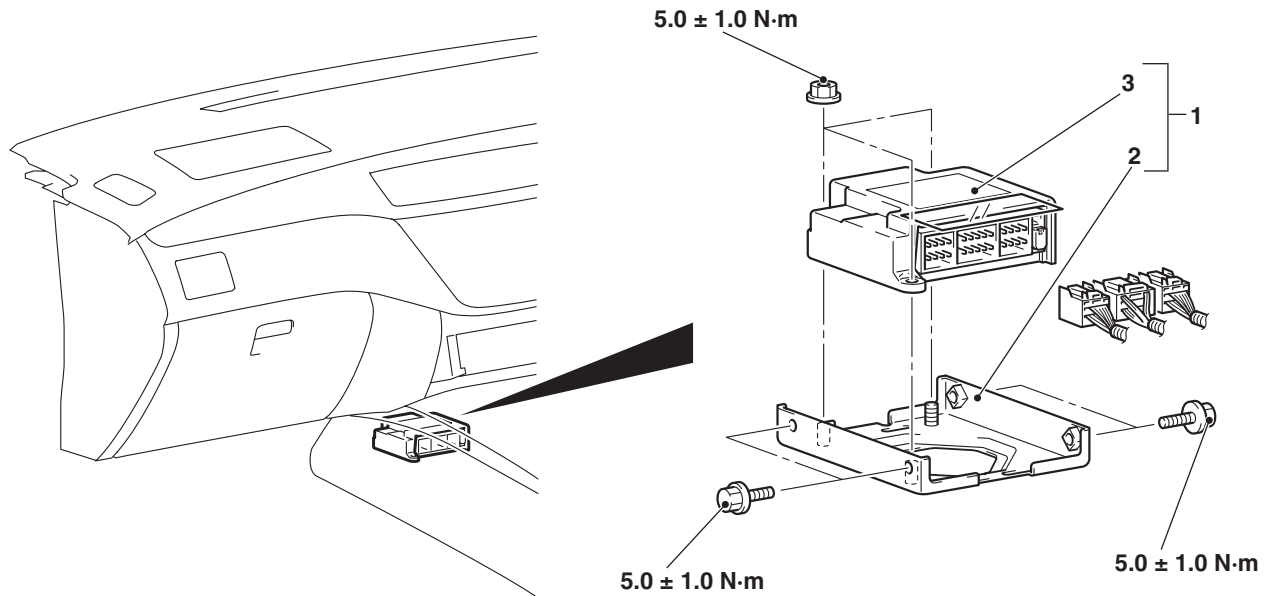
AC300613 AB

#### **Pre-removal Operation**

- Turn the ignition switch to the "LOCK" (OFF) position.
- Disconnect the Negative Battery Terminal.

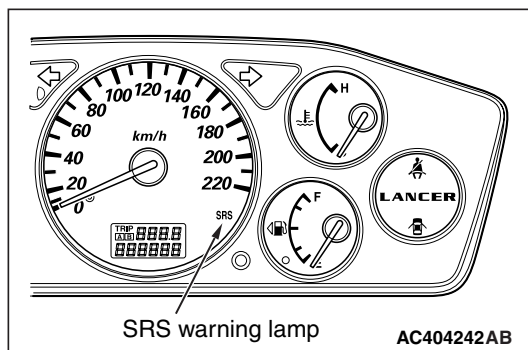
1. Connect the negative battery cable.
2. Turn the ignition switch to "ON" position.

3. Does the SRS warning lamp illuminate for about 7 seconds and then goes out?
4. If no, refer to troubleshooting (Refer to [P.52B-12](#)).

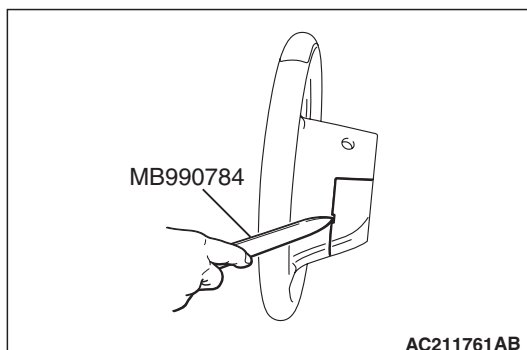
AC211761 AB

**<<A>>COVER REMOVAL**

Insert the special tool ornament remover (MB990784) to remove the cover.

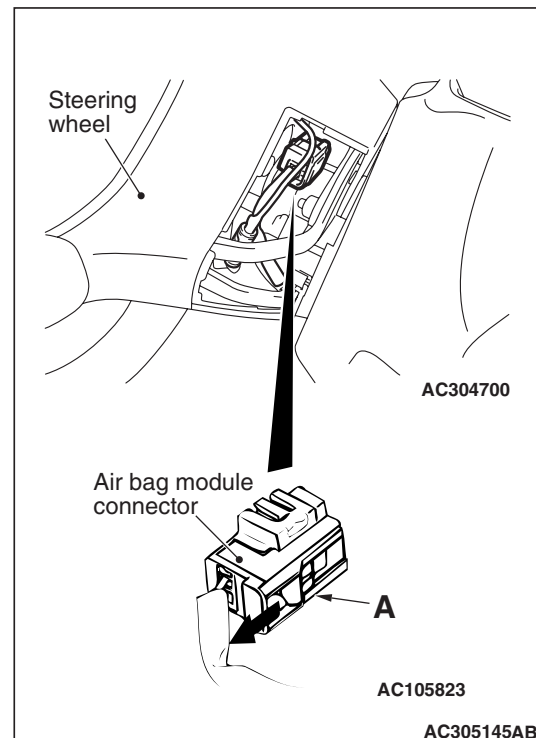
AC305145 AB

1. By sliding the A section (in the figure) of the air bag module connector in the arrow direction, disconnect the connector.

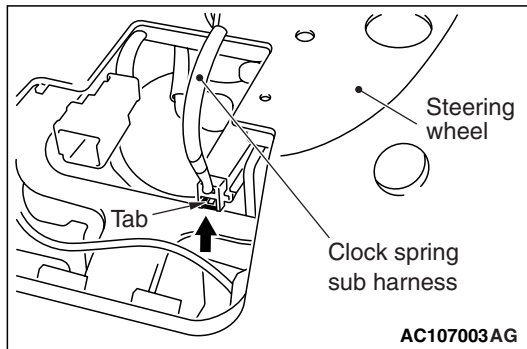
2. Disconnect the connector while pushing its claw to the arrow direction toward the shift switch of clock spring sub harness.

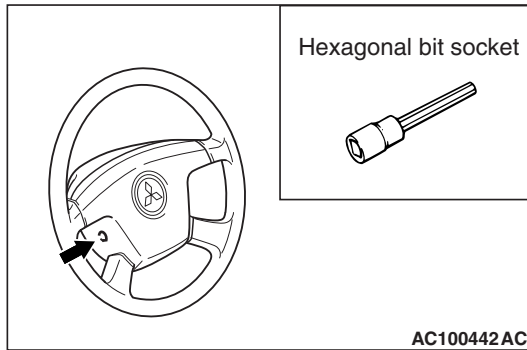
3. Insert the hexagonal bit socket into the arrow section in the figure. Completely loosen the bolt, and then remove the steering wheel air bag module assembly.

**NOTE:** Use a hexagonal bit socket or a hexagonal wrench having an effective length of 75 mm or more in the hexagonal section and the diameter of 8 mm or more.

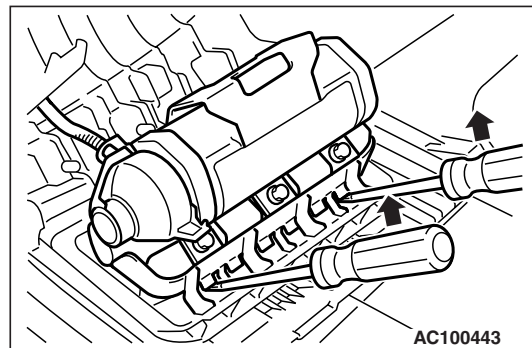
Insert the screwdriver (→) into the position specified in the figure and lift the screwdriver upward to release the pawls engaged, and then remove the passenger's (front) air bag module.

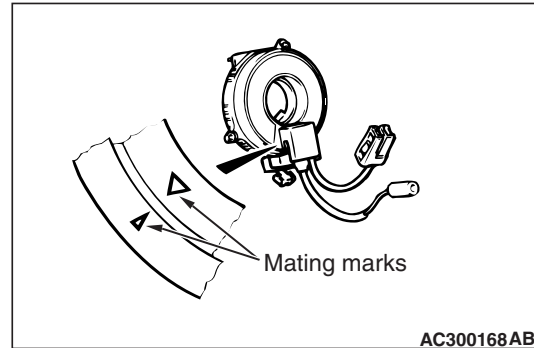
**Ensure that the clock spring's mating marks are properly aligned. If not, the steering wheel may not rotate completely during a turn, or the flat cable in the clock spring could be damaged. This would prevent normal SRS operation and possibly cause serious injury to the driver.**

1. Align the mating marks of the clock spring.

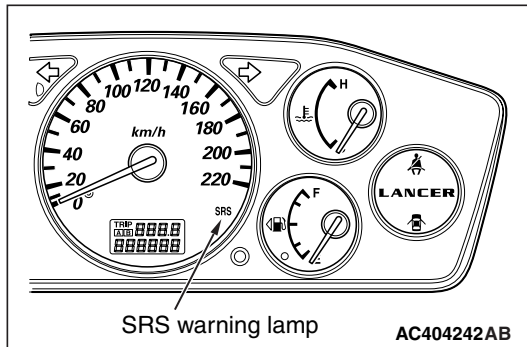
1. Reconnect the negative battery cable.
2. Turn the ignition switch to "ON" position.

3. Does the SRS warning lamp illuminate for about 7 seconds and then goes out?
4. If yes, the SRS system is functioning properly. If no, refer to [P.52B-11](#).

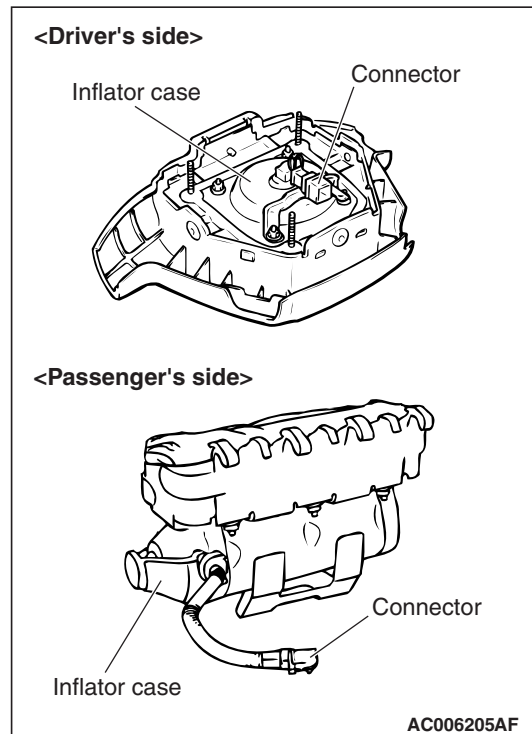
1. Check the pad cover for dents, cracks or deformation.
2. Check the connectors for damage, the terminals for deformation, and the harness for binds.
3. Check the air bag inflator case for dents, cracks or deformation.
4. Install the air bag module (driver's side) to the steering wheel and check fit and alignment with the wheel.
5. Install the air bag module (front passenger's side) to the instrument panel and front deck crossmember and check fit and alignment.

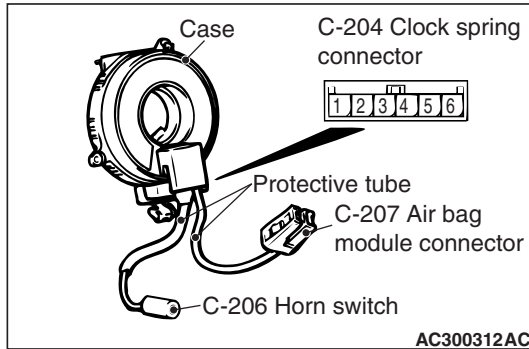
## CLOCK SPRING CHECK

1. Check the connectors and protective tube for damage, and the terminals for deformation.
2. Visually check the case for damage.
3. Check to see that there is a charge (continuity) between the C-204 clock spring connector terminal 1 and C-206 horn switch.

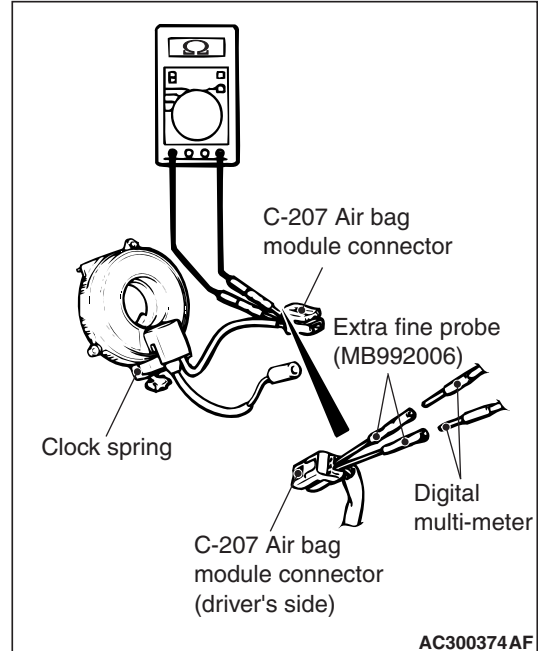
**Do not directly insert a probe, etc. into the terminal from the front of the connector.**

4. Insert the special tool extra fine probe (MB992006) from behind the C-207 air bag module connector (driver's side).
5. As shown in the Figure, connect the circuit tester to the special tool extra fine probe (MB992006) and check to see that there is a charge between the terminals.

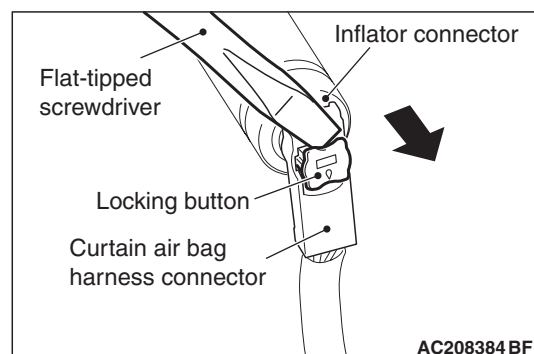
## <<B>>CONNECTOR REMOVAL

Use a flat-tipped screwdriver to pull out forward and unlock the locking button of the curtain air bag harness-side connector.

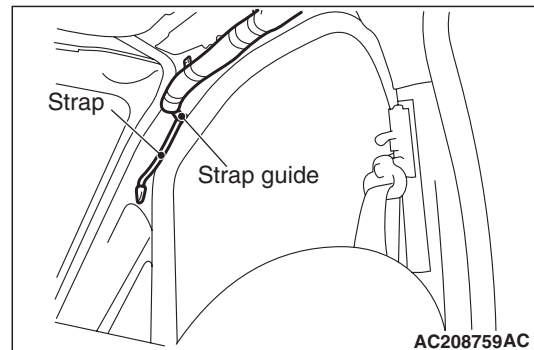
- Take care not to contort the curtain air bag when installing it.
- Take care that the surrounding components do not trap the air bag.
- Take care that the front pillar trim clips or other do not trap the strap.

Hang the strap on the strap guide.

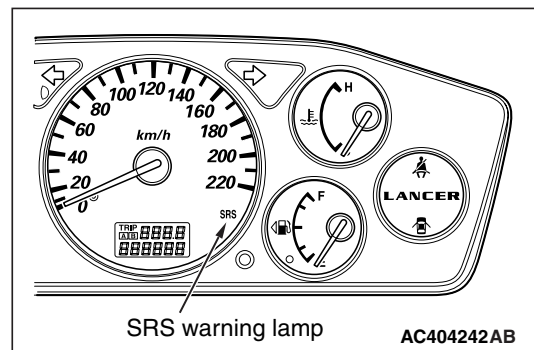
3. Does the SRS warning lamp illuminate for about 7 seconds and then goes out?
4. If yes, the SRS system is functioning properly. If no, refer to P.52B-11.

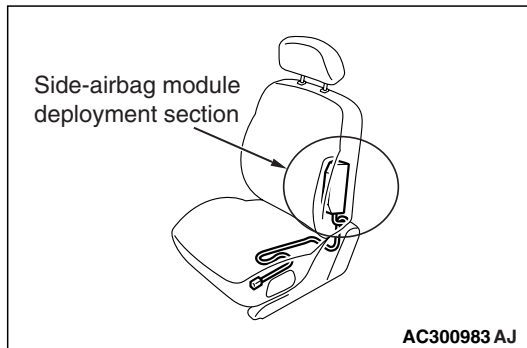
1. Check the side-airbag module deployment section for dents or deformation.
2. Check connector for damage, terminals for deformation, and harness for binds.

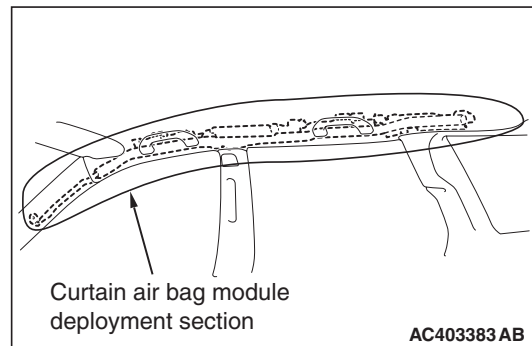
1. Check that the curtain air bag deployment part of the headlining is normal.
2. Check the inflator surface for cracks, dents or deformations.
3. Check the air bag for breakage.
4. Check the connector for damage, the terminal for deformation and the harness for binding.

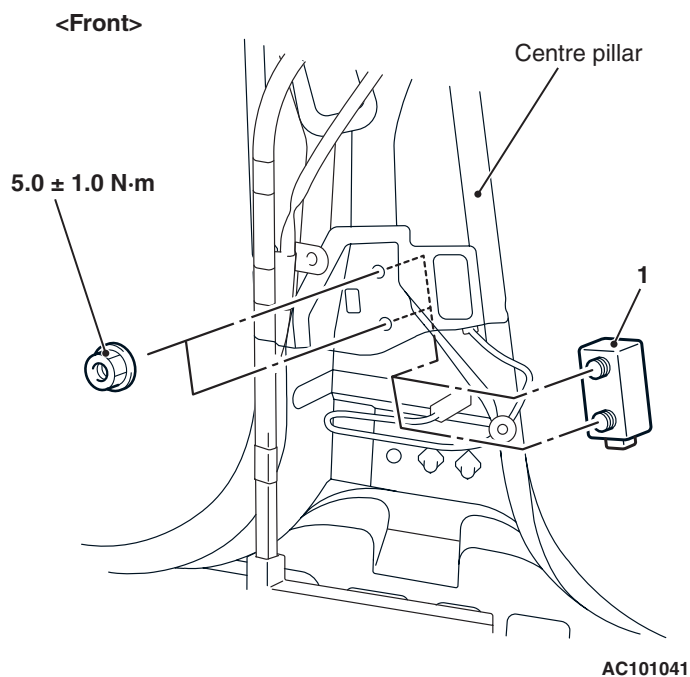
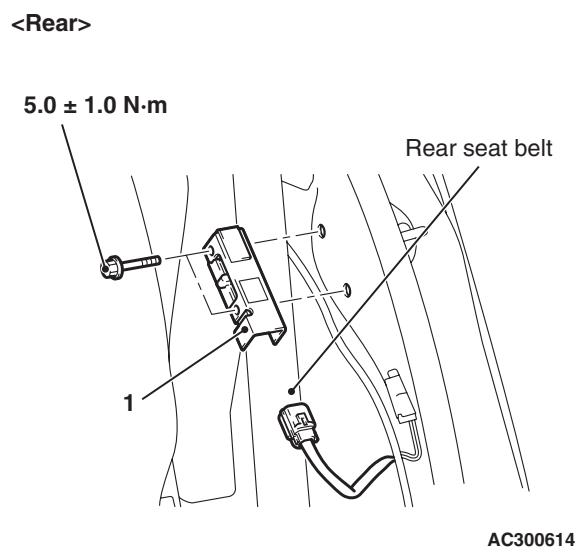
AC403385 AB

**Side impact sensor (front)  
removal steps**

- >>A<<
- Pre-installation inspection
- >>B<<
1. Side impact sensor (front)
  - Seat belt with pre-tensioner (Refer to GROUP 52A, Front seat belt [P.52A-29](#)).
  - Centre pillar trim lower (Refer to GROUP 52A, Trims [P.52A-11](#)).

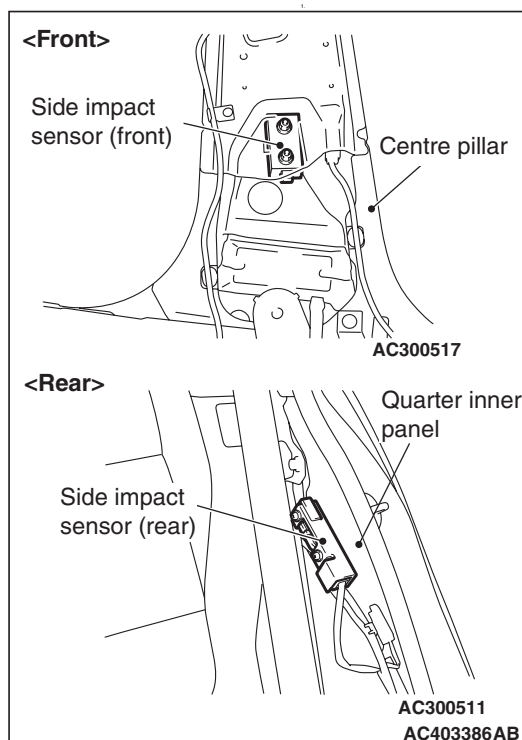
- Check the side impact sensor and bracket for dents, cracks or deformation.
2. Check the connector for damage, and terminal for deformation.
  3. Check the centre pillar and the quarter inner panel for deformation or corrosion.

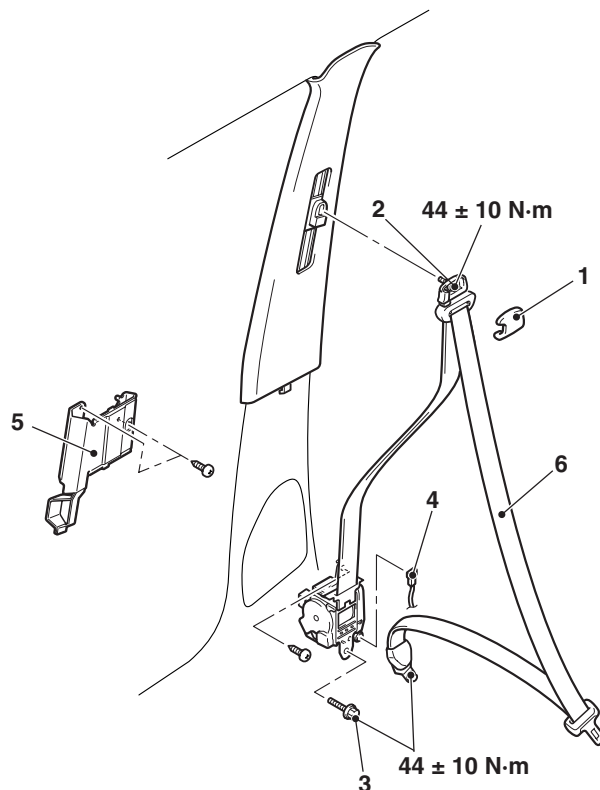
**Removal steps**

1. Sash guide cover
2. Seat belt shoulder anchor bolt
3. Seat belt lower anchor bolt
  - Centre pillar trim, lower (Refer to GROUP 52A, Trims P.52A-11).
4. Seat belt pre-tensioner connector connection
5. Bracket
6. Seat belt with pre-tensioner

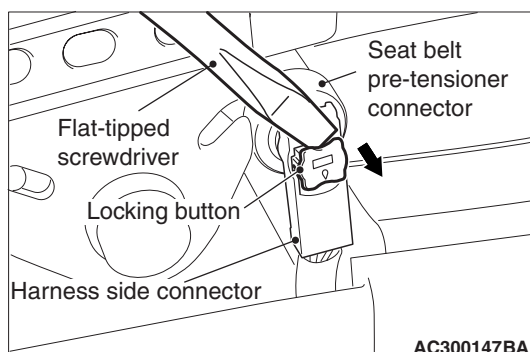
1. Use a flat-tipped screwdriver to pull out forward and unlock the locking button of the harness-side connector.
2. Disconnect the seat belt pre-tensioner connector.

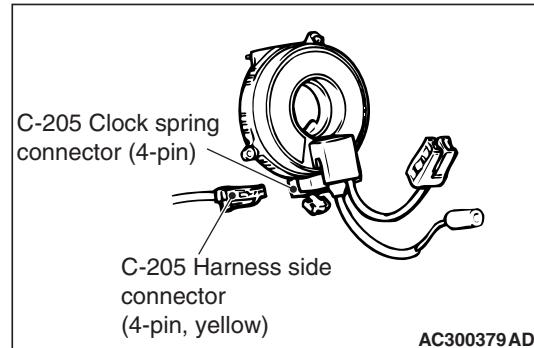
4. Remove the connection between the C-205 clock spring connector (4-pin) and the harness side connector (4-pin, yellow).

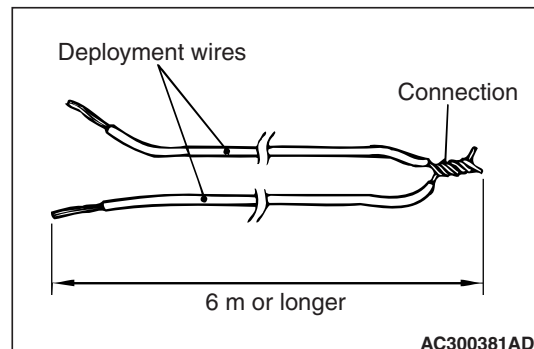
5. Obtain two suitable wires, which are 6 meters or longer, as deployment wires. Then connect the wires at one end to short.
6. Touch the vehicle's body with bare hands to discharge static in you.
