## GROUP 52B

# SUPPLEMENTAL RESTRAINT SYSTEM (SRS)

## GENERAL INFORMATION

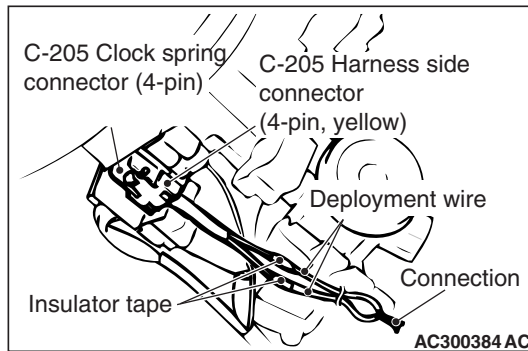
7. Cut with a pliers, etc. the instrument panel wiring harness shown in the figure of the instructions, while the C-205 clock spring connector is disconnected.  
*NOTE: The disconnection location should be sufficiently away from the C-205 harness side connector with consideration to the expansion harness connection location upon disconnections.*
8. Connect the deployment wires on the two instrument panel wiring harnesses disconnected, cover the connection areas with insulator tape and then pull out the deployment wires outside the vehicle.
9. Connect the C-205 harness side connector connected with an expansion harness to the C-205 clock spring connector.

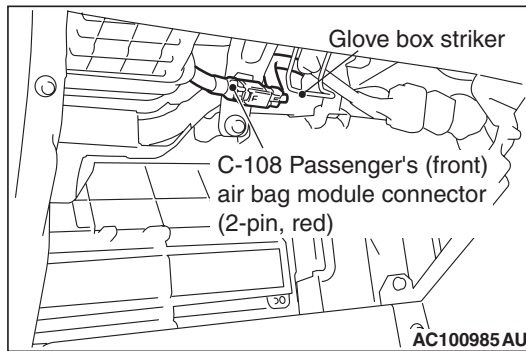
4. Remove the connection between the C-108 passenger's (front) air bag module connector (2-pin, red) and the harness side connector (2-pin, red).

**NOTE:** Once disconnected from the instrument panel wiring harness, both electrodes of the passenger's (front) air bag module short automatically. This prevents the passenger's (front) air bag from accidental deployment caused by static, etc.

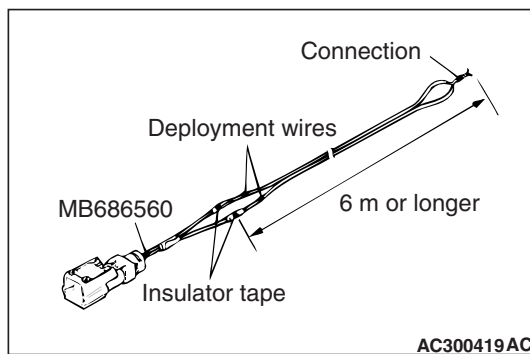
5. Connect deployment wires longer than 6 m to each SRS air bag adapter harness (MB686560) and insulate the connections with insulator tape. Also, connect the deployment wires in the other ends to short, thereby preventing the passenger's (front) air bag from accidental deployment caused by static etc.

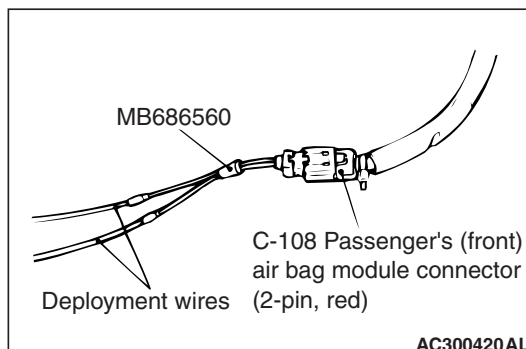
6. Connect the C-108 passenger's (front) air bag module connector (2-pin, red) to special tool SRS air bag adapter harness (MB686560) and move the deployment wires out of the vehicle.

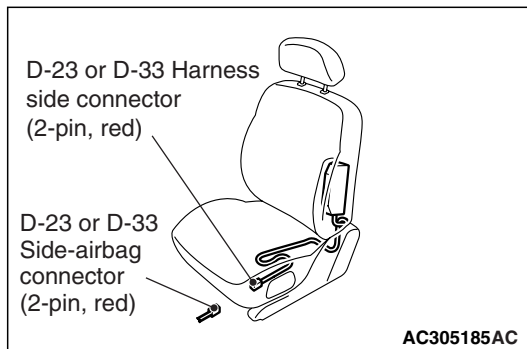
3. Remove the connection between the D-23 or D-33 side-airbag module connector (2-pin, red) and the harness side connector (2-pin, red).  
*NOTE: Once disconnected from the instrument panel wiring harness, both electrode of the side-airbag module connector short automatically. This prevents the side-airbag from accidental deployment caused by static etc.*

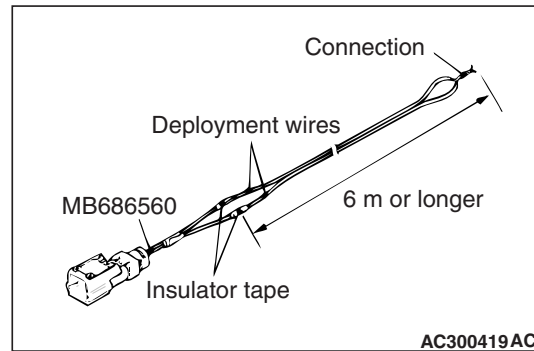
4. Connect deployment wires longer than 6 m to each SRS air bag adapter harness (MB686560) and insulate the connections with insulator tape. Also, connect the deployment wires in the other ends to short, thereby preventing the side-airbag from accidental deployment caused by static etc.

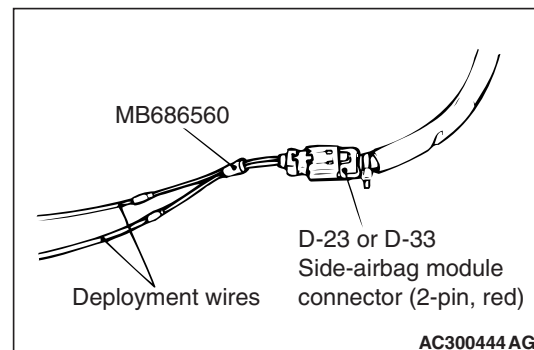
5. Connect the D-23 or D-33 side-airbag module connector (2-pin, red) to SRS air bag adapter harness (MB686560) and move the deployment wire out of the vehicle.

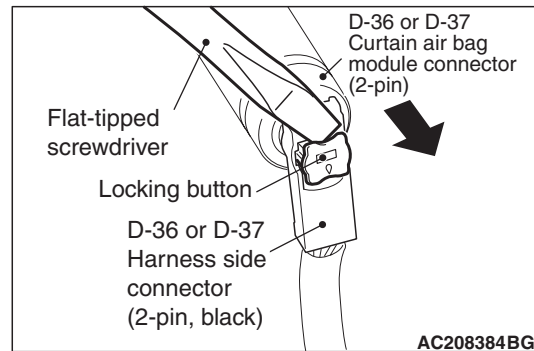
4. Execute the following steps to disconnect the connection between D-36 or D-37 curtain air bag module connector (2-pin) and harness side connector (2-pin, black).

- (1) Use a flat-tipped screwdriver to pull out forward and unlock the locking button of the harness-side connector (2-pin, black).
- (2) Disconnect the D-36 or D-37 harness side connector.

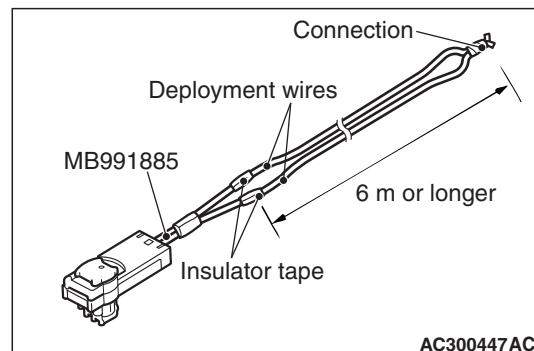
5. Connect deployment wires longer than 6 m to each special tool SRS air bag adapter harness (MB991885) and insulate the connections with insulator tape. Also, connect the deployment wires in the other ends to short, thereby preventing the curtain air bag from accidental deployment caused by static etc.

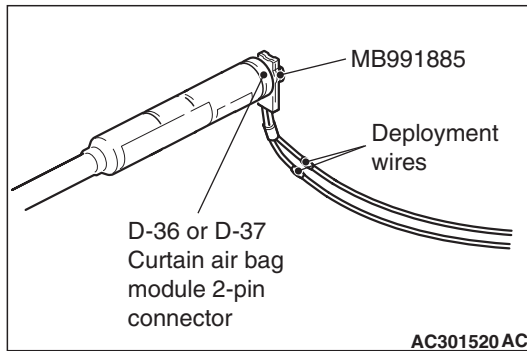
6. Connect the D-36 or D-37 curtain air bag module 2-pin connector (black) to special tool SRS air bag adapter harness (MB991885) and move the deployment harness out of the vehicle.

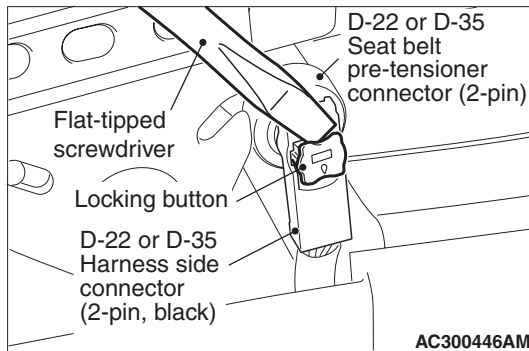
4. Execute the following steps to disconnect the connection between D-22 or D-35 seat belt pre-tensioner connector (2-pin) and harness side connector (2-pin, black).

- (1) Use a flat-tipped screwdriver to pull out forward and unlock the locking button of the harness-side connector (2-pin, black).
- (2) Disconnect the D-22 or D-35 harness side connector.

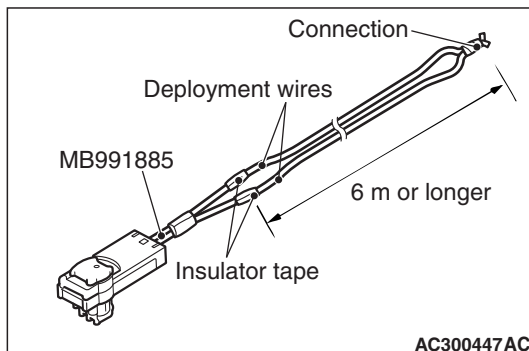
5. Connect deployment wires longer than 6 m to each special tool SRS air bag adapter harness (MB991885) and insulate the connections with insulator tape. Also, connect the deployment wires in the other ends to short, thereby preventing the seat belt pre-tensioner from accidental deployment caused by static etc.

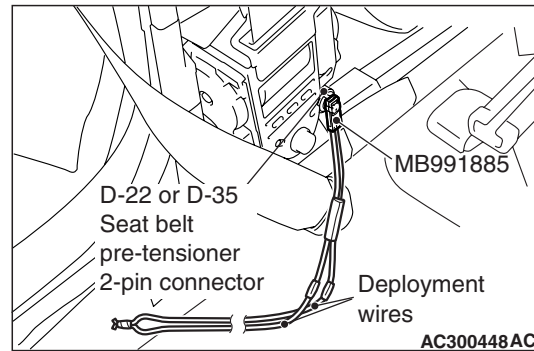
6. Connect the D-22 or D-35 seat belt pre-tensioner 2-pin connector (black) to special tool SRS air bag adapter harness (MB991885) and move the deployment harness out of the vehicle.

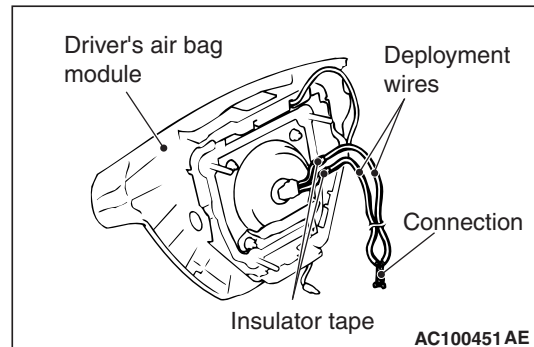
- Using pliers, cut the driver's air bag module connector from the harnesses. Connect the deployment wires to each harness that has been cut and insulate the connections with insulator tape.

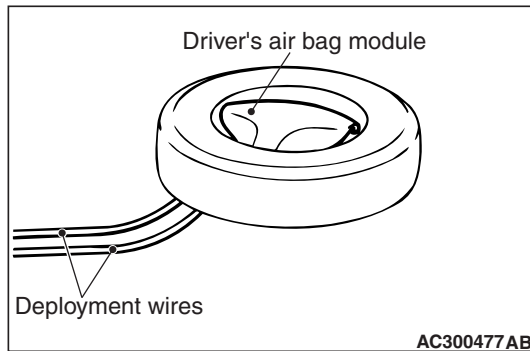
6. Install a nut to the bolt behind the driver's air bag module and tie thick wire there for securing.
7. Route the deployment wires connected to the driver's air bag module beneath an old tyre and wheel assembly. Then, using the wire tied to the bolt, secure the driver's air bag module to the tyre and wheel assembly with the deployment surface facing up.

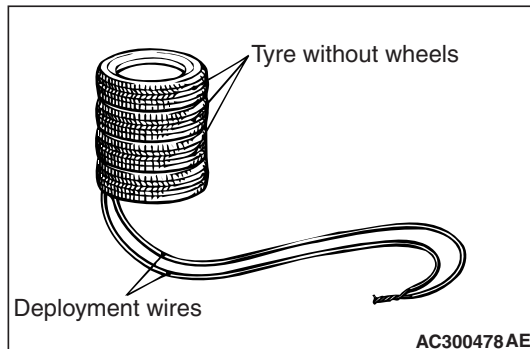
8. Place three old tyres without wheels on the tyre secured with the driver's air bag module.

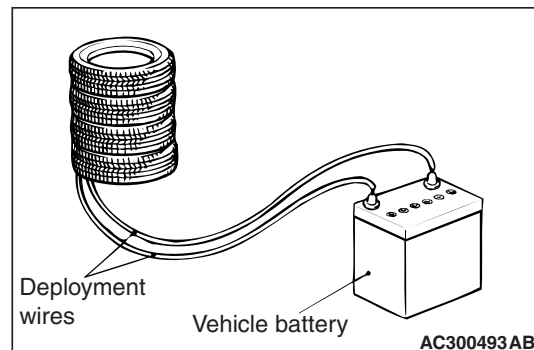
9. At a location as far away from the driver's air bag module as possible, and from a shielded position, disconnect the two connected wires from each other, and connect them, to the two terminals of the battery (which has been removed from the vehicle) to deploy the air bag.
10. Discard the deployed driver's air bag module as specified in Deployed Air Bag Module and Operated Seat Belt Pre-tensioner Disposal (Refer to [P.52B-187](#)).

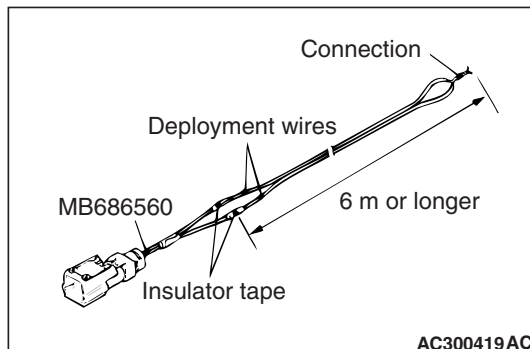
3. Connect deployment wires longer than 6 m to each SRS air bag adapter harness (MB686560) and insulate the connections with insulator tape. Also, connect the deployment wires in the other ends to short, thereby preventing the passenger's (front) air bag from accidental deployment caused by static etc.

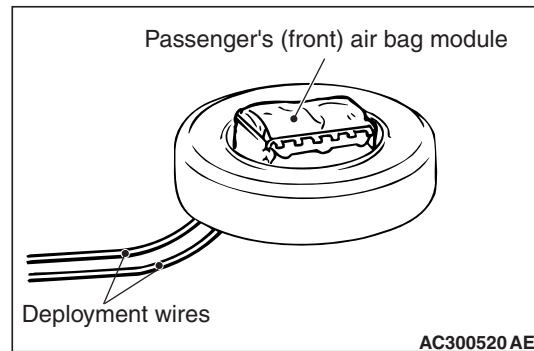
4. Connect the deployment wires to SRS air bag adapter harness (MB686560), pass it beneath the tyre and wheel assembly, and connect it to the passenger's (front) air bag module.

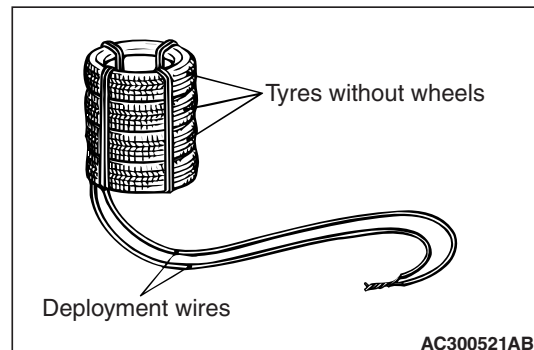
6. Place three old tyres without wheels on top of the tyre secured to the air bag module, and secure all tyres together with ropes (four locations).

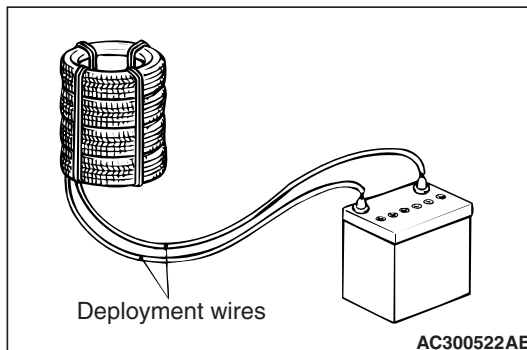
7. At a location as far away from the passenger's (front) air bag module as possible, and from a shielded position, disconnect the two connected wires from each other, and connect them, to the two terminals of the battery (which has been removed from the vehicle) to deploy the air bag.
8. Discard the deployed air bag module as specified in *Deployed Air Bag Module and Operated Seat Belt Pre-tensioner Disposal* (Refer to [P.52B-187](#)).

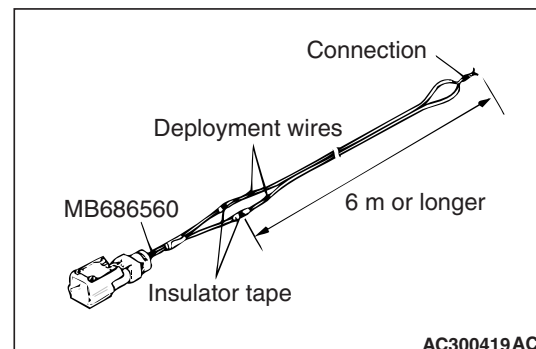
4. Connect deployment wires longer than 6 m to each SRS air bag adapter harness (MB686560) and insulate the connections with insulator tape. Also, connect the deployment wires in the other ends to short, thereby preventing the side-airbag from accidental deployment caused by static etc.

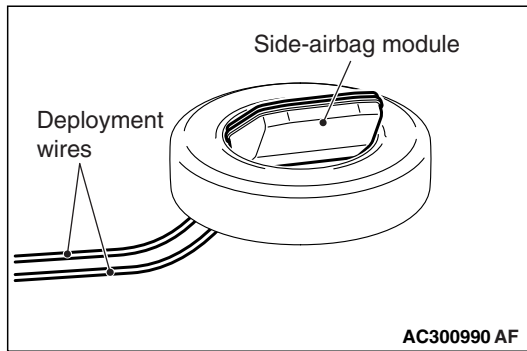
5. Pass the SRS air bag adapter harness (MB686560) connected with deployment wires beneath an old tyre and wheel assembly, and connect it to the side-airbag module connector.

- The adapter harness below the wheel should be loose. If it is too tight, the reaction when the air bag deploys could damage the adapter harness.
  - During deployment, the connector of SRS air bag adapter harness (MB686560) must not be between the tyres.
6. Connect the thick wire to the side-airbag module installation bolt with a used nut, and place the side-airbag module on an old tyre and wheel assembly so that its deployment side is facing upward.

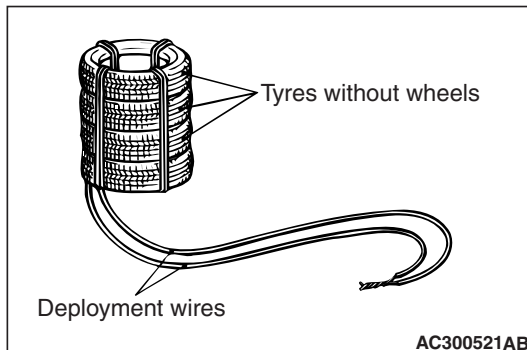
7. Place three old tyres without wheels on top of the tyre secured to the air bag module, and secure all tyres together with ropes (four locations).

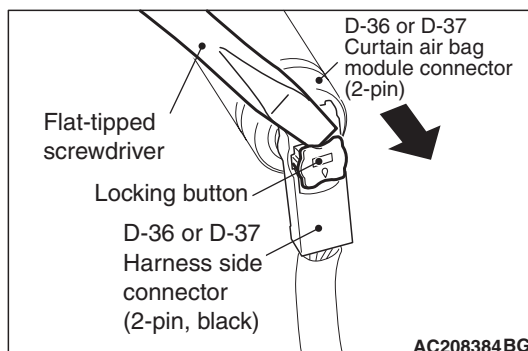
3. Use a flat-tipped screwdriver to unlock the locking button of the harness-side connector (2-pin, black) by with drawing it toward you in two stages.
4. Disconnect the D-36 or D-37 harness side connector.

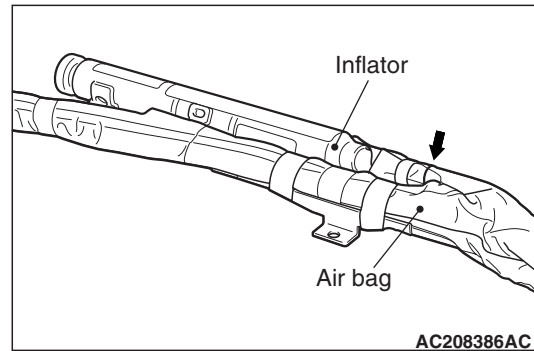
5. Cut the inflator and the air bag with a cutter.

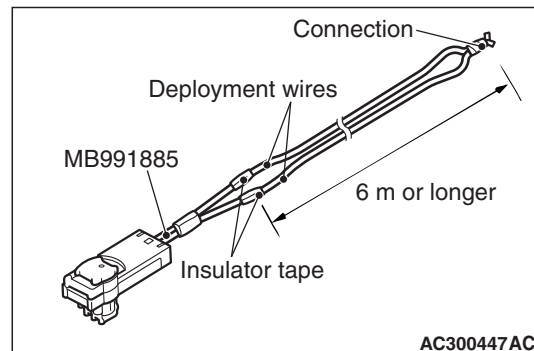
6. Connect deployment wires longer than 6 m to each special tool SRS air bag adapter harness (MB991885) and insulate the connections with insulator tape. Also, connect the deployment wires in the other ends to short, thereby preventing the curtain air bag from accidental deployment caused by static etc.

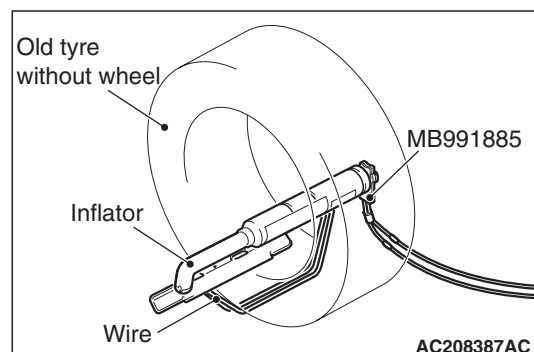
7. Feed a thick wire through the bracket of the inflator, and connect it to an old tyre with a wheel.
8. Connect the SRS air bag adapter harness (MB991885) to the inflator connector.

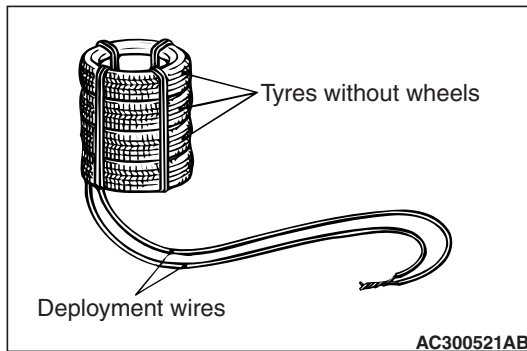
9. Place three old tyres without wheels on top of the tyre secured to the curtain air bag module, and secure all tyres together with ropes (four locations).

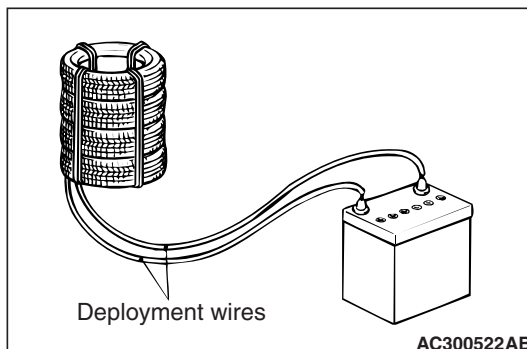
10. At a location as far away from the curtain air bag module as possible, and from a shielded position, disconnect the two connected wires from each other, and connect them to the two terminals of the battery (which has been removed from the vehicle) to deploy the air bag.

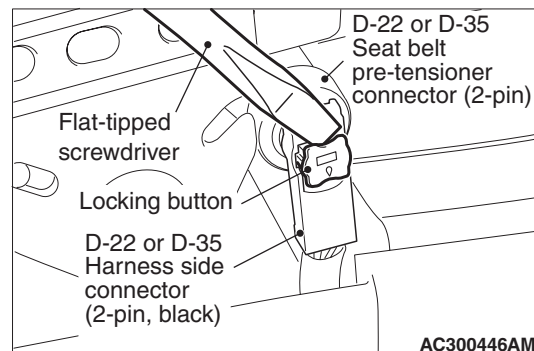
3. Use a flat-tipped screwdriver to unlock the locking button of the harness-side connector (2-pin, black) by with drawing it toward you in two stages.
4. Disconnect the D-22 or D-35 harness side connector.

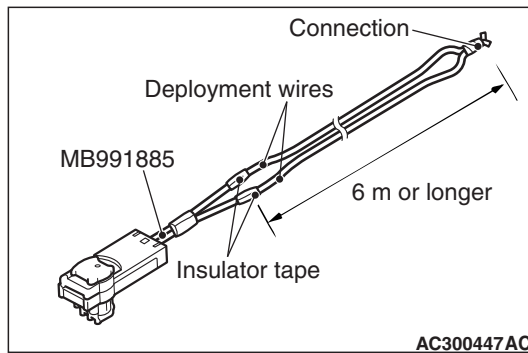
5. Connect deployment wires longer than 6 m to each special tool SRS air bag adapter harness (MB991885) and insulate the connections with insulator tape. Also, connect the deployment wires in the other ends to short, thereby preventing the seat belt pre-tensioner from accidental deployment caused by static etc.
6. Connect the special tool SRS air bag adapter harness (MB991885), which the deployment wires is attached to, to the seat belt pre-tensioner connector.

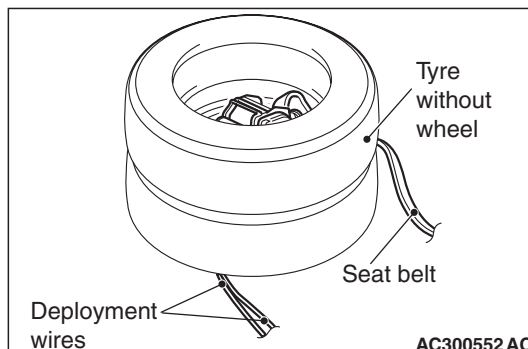
8. Pull the seat belt out the outside of the tyre, and then place one tyre without a wheel inside on top of the existing tyre.

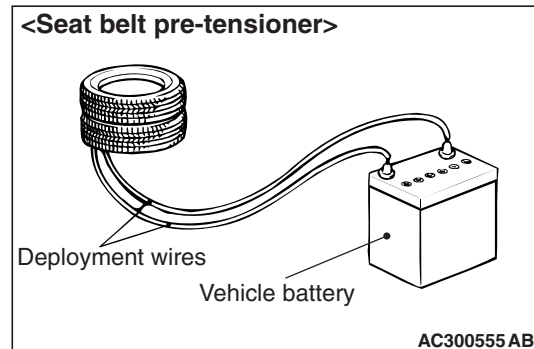
- **If the seat belt pre-tensioner fails to operate, do not go near the seat belt pre-tensioner. Contact your distributor.**
9. At a location as far away from the seat belt as possible, and from a shielded position, disconnect the two connected wires from each other, and connect them to the two terminals of the battery (which has been removed from the vehicle) to operated seat belt pre-tensioner.

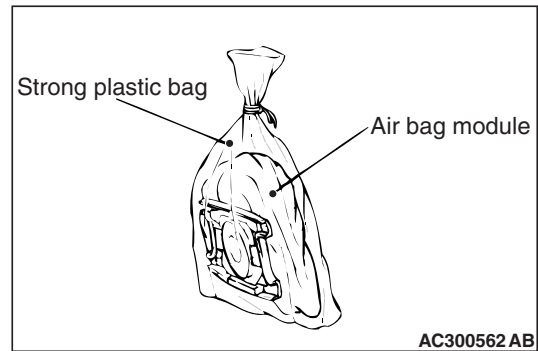
4. Tightly seal the air bag module and seat belt pre-tensioner in a strong plastic bag for disposal.
5. Be sure to always wash your hands after completing this operation.
