SERVICE SPECIFICATIONS

AUTOMATIC TRANSMISSION – Special Tools

TROUBLESHOOTING

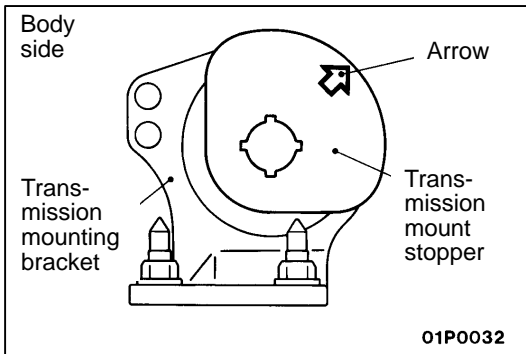
▶B◀ TRANSMISSION MOUNT STOPPER INSTALLATION

Install the transmission mount stopper so that the arrow mark points as shown in the illustration.
